SMELT SPOUT CORROSION IN A RECOVERY BOILER

Dissertação apresentada à Universidade Federal de Viçosa, como parte das exigências do Programa de Pós-Graduação do Mestrado Profissional em Tecnologia de Celulose e Papel, para obtenção do título de *Magister Scientiae*.

**VIÇOSA
MINAS GERAIS - BRASIL
2010**

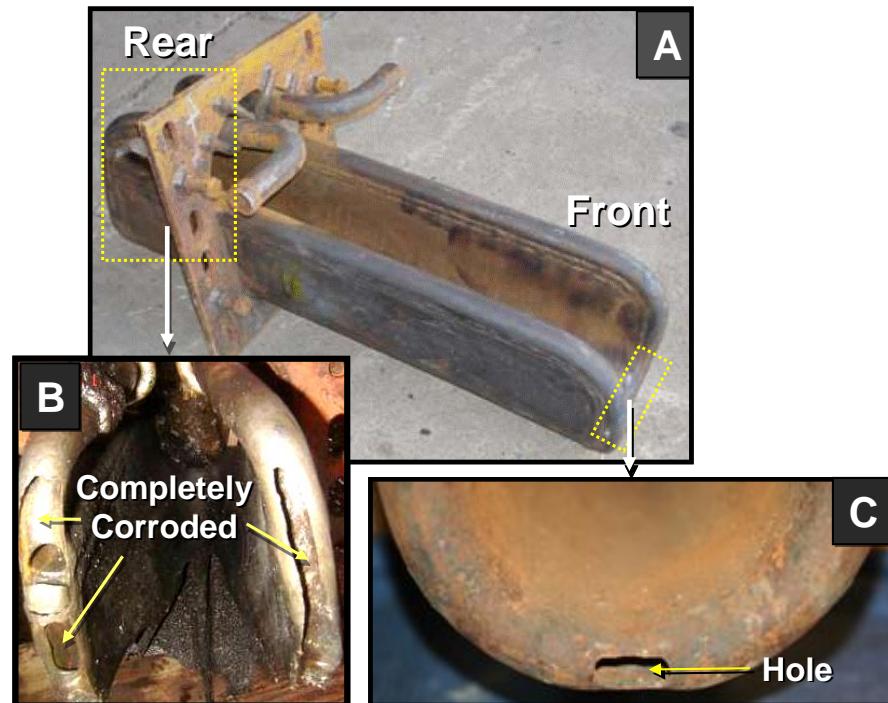
Figure 2. Large perforations at the rear end and a hole at the front lip of the severely corroded Spout #5.

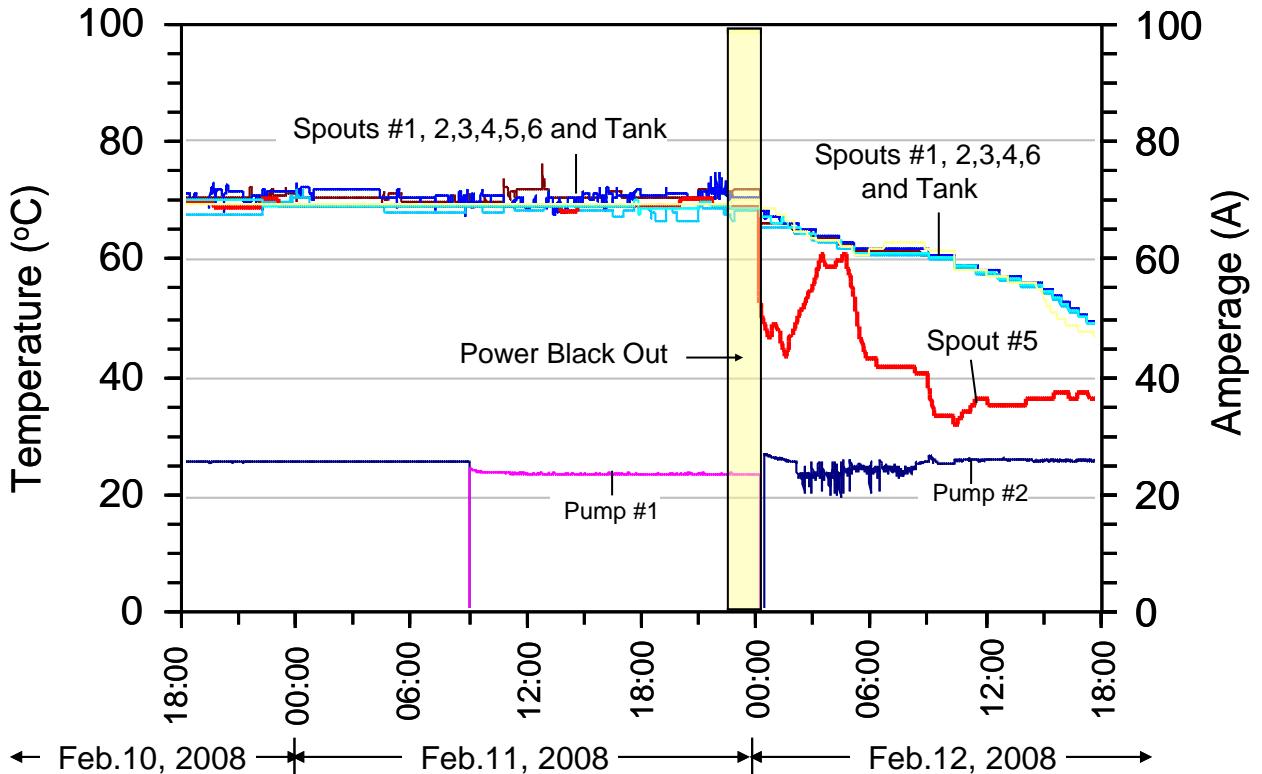
Figure 4 shows the trend data for the cooling water temperatures from individual spouts and the amperages of the recirculation pumps for the period before and after the blackout. Before the blackout, the cooling water temperature from all six spouts appeared to be normal, $70 \pm 3^{\circ}\text{C}$. After the black out, however, the cooling water temperature of spout #5 behaved erratically and was much lower than those of other spouts. This indicates that something had happened to spout #5, although it was not noticed at the time because the boiler was down.

Figure 4. Cooling water trend before and after the blackout period

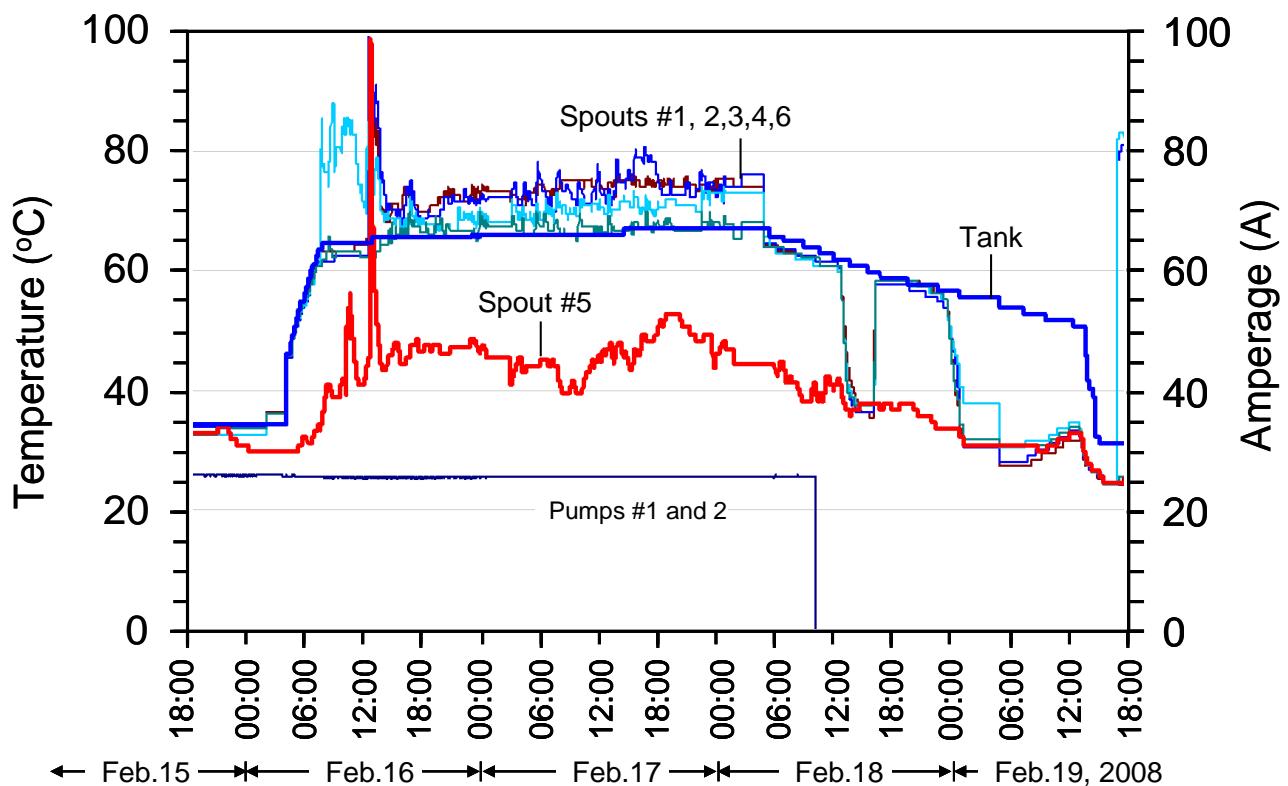
The boiler was firing 1800 t BLds/d when ESP was initiated. The sequence of events shows that the boiler had been burning black liquor with spout #5 operated at an usually low cooling water temperature for nearly 2 days before the ESP.

Figure 5. Cooling water trends on restart of #2 recovery boiler

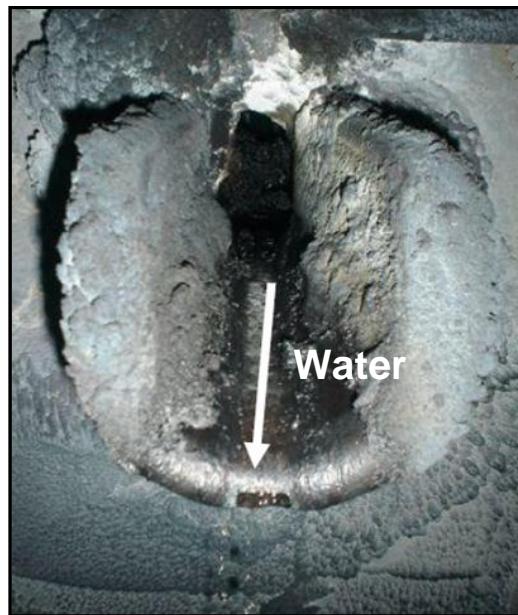
An initial inspection at the smelt spout floor about 12 hours after the ESP showed water running down the trough of spout #5 from within the furnace as well as from a hole at the

Figure 6. Water running out of spout #5 from inside the furnace, 12 hours after ESP.

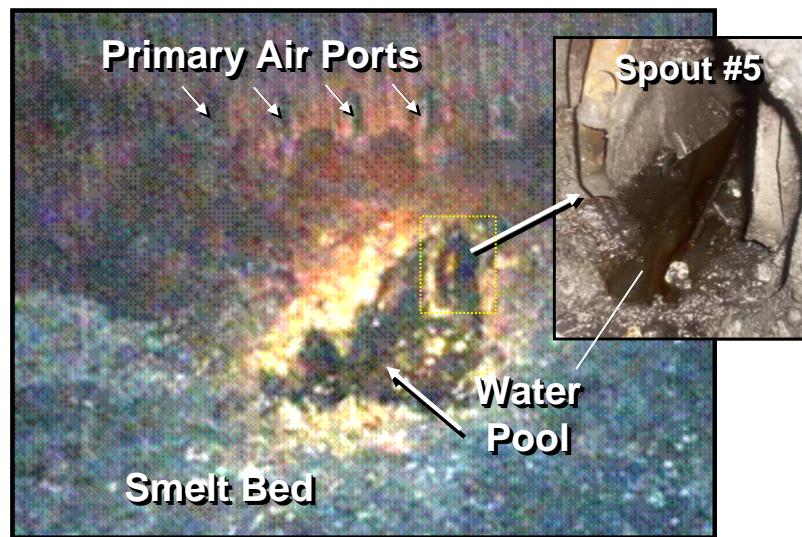
spout lip (Figure 6). From a mandoor one floor above the spout floor, a pool of water could be seen around spout #5 (Figure 7). A close look at the rear end of the spout revealed that the inlet and outlet of the cooling water tubing and the trough were completely corroded through, and some water still remained on the trough (Figures 7, 2B, and 8B).

Figure 7. Water pool accumulated on frozen smelt bed at the spout #5 opening. Box photo shows extensive damage to the cooling water tubing and water on spout trough

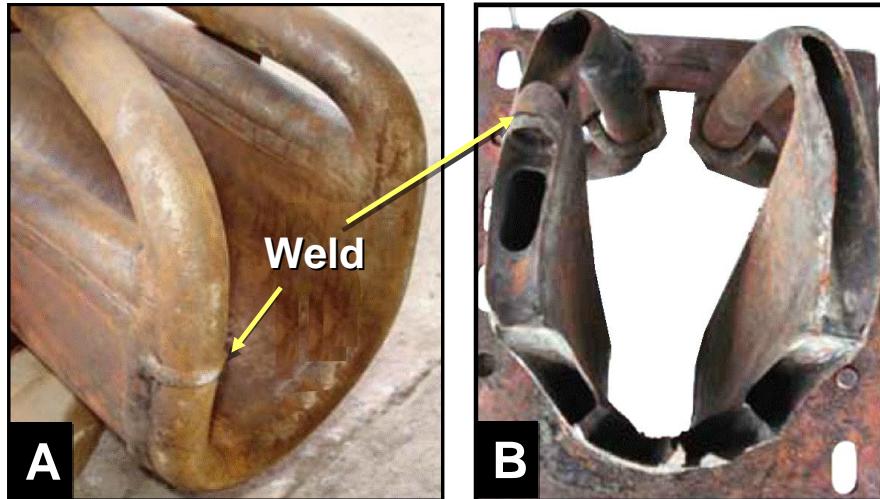
Non destructive dye-penetrant tests, thickness measurements and visual inspection were performed on all spouts and waterwall tubes near spout openings. The results showed that waterwall tubes were intact and that spout #1, 2, 3, 4 and 6 were in excellent condition with no signs of thinning, cracking or internal deposits. On spout #5, however, in addition to large perforations along the cooling water tubing at the rear end of the spout, there appeared to be a defect in the weld that joined the inlet cooling water tube and the outlet tube as can be seen on figures 8A and B.

Figure 8. (A) Weld connecting the cooling water tube to the spout at the rear end of a good spout. (B) Suspected “defect” on the weld joining the inlet and outlet cooling water tubes of spout #5

The suggested “defect” found in the weld of spout #5 (Figure 8) may play a role in its failure. It is possible that the sudden temperature change in the boiler due to power blackout may have caused the weld to fail, resulting in a small crack through which cooling water leaks out to the furnace. This, in turn, reduces the cooling water flow to the spout, causing it to overheat, and hence, to corrode. As the crack becomes larger, more water leaks out and less passes through the spout, aggravating the problem further.

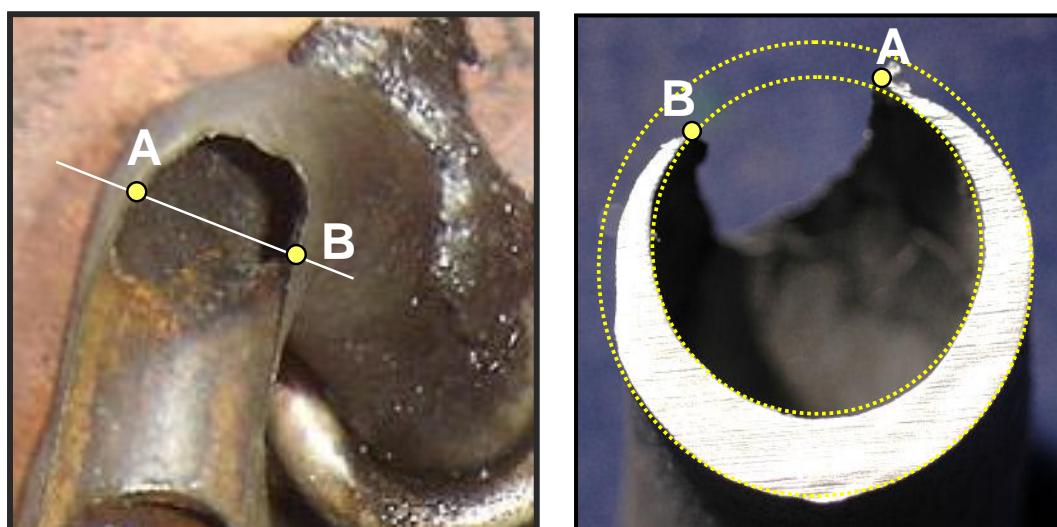
The metallurgical analysis by Nalco revealed that the metal loss of spout #5 was mainly from the external surface (Figure 9). In the areas of severe wastage and along the bottom of the trough, the metal surface was smooth with signs of gouging, resulting presumably from the erosion-corrosion action of molten smelt flowing over the spout surface (Figure 10). The analysis also revealed that the wastage on spout #5 was mainly on the furnace side where heat input is greatest, suggesting a strong temperature dependence of corrosion rates. The microstructure consisted of spheroidized carbides in a ferrite matrix (Figure 11), suggesting that the metal temperature must have exceeded 540°C (1000°F) for a period of time.

Figure 9. Cross section through a perforation on the cooling water tubing of spout #5 showing severe external metal loss. Broken circles are contours of original tube surfaces. The difference in original tube thickness is due to bending.

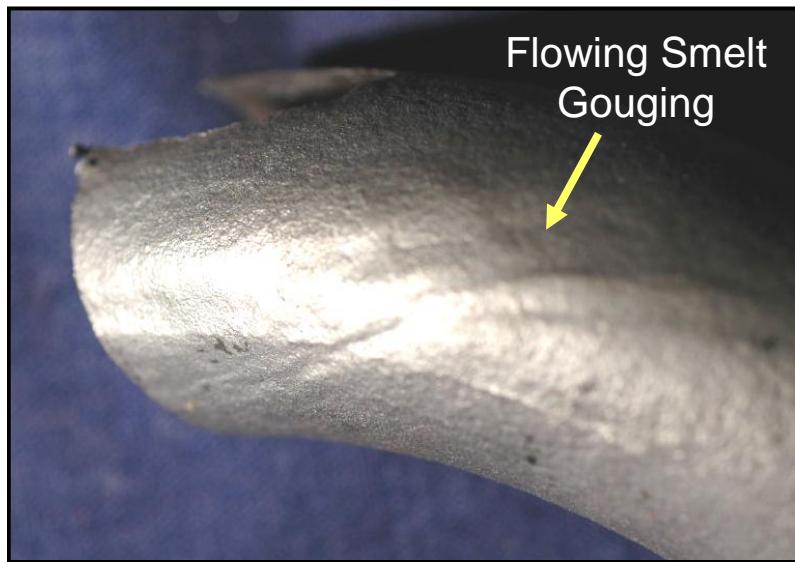
Figure 10. Smooth surface of spout #5 with signs of gouging by molten smelt.

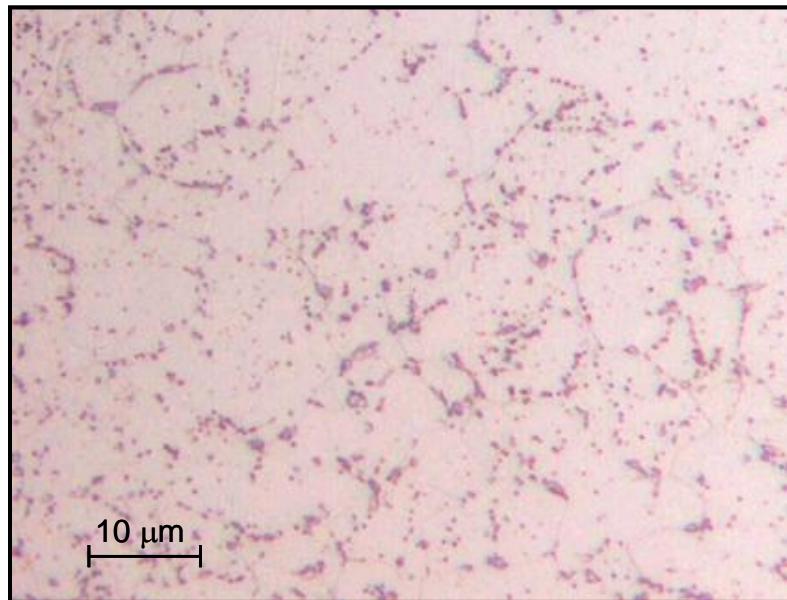
Figure 11. Microstructure of the metal near the corroded area of spout #5

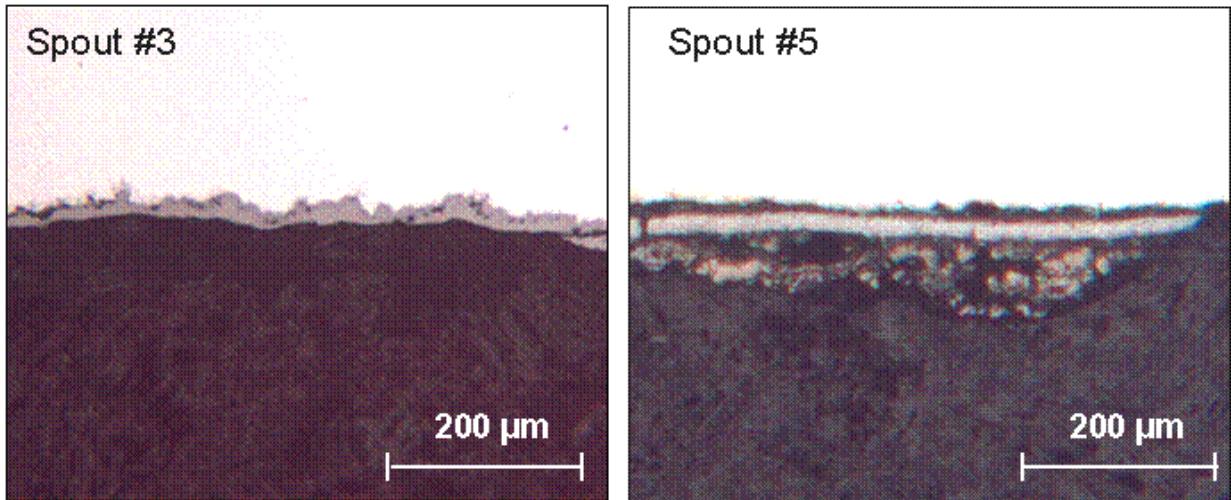
Although some wastage was also observed along the bottom of the trough of spout #3, the extent was insignificant and was expected of a smelt spout that has been in service for 10 months. The internal surface was covered with only a thin and dense layer of oxides (Figure 12), as opposed to thick layers of deposits and oxides observed on the internal surface of

spout #5. This implies that spout #3 did not experience significant overheating, despite the fact that it had its cooling water flow cut off just before the ESP and would have been exposed to smelt flow for some time while the ESP was in effect.

Figure 12. Internal surface of Spout #3 (left) and Spout #5 (right)

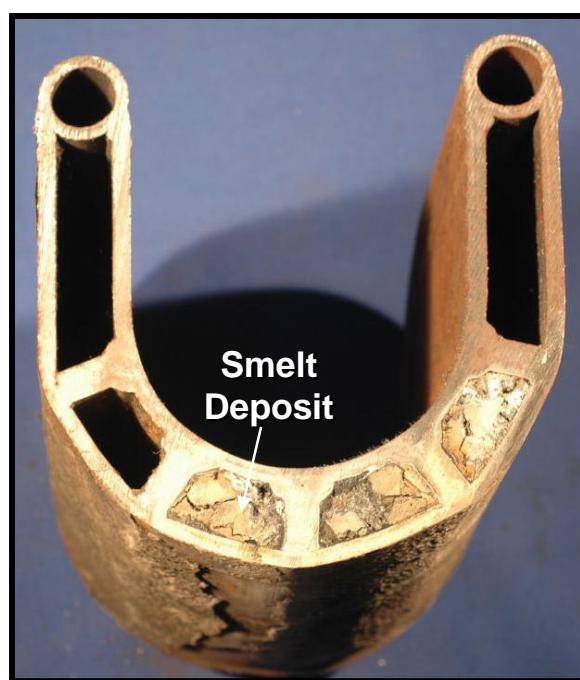
The leaked water begins to accumulate in the furnace near the spout when there is more of it there than it can vaporize. It forms a pool of concentrated smelt solution (saturated green liquor) which pours out the boiler through the spout. This concentrated smelt solution can also be detrimental to the spout (carbon steel) for two main reasons: i) it contains corrosive $\text{Na}_2\text{S}_2\text{O}_3$ as a result of partial oxidation of Na_2S in the solution, and ii) it cannot vaporize easily due to boiling point rise and thus can remain as liquid at a temperature as high as 180°C [3]. Some smelt solution entered the interior of spout #5 where it re-crystallized to form deposits, leading eventually to complete clogging of cooling water passes, as shown in Figure 13.

Figure 13. Crossed section of spout #5, showing smelt deposits locking cooling water passage.

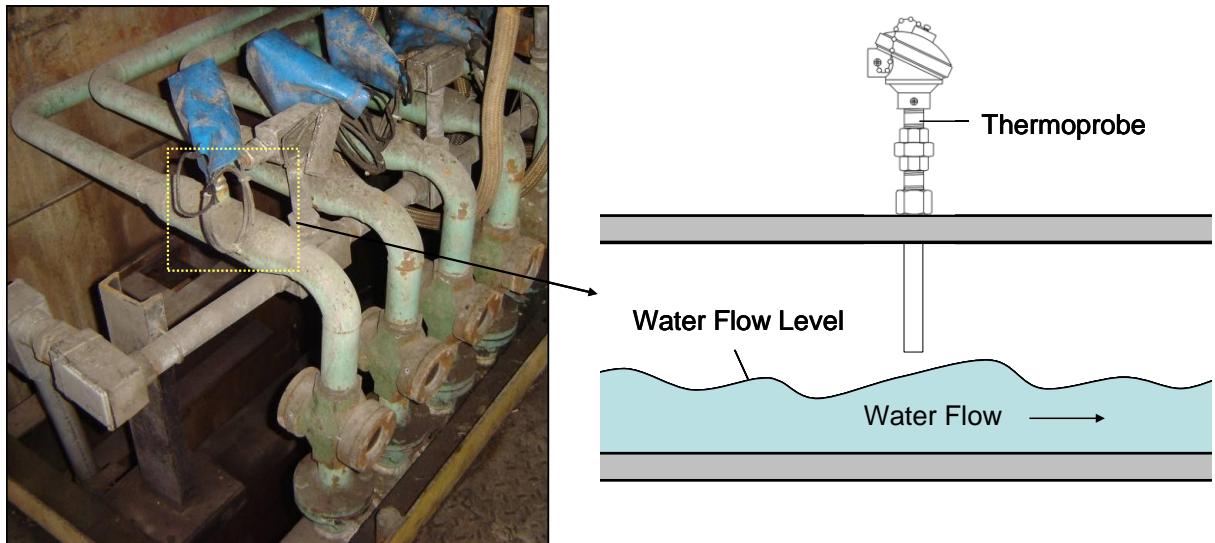
The clogging, in turn, impaired the cooling water flow, forcing it to partially by-pass the spout and flow directly to the outlet tube. This could be one of the reasons for the lower cooling water temperature of spout #5 compared to other spouts. There are two other possible reasons for the low cooling water temperature. One is the lower flow rate and temperature of molten smelt flowing over the spout because of the cooling effect of leaked water. The other is that due to the reduced flow rate of the cooling water from spout #5, the water level in the pipe line was low, and so, the thermoprobe might not be able to “touch” the water to provide proper temperature readings (Figure 14).

Figure 14. Thermoprobe and suspected water level in the cooling water pipe line during the time of reduced flow rate.

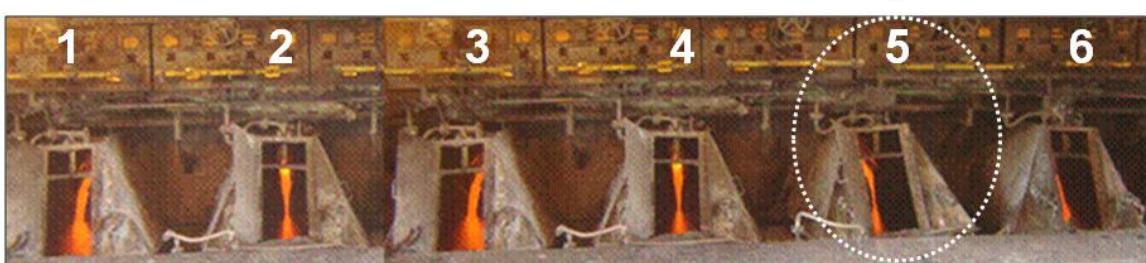
Corroded
Spout

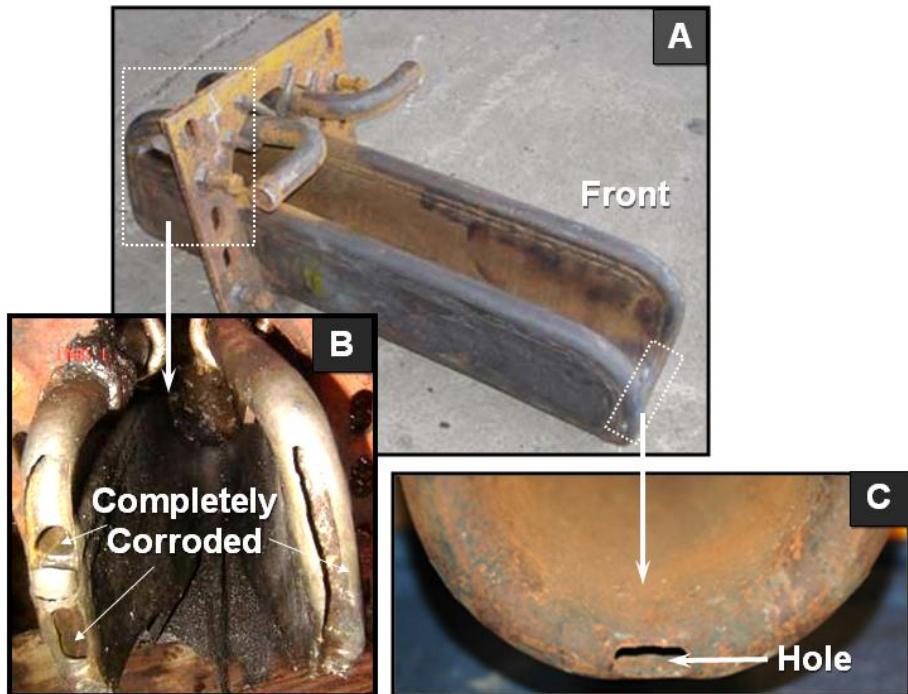
Corrosion in Spout #5

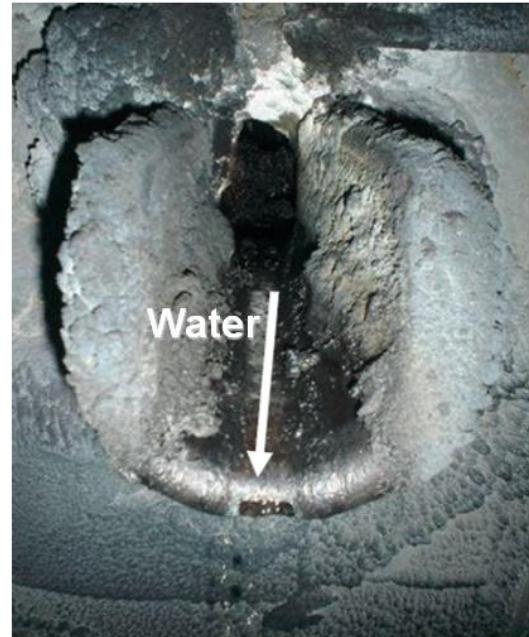
- Water was still running down the trough of spout #5 from within the furnace as well as from a hole at the spout lip about 12 hours after the ESP

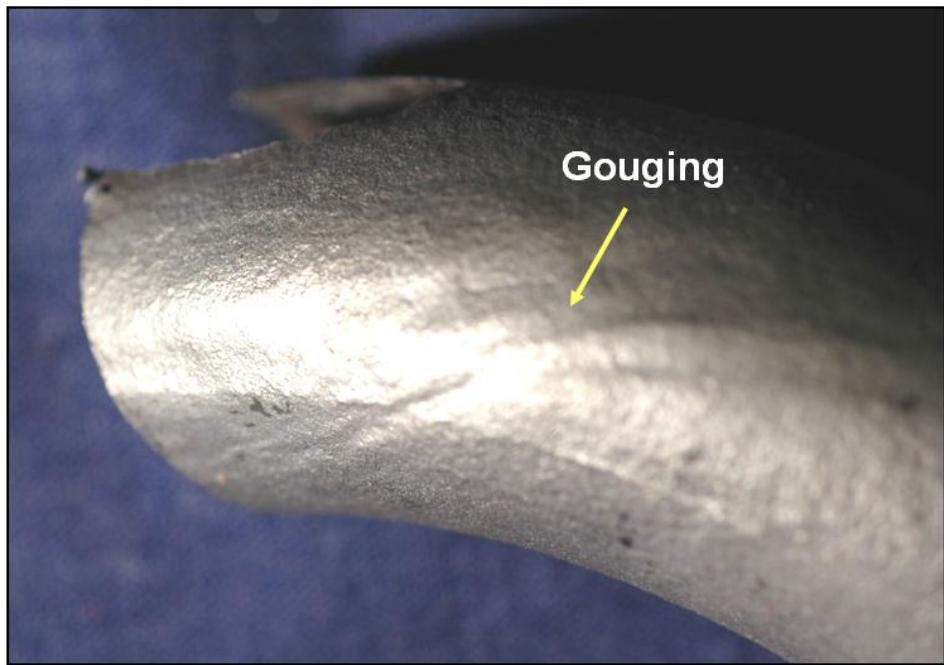
Flowing Smelt Gouging

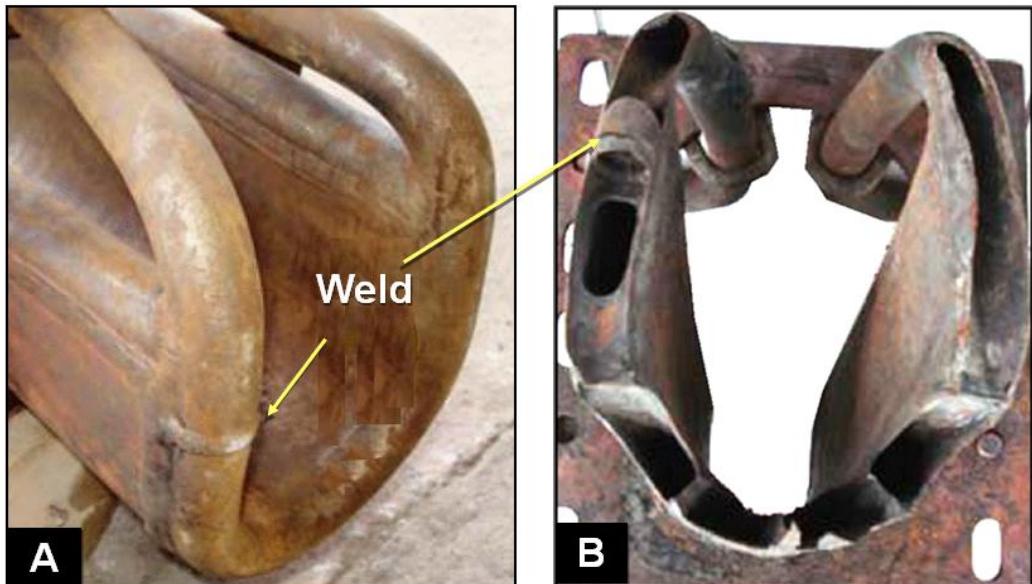
Weld Defect?

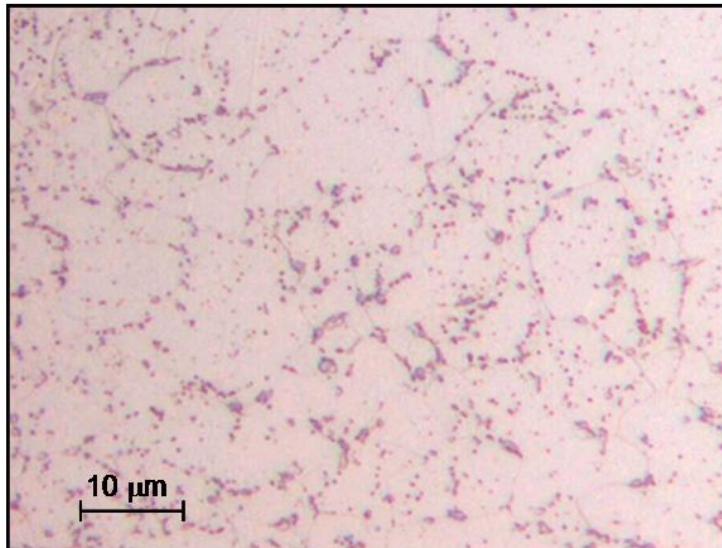
Microstructure of the metal near the corroded area of spout #5

Microstructure consisting of spheroidized carbides in a ferrite matrix → Typical of overheating.

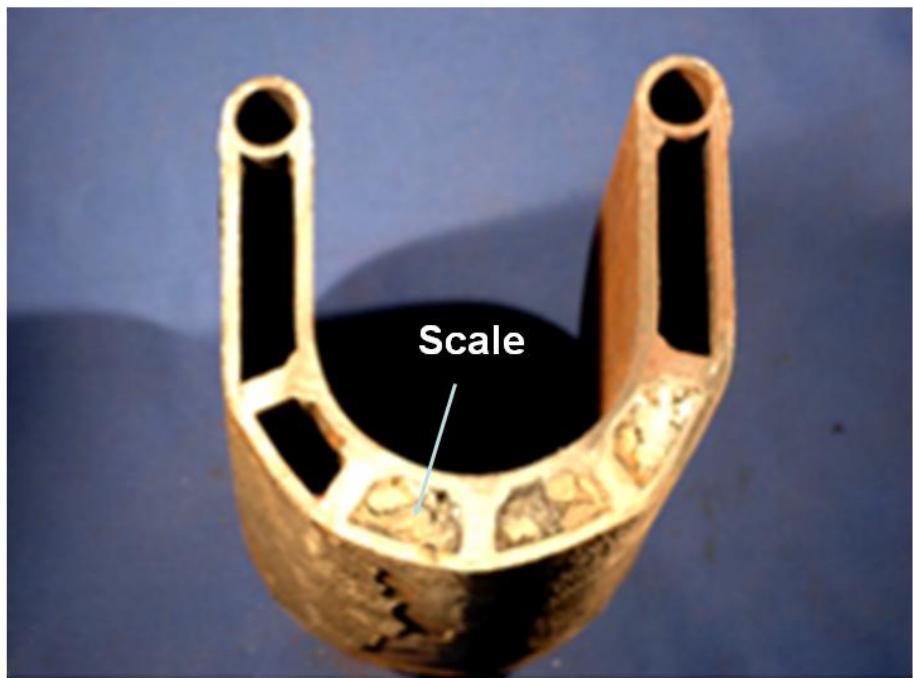
Smelt Deposits in Water Passages
