**DURABILIDADE E PROPRIEDADES MECÂNICAS DE COMPÓSITOS
CIMENTÍCIOS REFORÇADOS POR FIBRAS DE SISAL**

Flávio de Andrade Silva

Tese de Doutorado apresentada ao Programa de Pós-graduação em Engenharia Civil, COPPE, da Universidade Federal do Rio de Janeiro, como parte dos requisitos necessários à obtenção do título de Doutor em Engenharia Civil.

Rio de Janeiro
Abril de 2009

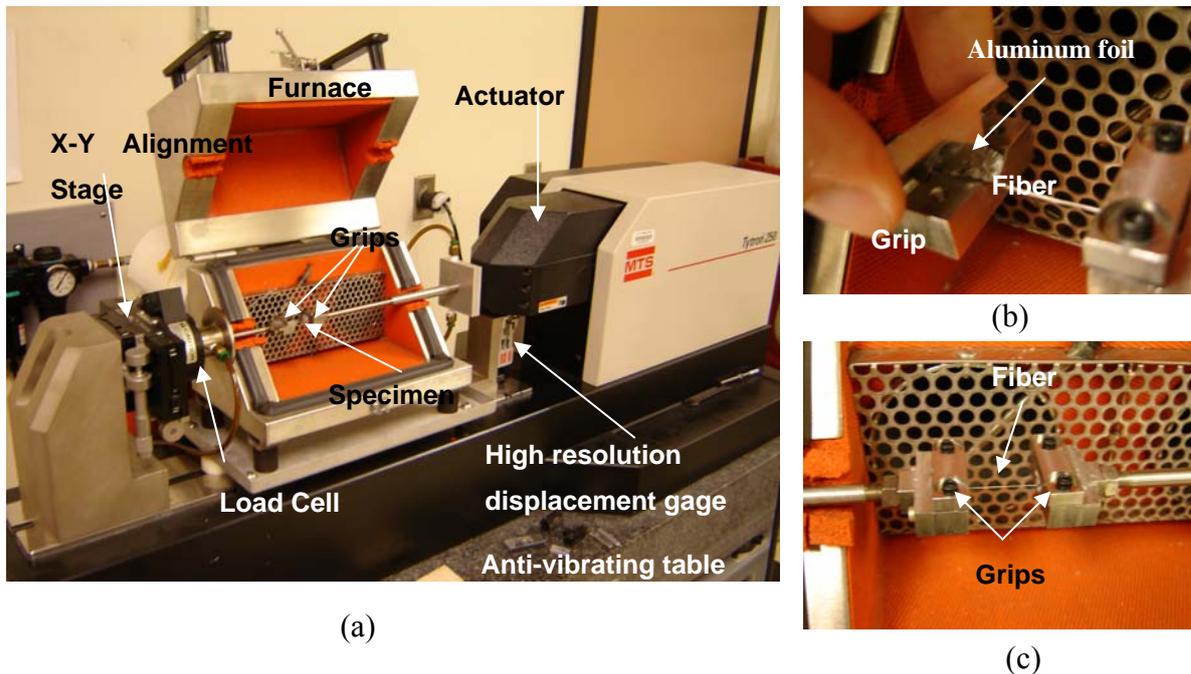
Fig. 4. Tytron microforce testing system used for the tensile test: (a) general view (b) and (c) detail of the grip and fiber.

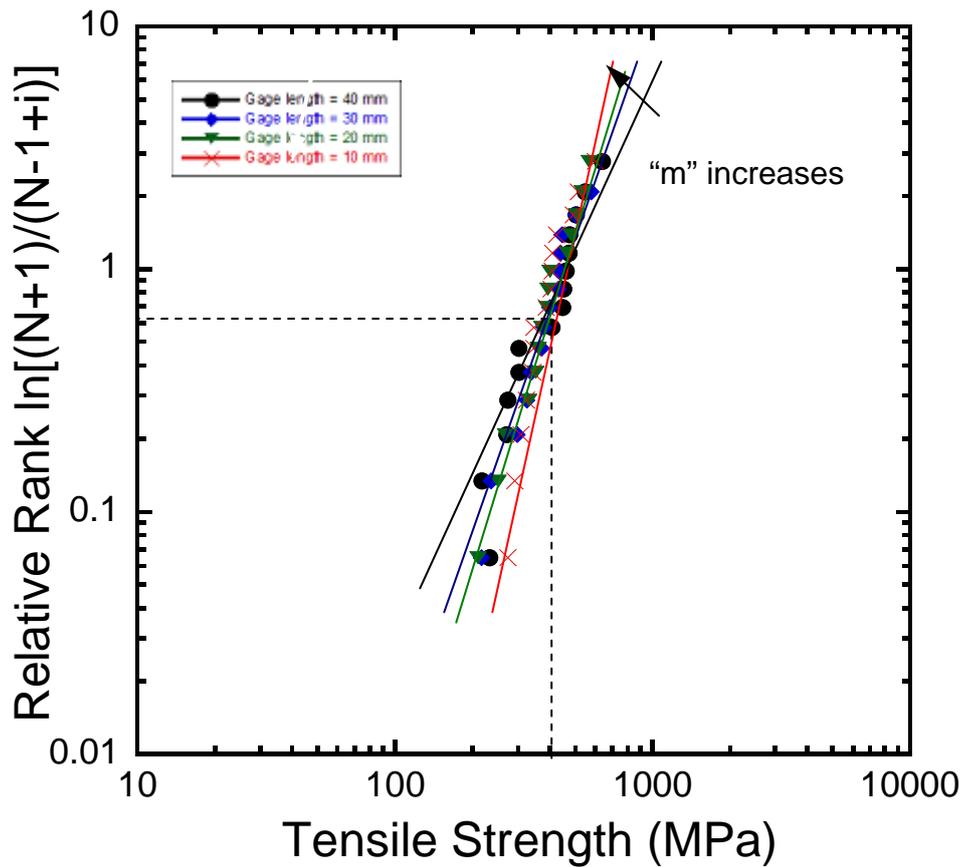
Fig. 8. Weibull distribution of the sisal fiber tensile strength for different gage lengths.

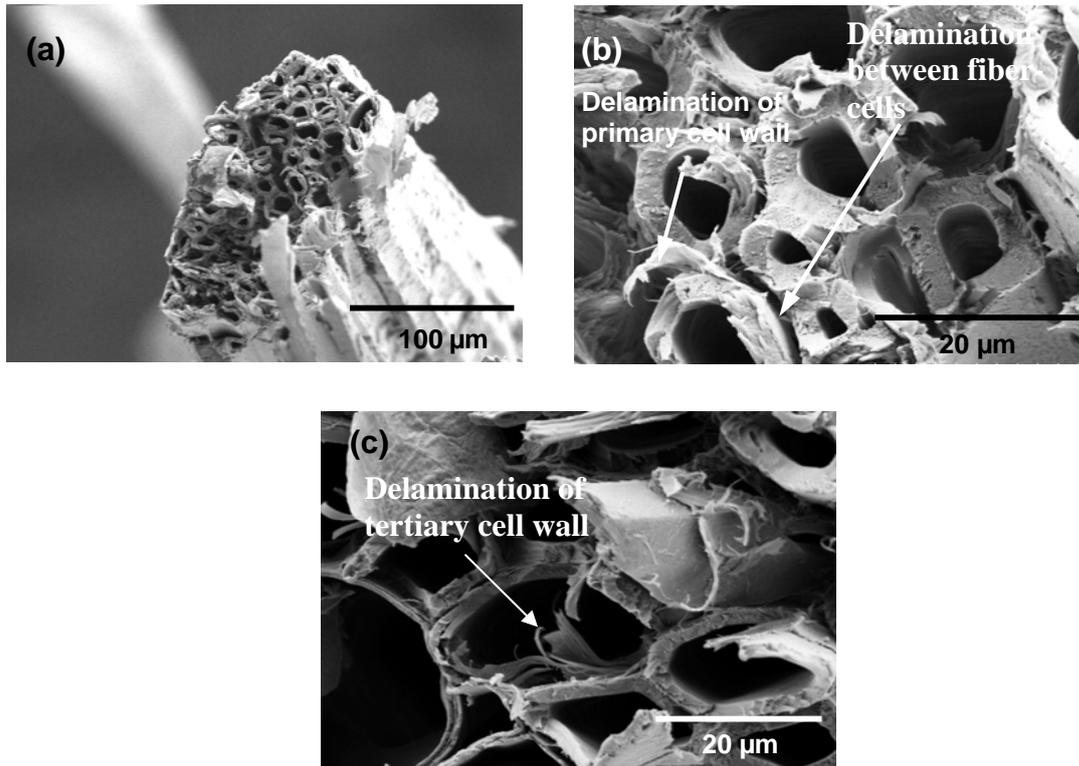
Fig. 9. Fractography of the sisal fibers: (a) overall view, (b) and (c) details of fiber cell fracture, fiber cell and fiber cell/wall delamination.

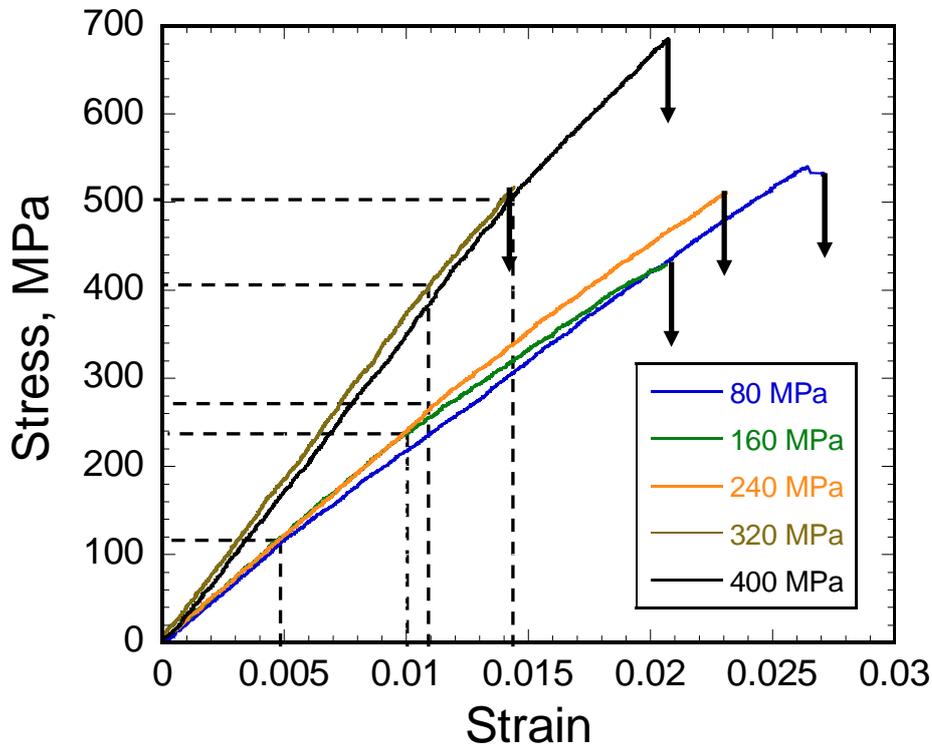
Figure 5. Monotonic tensile behavior of fibers that have survived 10^6 cycles. The dotted lines show the proportional limit stress (σ_{pl}).

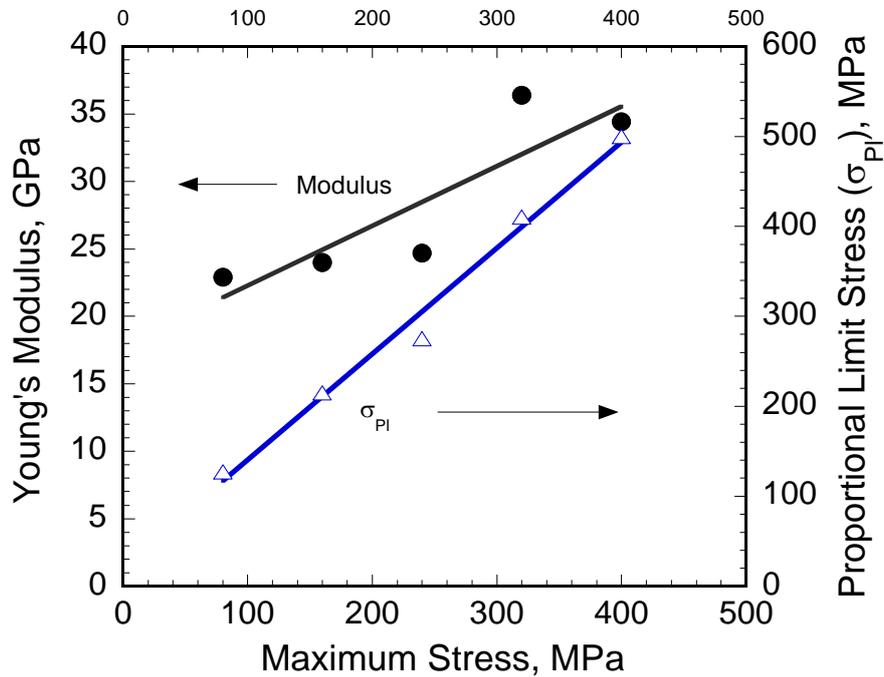
Figure 6. Relationship between Young's modulus and proportional limit stress vs. maximum applied stress for samples that survived 10^6 cycles and were tested under monotonic tension. The modulus and proportional limit stress increase with fatigue stress.

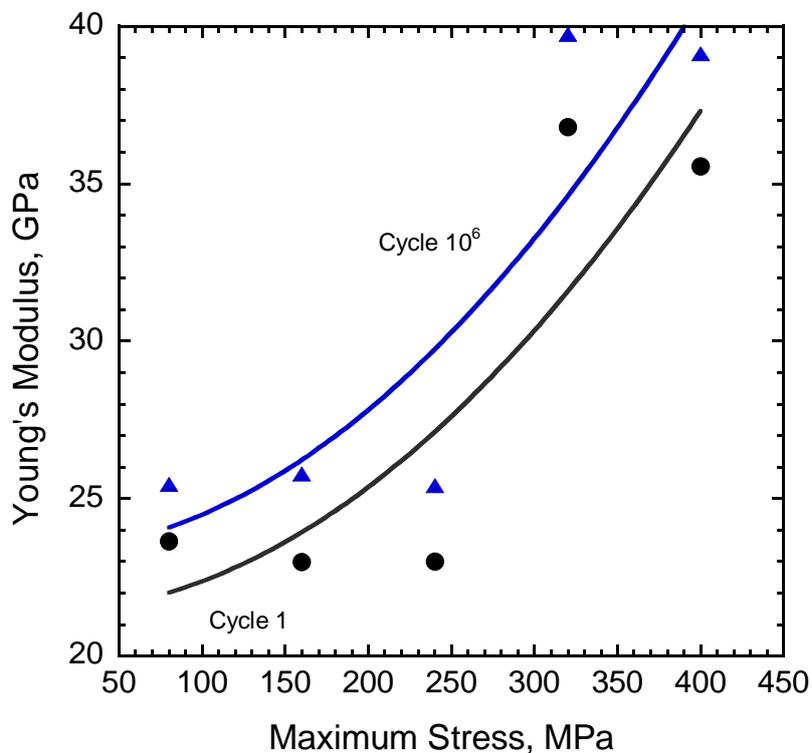
Figure 8. Effect of the maximum fatigue stress on the Young's modulus. The modulus increases due to alignment of the fibrillar structure during fatigue.

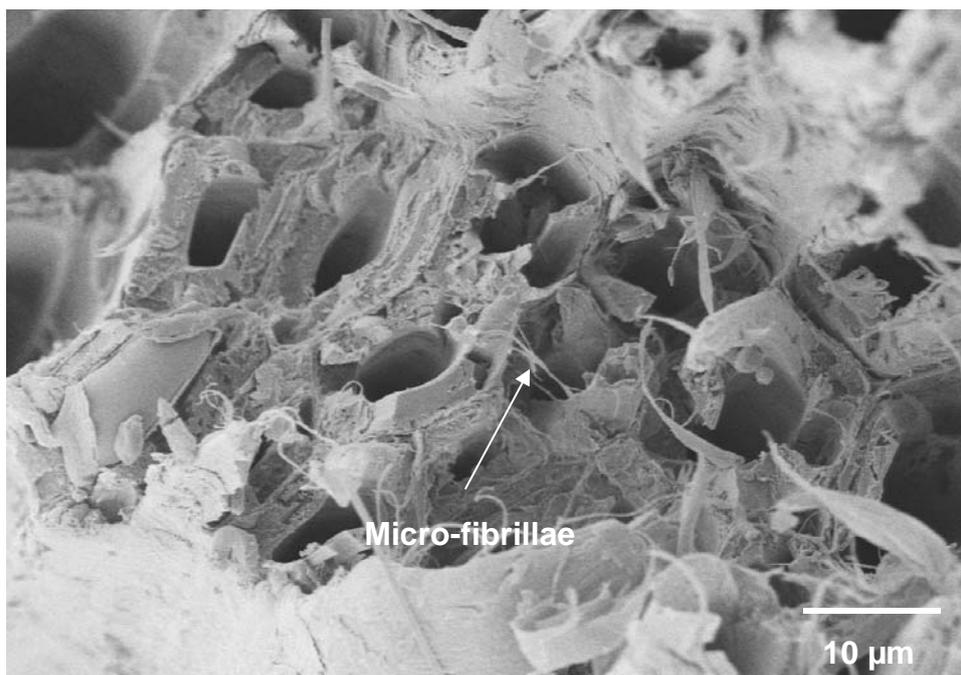
Figure 9. Fatigue fracture surface showing alignment of the fibrillar structure (nanofibers) that compose the fiber-cell walls.

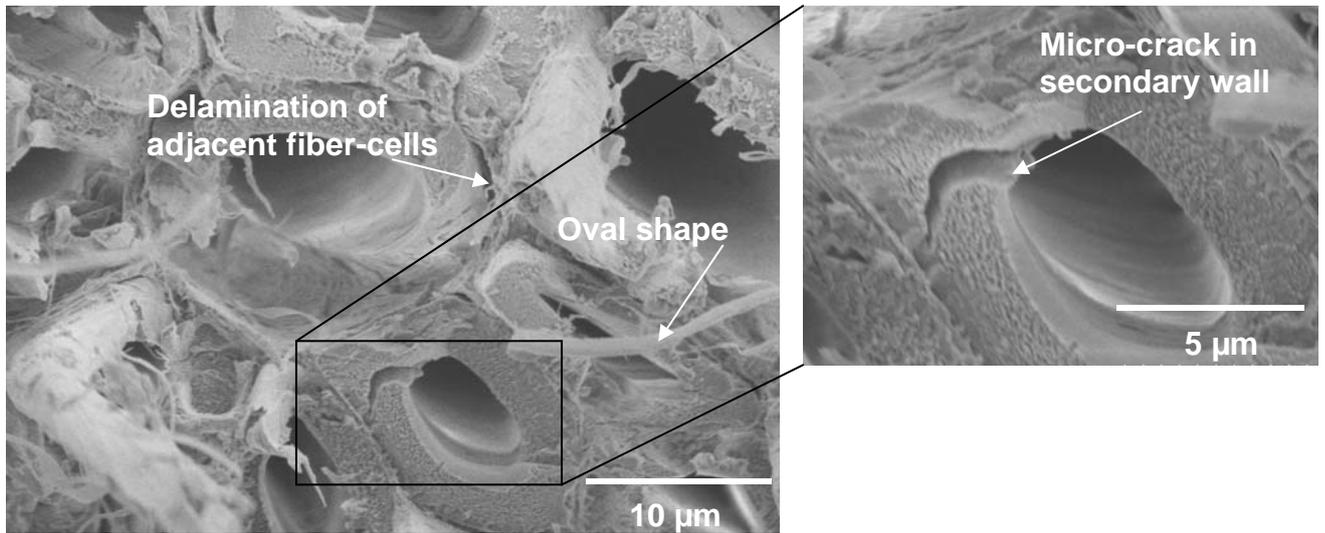
Figure 10. Fatigue fracture surface showing the formation of microcracks in the secondary wall and propagation to the middle lamellae.

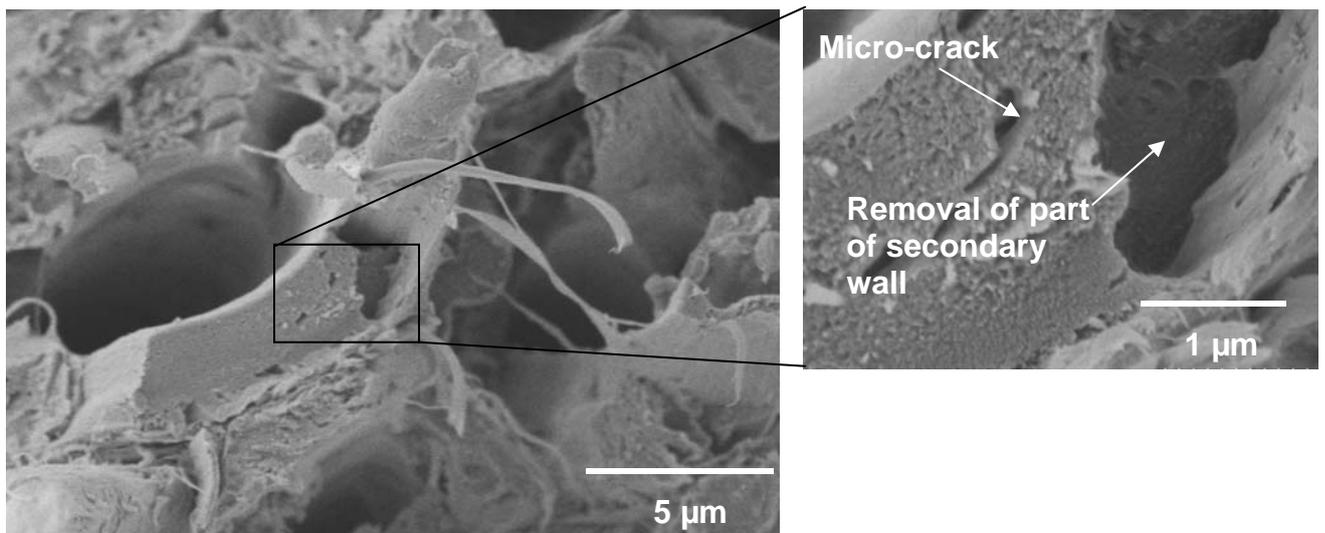
Figure 11. Fatigue fracture surface showing the formation of microcracks in the secondary wall and removal of part of the secondary wall material.

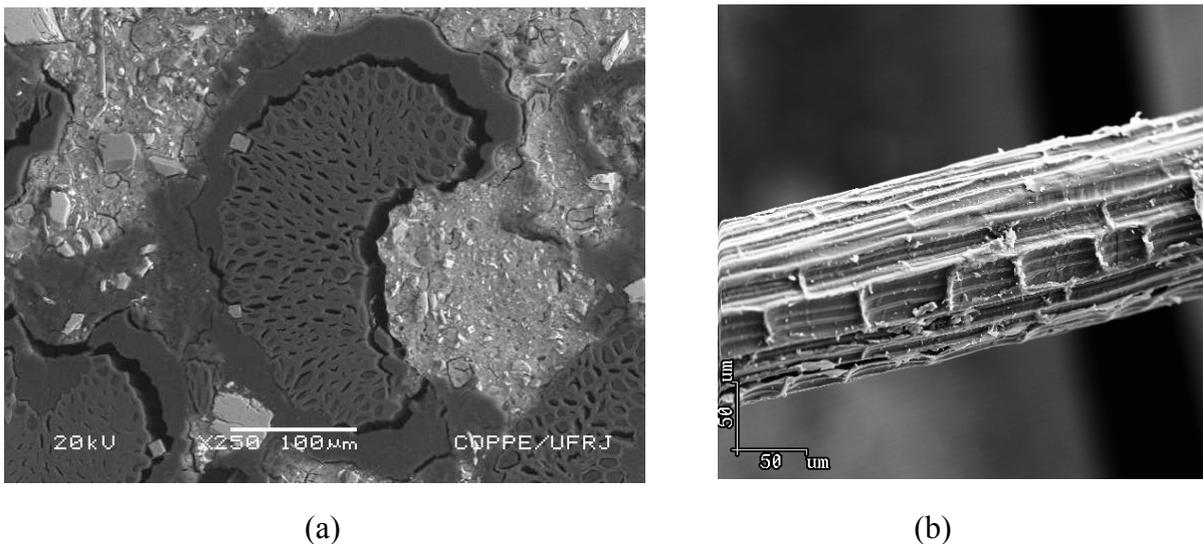
Figure 1 – Structural Fiber geometry: (a) horse shoe shape and (b) rough surface.

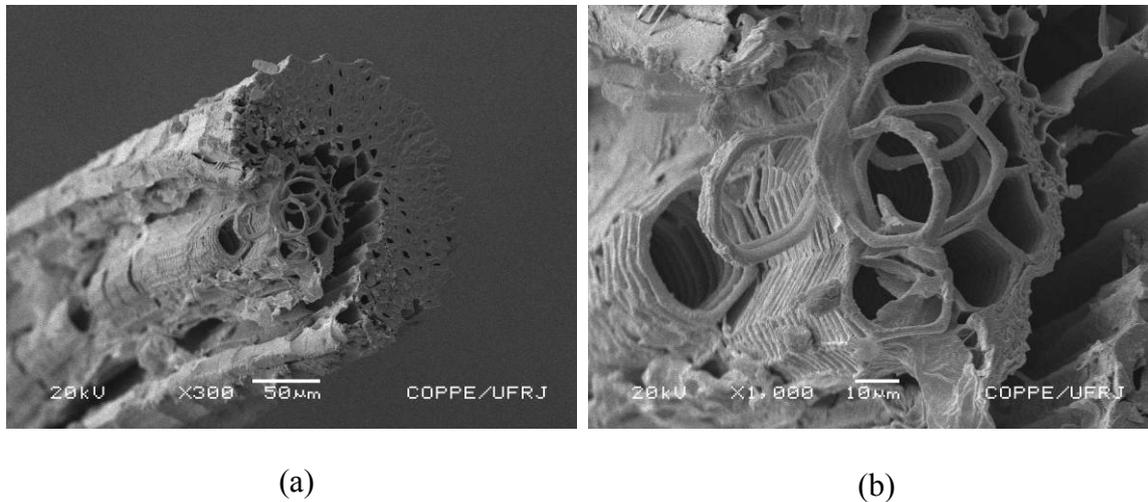
Figure 2 - Arch fiber morphology: (a) arch fiber connected with its conducting tissues and (b) conducting tissues detail.

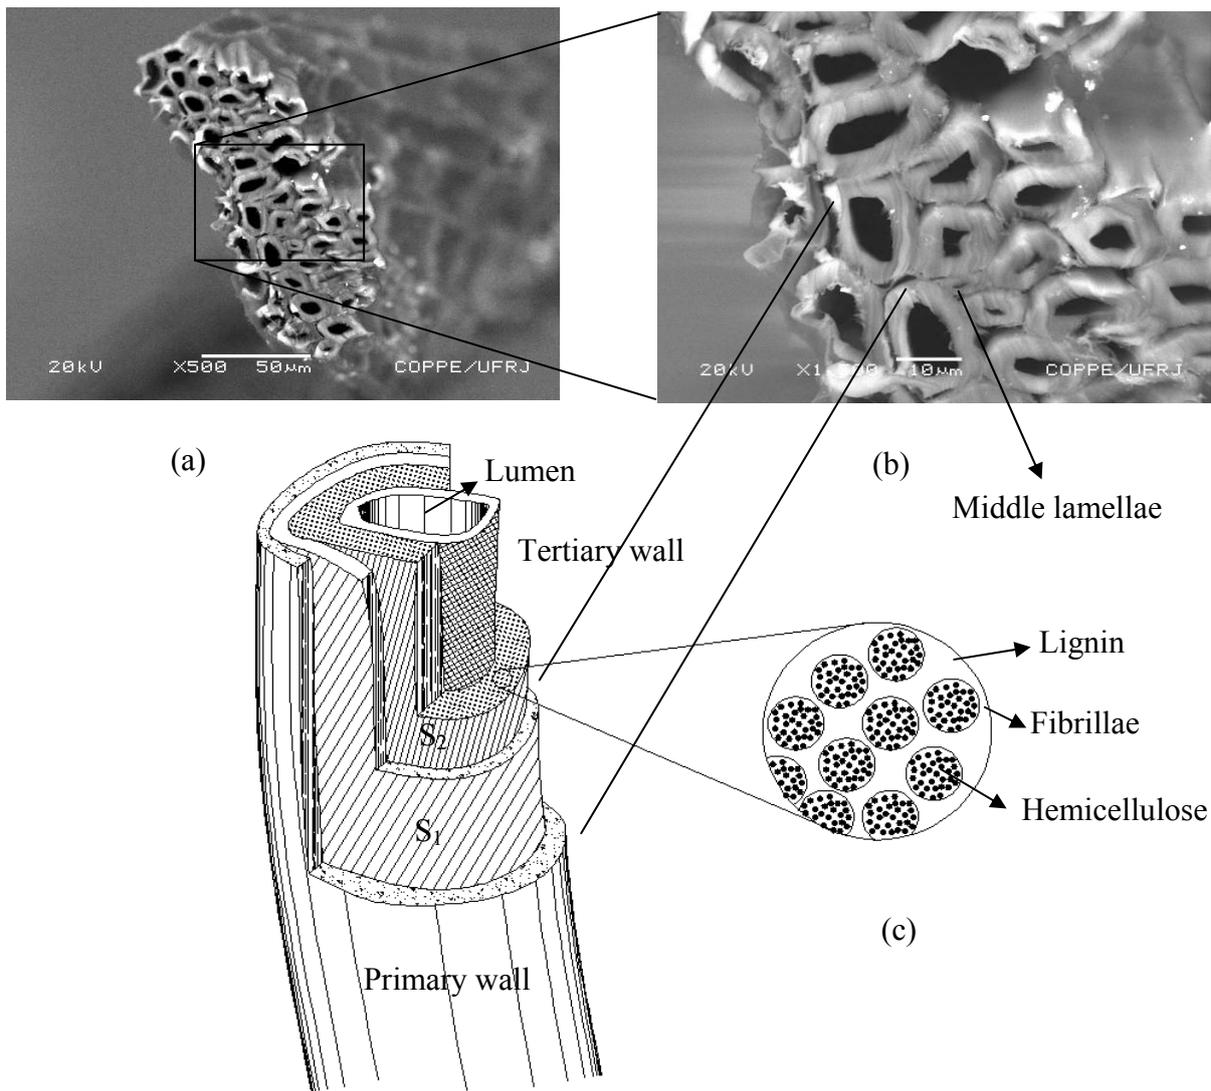
Figure 3 – Fiber-cell microstructure: (a) cross section view showing the fiber-cells, lumens and middle lamellae (b) magnification of the cross section and (c) schematic drawing showing the different layers of an individual fiber cell.

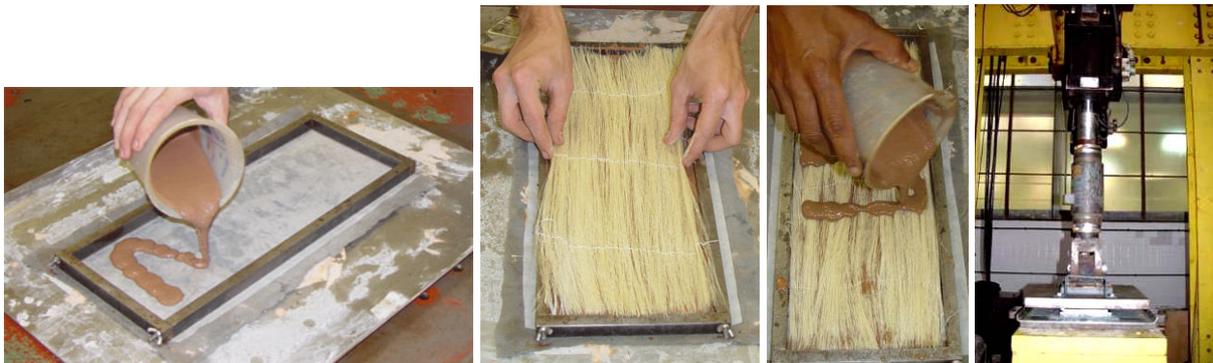
Figure 6 - Composite molding process.

The mortar matrix used in this study presented a mix design 1:1:0.4 (cementitious material:sand:water by weight). The matrix was produced using a bench-mounted mechanical mixer of 20 liters capacity. The cementitious materials were dry mixed during 30 seconds (for homogenization) with the subsequent addition of sand and then a volume fraction of 5% wollastonite. The powder material was mixed for more 30 seconds when the superplasticizer diluted in water were slowly poured in the running mixer and then mixed for 3 minutes. For the production of the laminates, the mortar mix was placed in a steel mould, one layer at a time, followed by one layer of long unidirectional aligned fibers (up to 5 layers) and vibration resulting in a sisal fiber volume fraction of 10%. The vibrating table was used at a frequency of 65 Hz. After casting the composites were compressed at 3 MPa during 5 minutes. Figure 6 illustrates the whole molding process. The specimens were covered in their molds for 24 hours and after this time they were demolded and fog cured for 28 days in a cure chamber with 100% RH and 23 ± 1 °C.

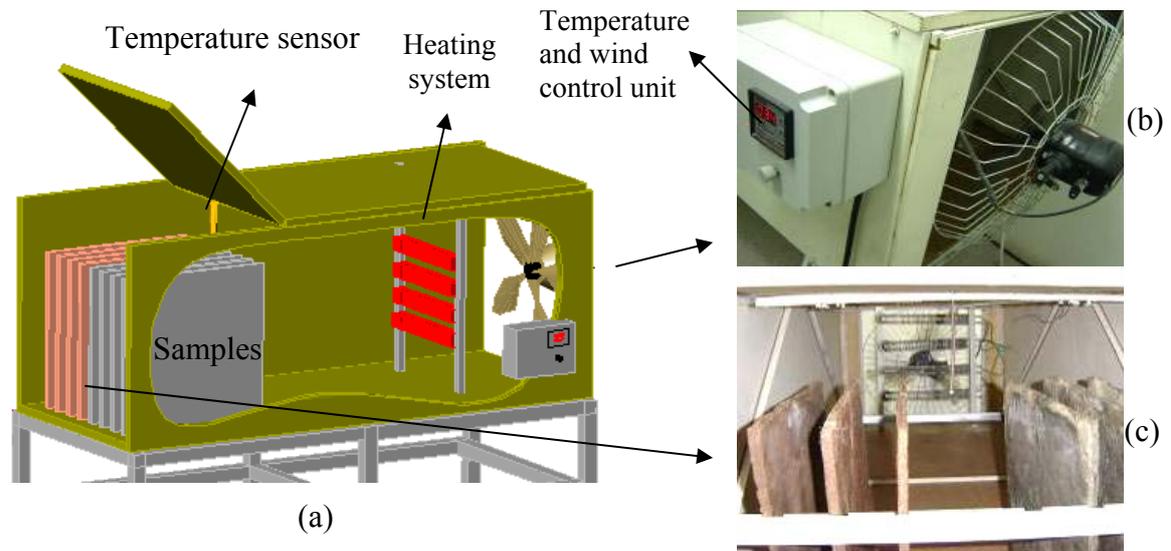
Figure 7 - Forced air flow chamber (FAFC): (a) schematic view, (b) fan, temperature and wind velocity control unit and (c) specimen holder and temperature sensor.

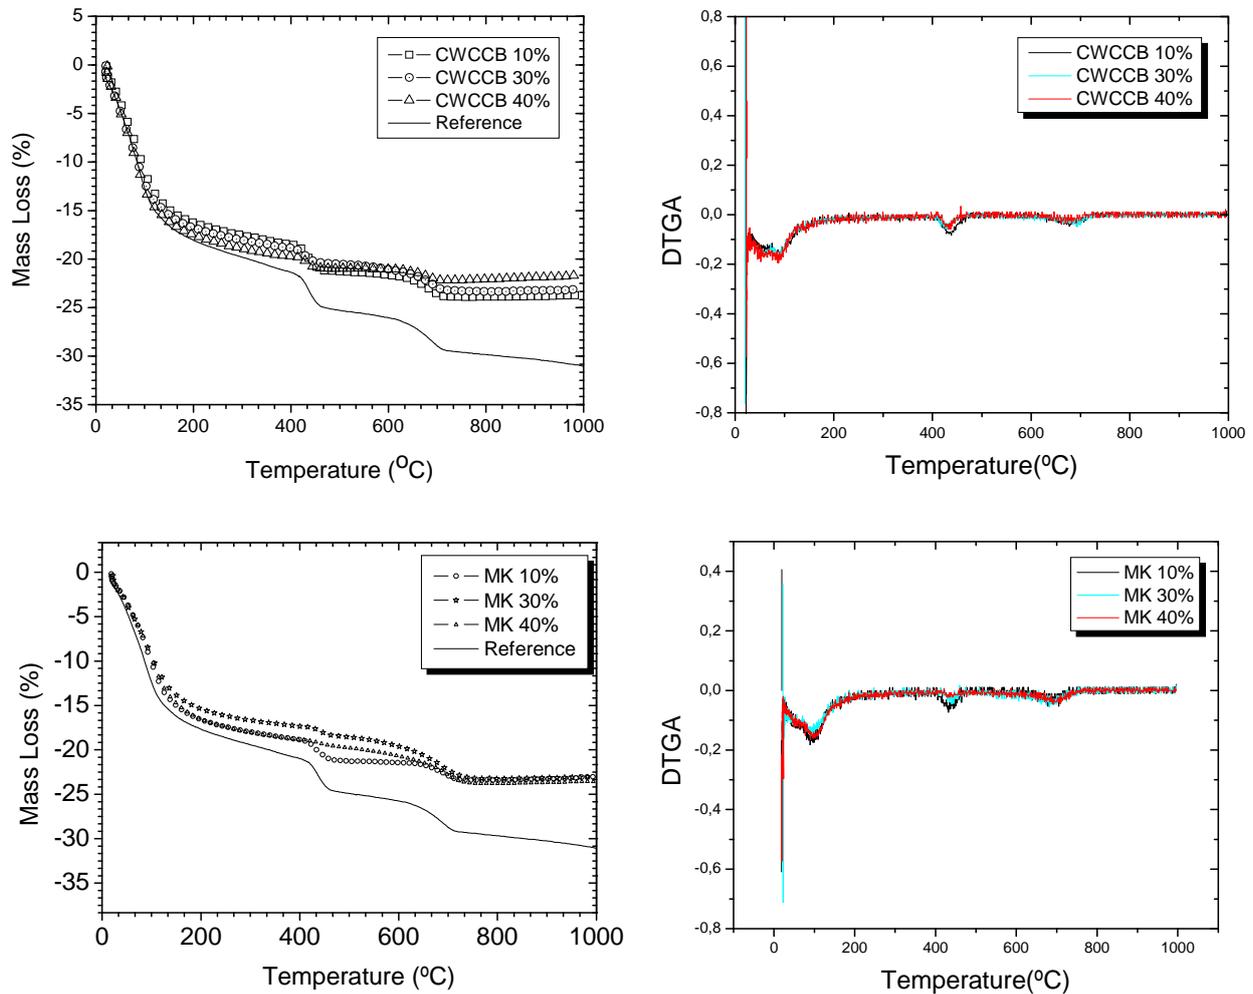
Figure 9 - TGA and DTGA curves for the OPC cement paste (reference) and for the mixes containing 10, 30 and 40% of CWCCB or MK as cement replacement.

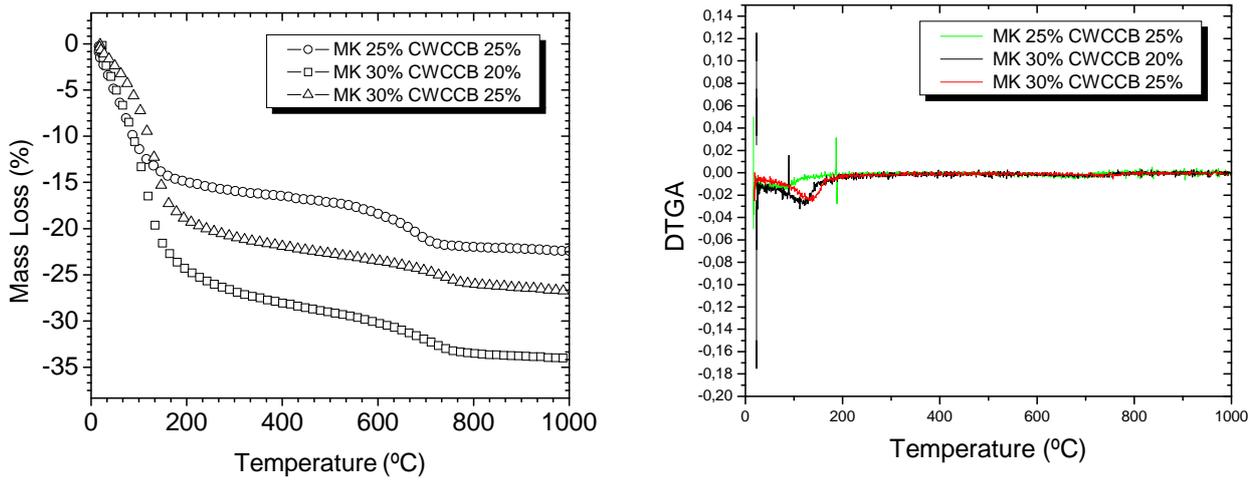
Figure 10 - TGA and DTGA curves for the cement pastes containing both CWCCB and MK as cement replacement.

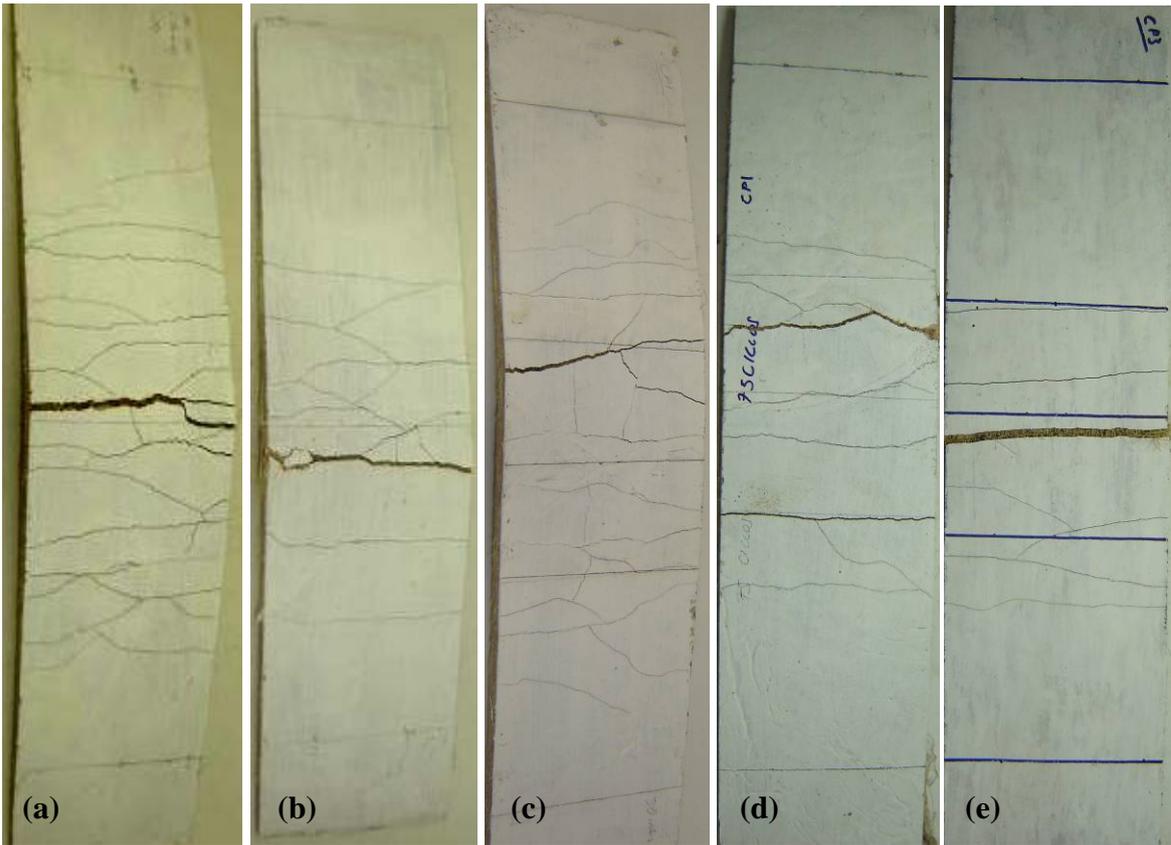
Figure 15 - Typical cracking patterns of CH free composites: (a) non-aged, (b) aged for 25 cycles, (c) aged for 50 cycles, (d) aged for 75 cycles and (e) aged for 100 cycles.

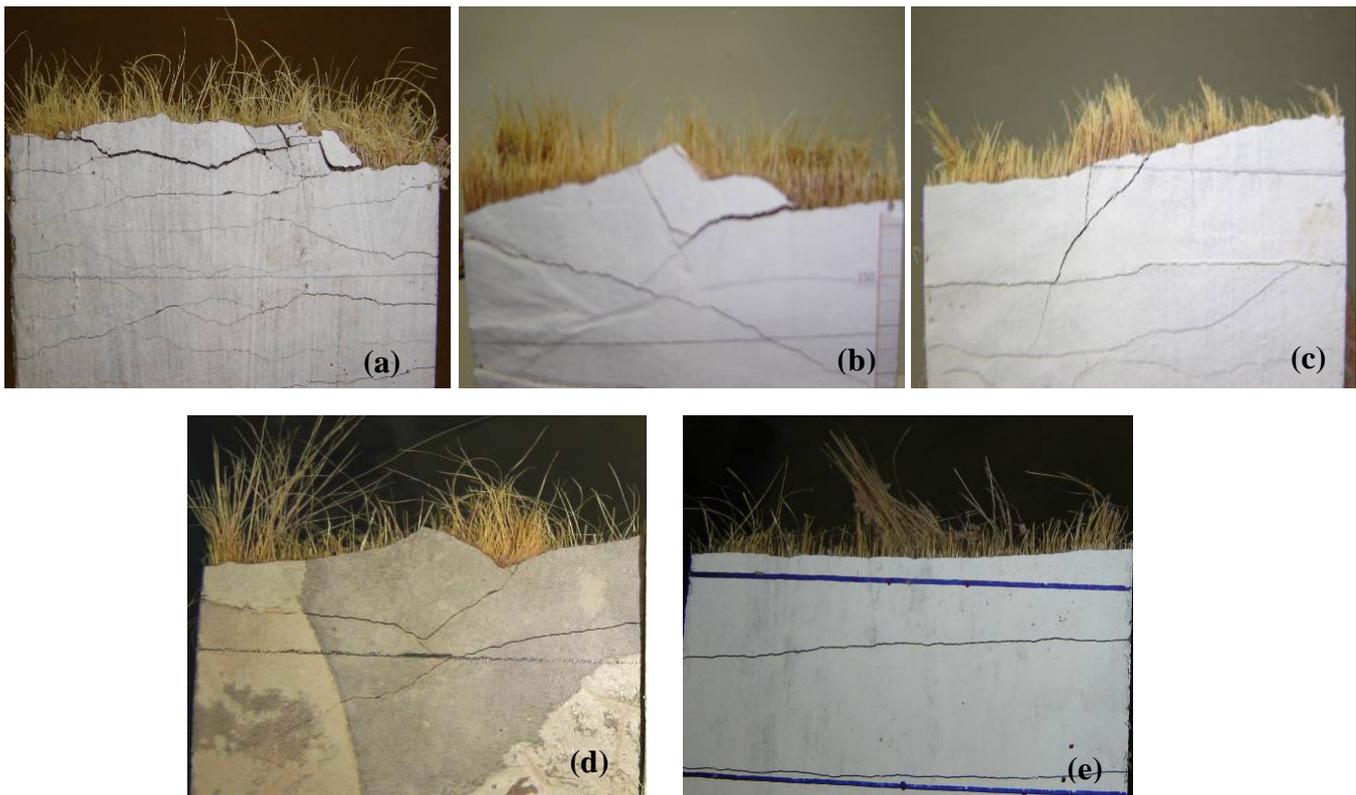
Figure 16 - Failure surface of the CH free specimens before and after aging. Pull-out length of the fibers for the reference specimens (a), for specimens submitted to 25 (b), 50(c), 75 (d) and 100 cycles of wetting and drying (e).

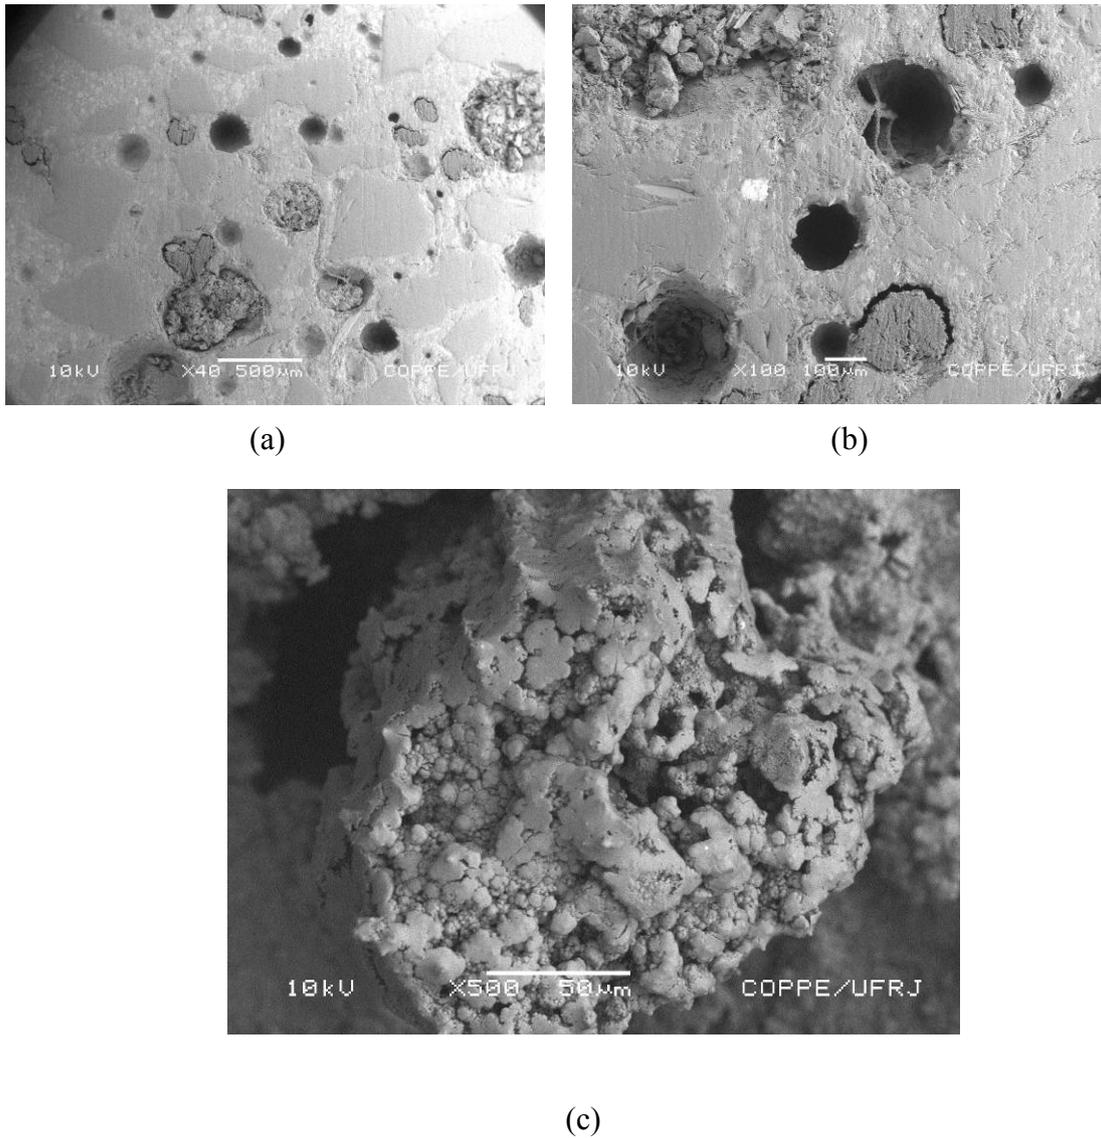
Figure 17 - Micrographs of aged PC specimens subjected to 25 cycles of wetting and drying: (a) and (b) cavities in the matrix due to fibers breaking and pull-out; (c) mineralized fiber inside the specimen.

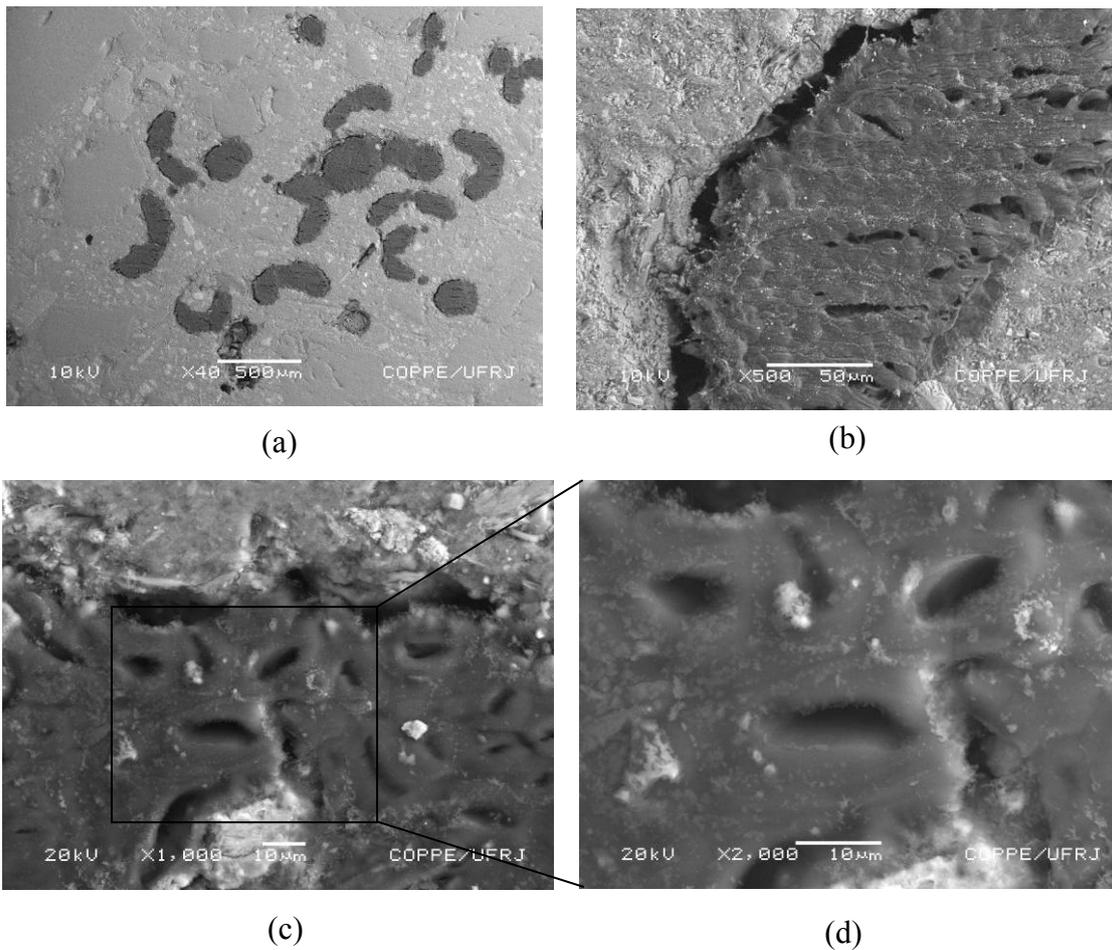
Figure 18 - Micrographs of CH free specimens: (a) specimen subjected to 25 cycles of wetting and drying (b) zoom in a sisal fiber subjected to 25 cycles (c) and (d) close up view of the sisal fiber cells in specimens subjected to 50 cycles of wetting and drying.

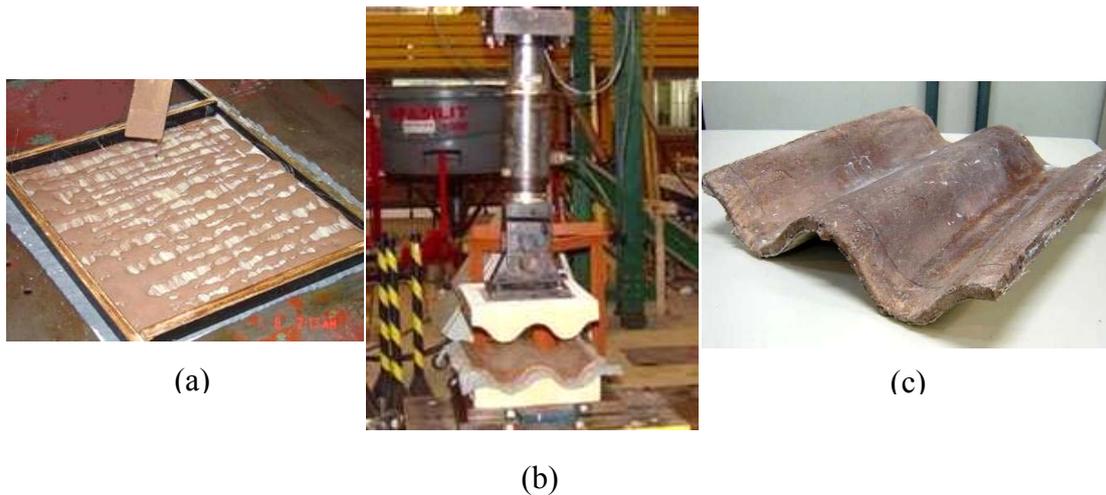
Figure 2. Production of the corrugated and flat laminates: (a) Placement of the matrix and fiber layers, (b) compression molding and (c) final product.

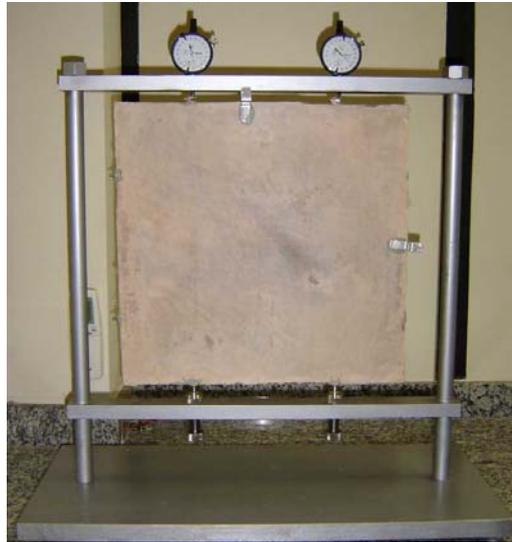
Figure 3. Drying shrinkage test set-up. The strains were measured by two strain indicators located at the top of the frame.

To determine the drying shrinkage of the CH free composite and its matrix, a frame (see Figure 3) was fabricated and two strain indicators were used to measure the

deformations. Flat plates with dimensions of 400 mm x 400 mm x 12 mm were tested after being cured for 60 days in a fog chamber with 100% RH. The tests were performed in a room with controlled temperature (19 ± 0.5 °C) and humidity (53 ± 5 %).

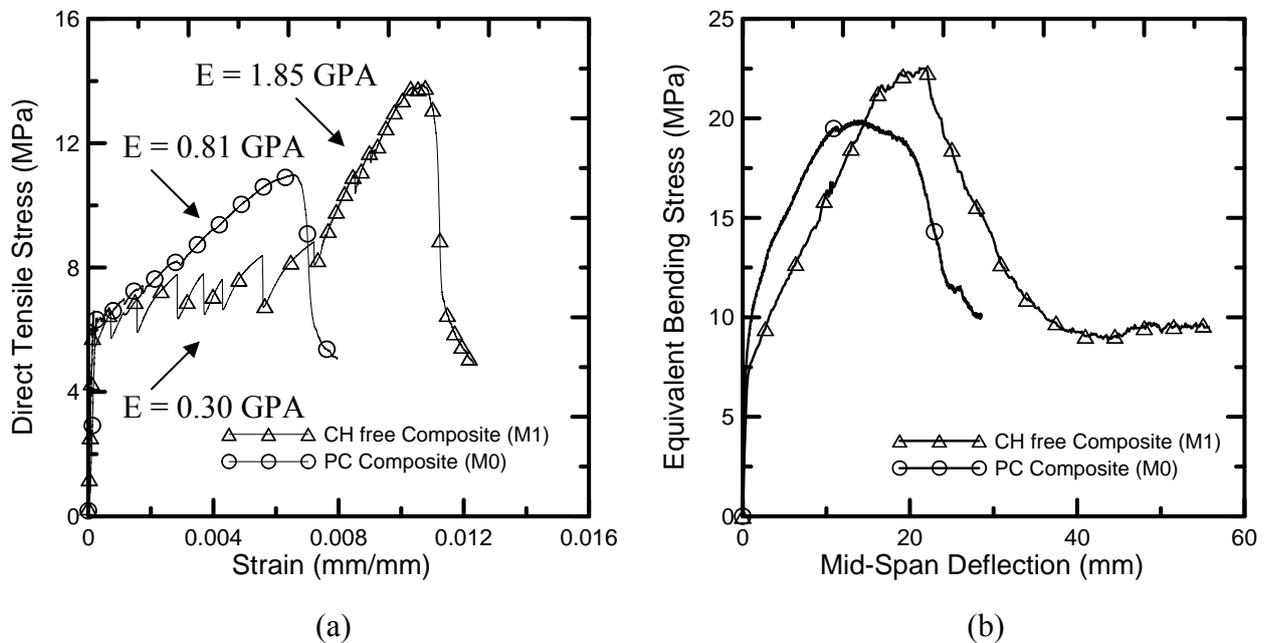
Figure 4. Mechanical response of CH free and PC non aged composites: (a) direct tension test (note the difference in the post-cracking modulus) and (b) four-point bending test.

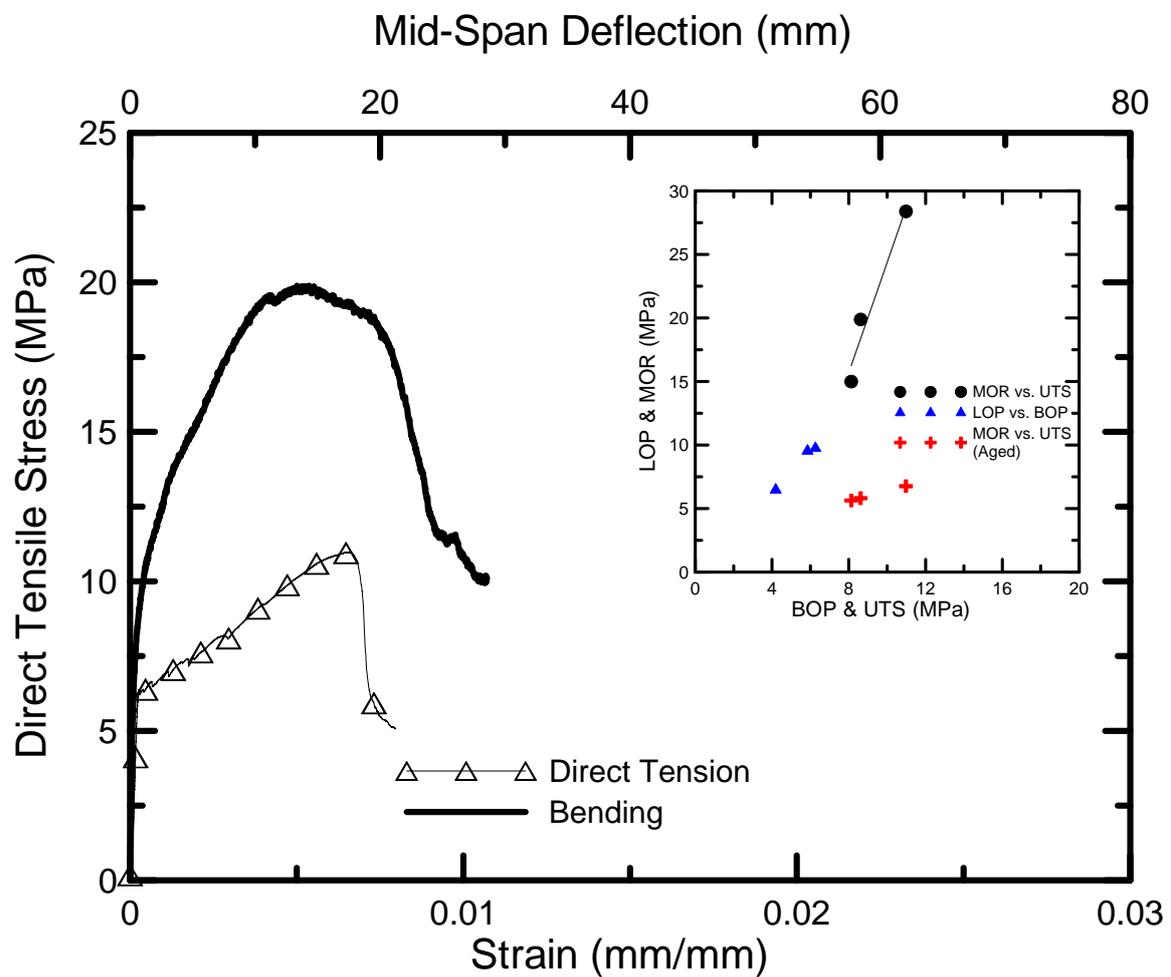
Figure 5. Comparison of direct tension and four-point bending behavior of PC composites. The inset shows a comparison of MOR vs. UTS and LOP vs. BOP.

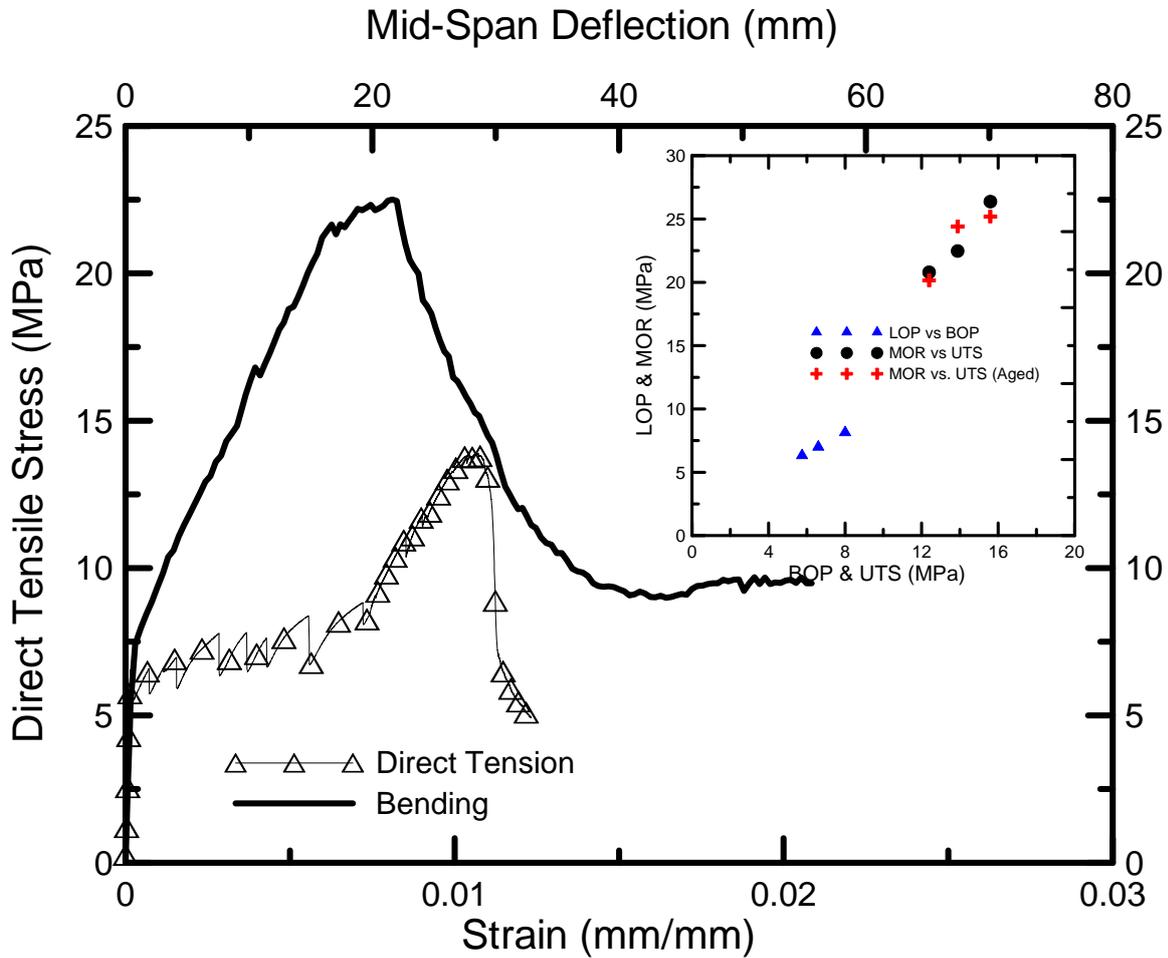
Figure 6. Comparison of direct tension and four point bending tests of CH Free Composites. A correlation of LOP vs. BOP and MOR vs. UTS is shown in the right upper corner.

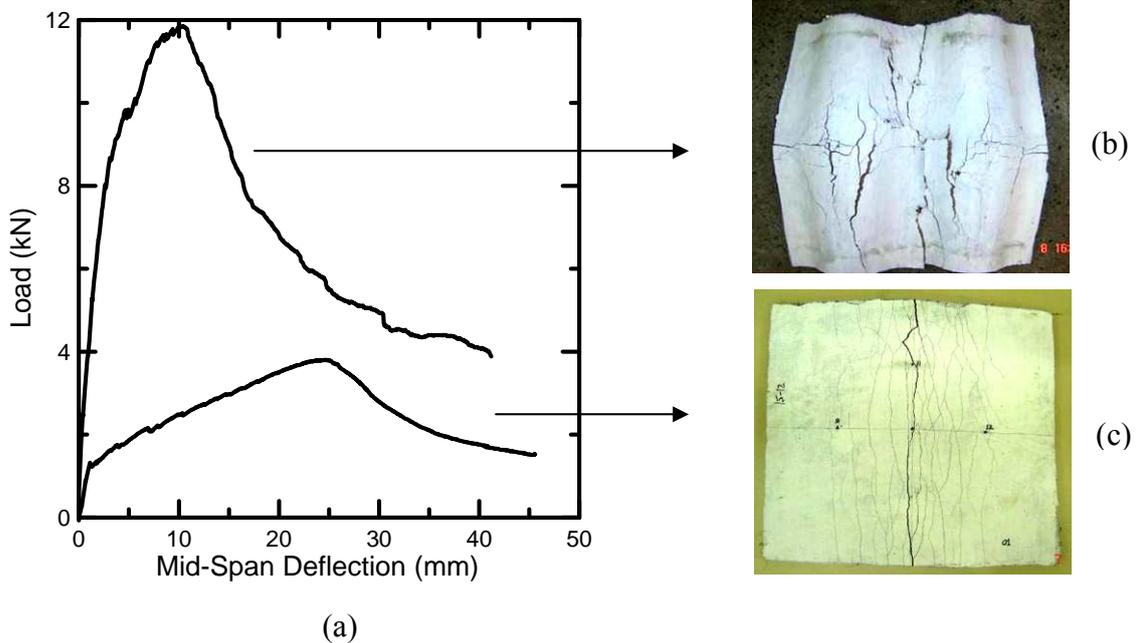
Figure 7. Effect of corrugation on the mechanical performance of the composites: (a) typical three-point bending curves of corrugated and flat laminates, (b) and (c) cracking pattern of the corrugated and flat laminates, respectively.
