**DURABILIDADE E PROPRIEDADES MECÂNICAS DE COMPÓSITOS
CIMENTÍCIOS REFORÇADOS POR FIBRAS DE SISAL**

Flávio de Andrade Silva

Tese de Doutorado apresentada ao Programa de Pós-graduação em Engenharia Civil, COPPE, da Universidade Federal do Rio de Janeiro, como parte dos requisitos necessários à obtenção do título de Doutor em Engenharia Civil.

Rio de Janeiro
Abril de 2009

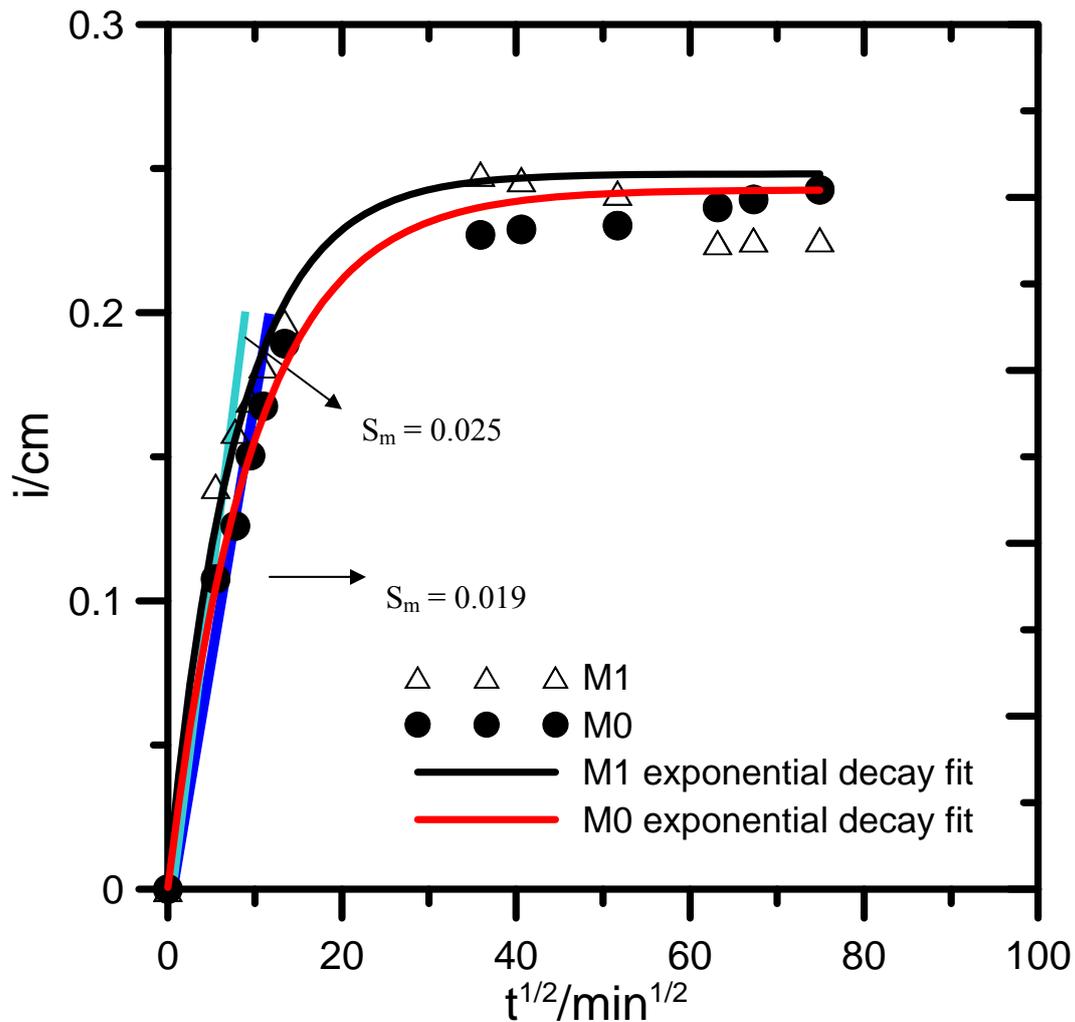
Figure 9. Capillary water absorption: Cumulative absorption i vs. $t^{1/2}$; experimental points are marked by triangles for CH free (M1) and circles for PC (M0) composites. The sorptivity S_m is defined by the main linear portion of the figure.

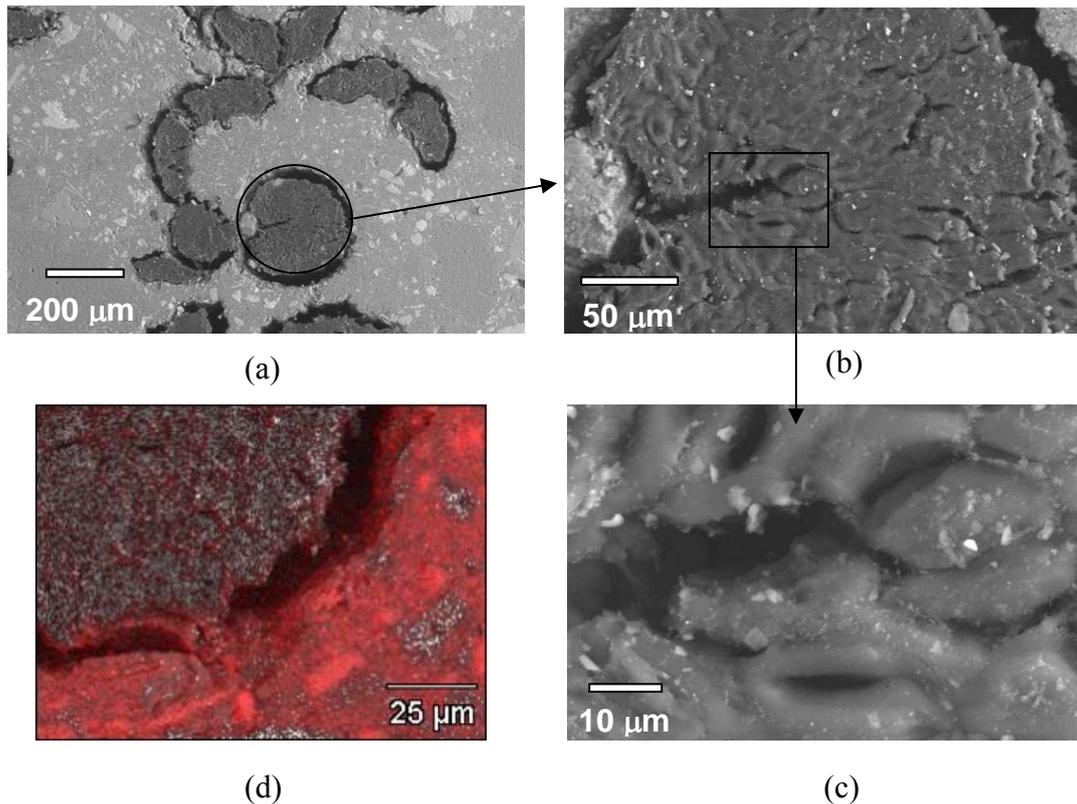
Figure 12. SEM images of the aged CH free composite: (a) Overall view of the composite (b) sisal fiber (c) X-ray mapping for Ca in the fiber-matrix interface and (d) detail of fiber cells.

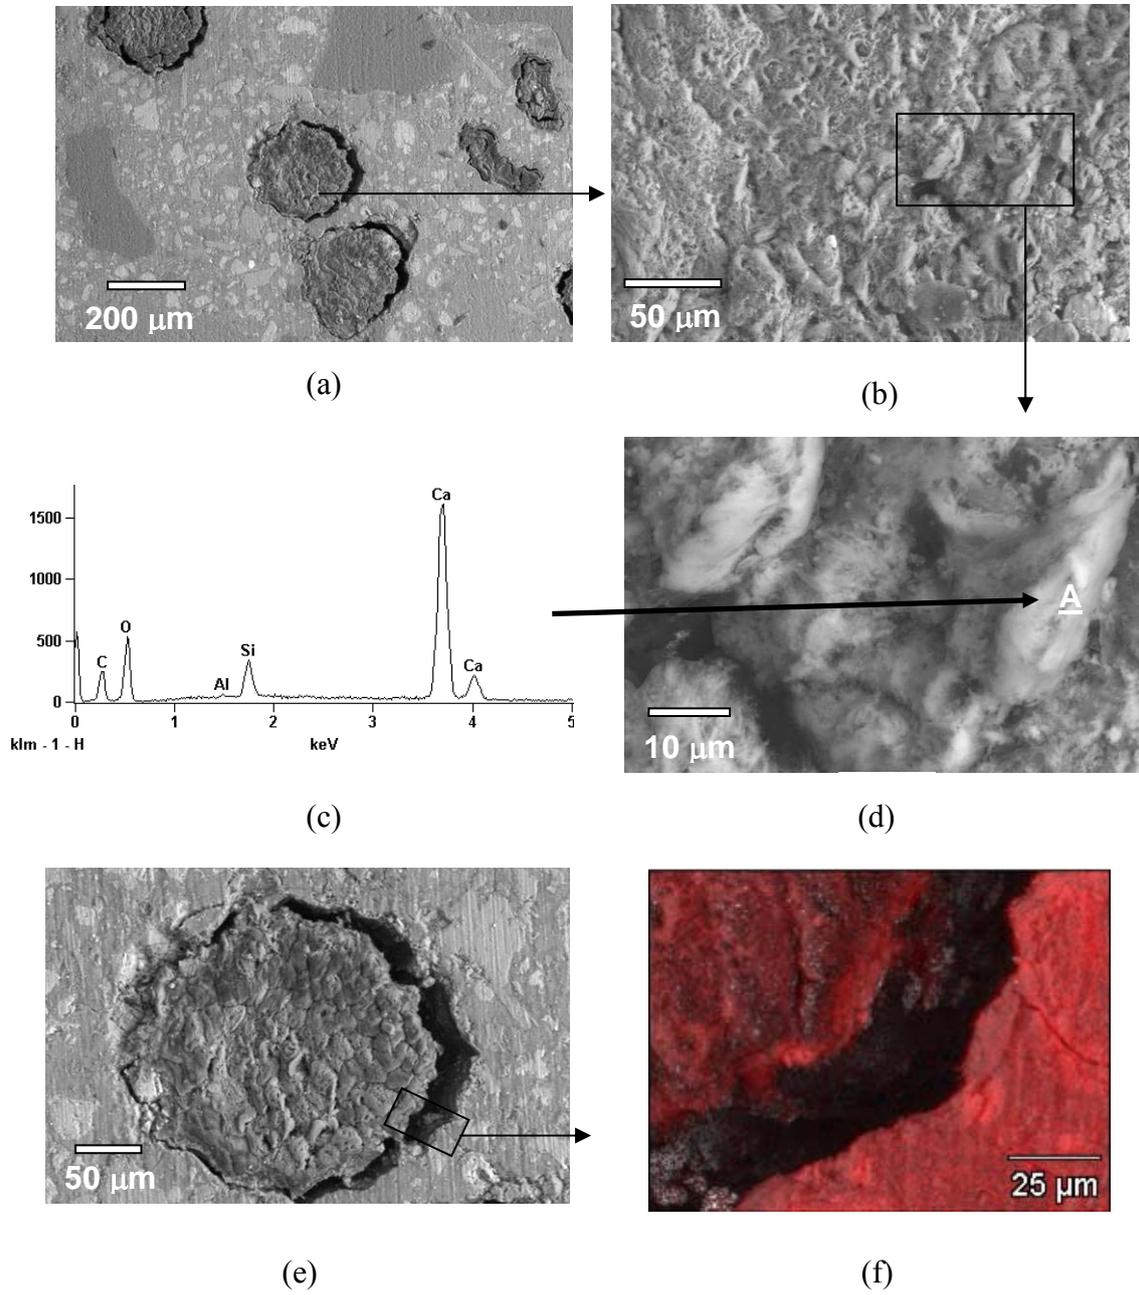
Figure 13. SEM images of PC aged composite: (a) Overall view of the composite (b) Sisal fiber (c) EDS analysis of point A (d) region analyzed by EDS (e) detail of X-ray mapped region (f) X-ray mapping for Ca in the fiber-matrix interface.

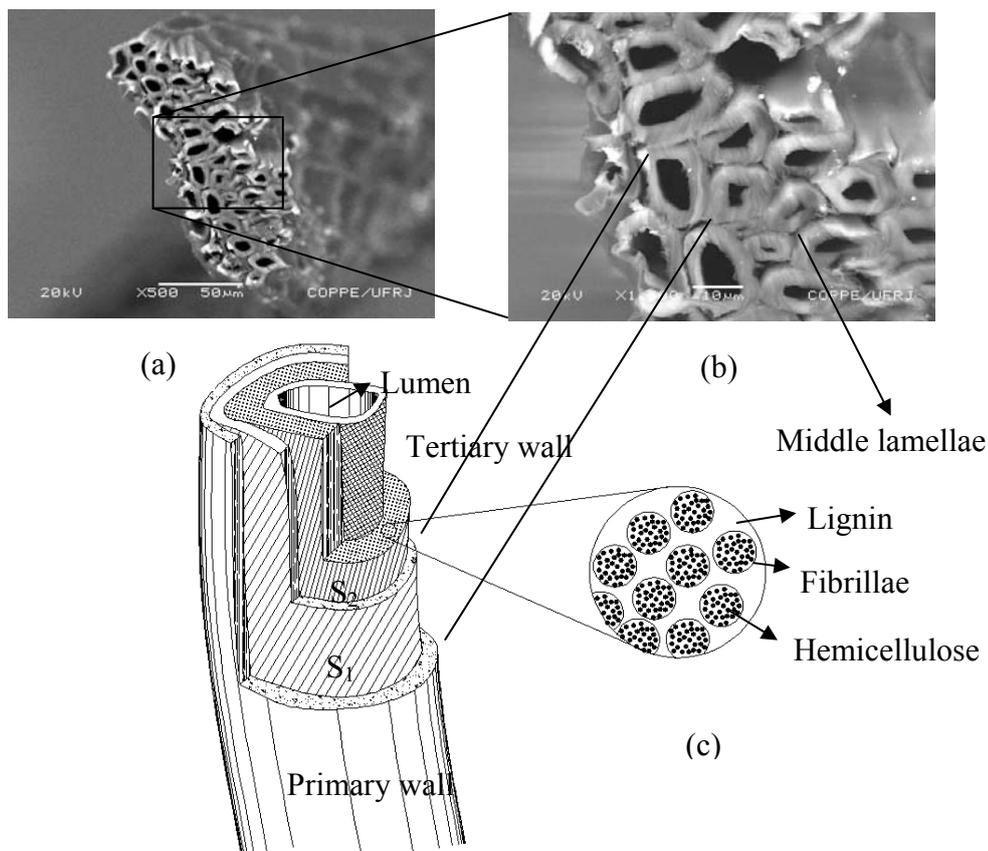
Figure 2. Fiber-cell microstructure: (a) cross section view showing the fiber-cells, lumens and middle lamellae (b) magnification of the cross section and (c) schematic drawing showing the different layers of an individual fiber-cell.

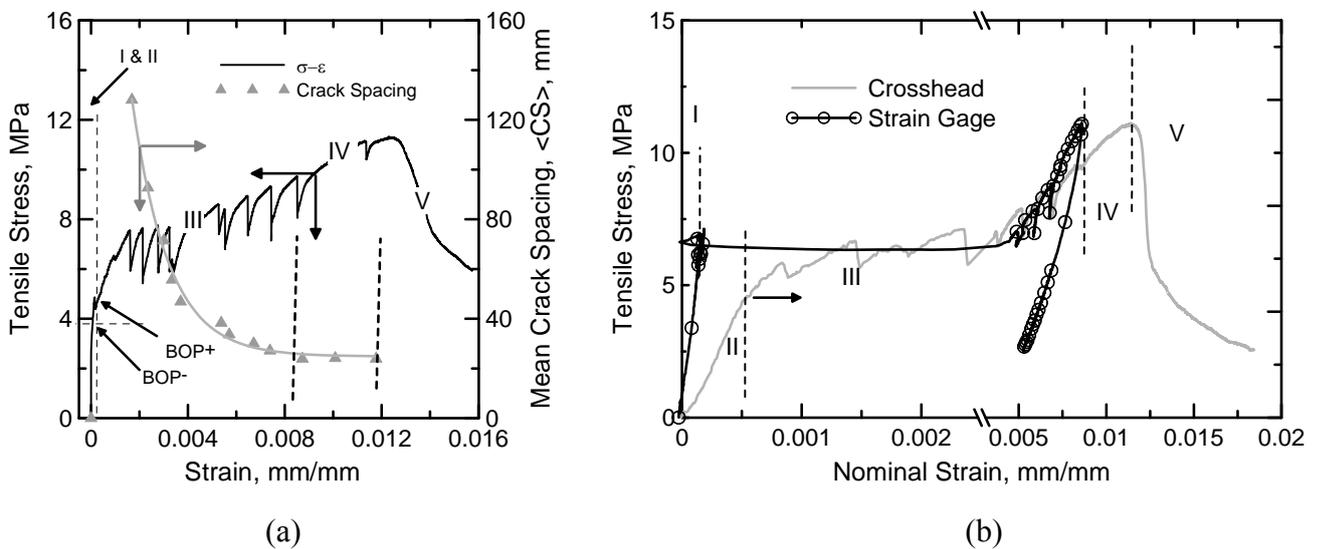
Figure 5. Tensile response of the sisal fiber reinforced composite system: (a) tensile stress and crack spacing vs. strain and (b) comparison of tensile stress vs. strain from strain gage measurements and cross-head displacement.

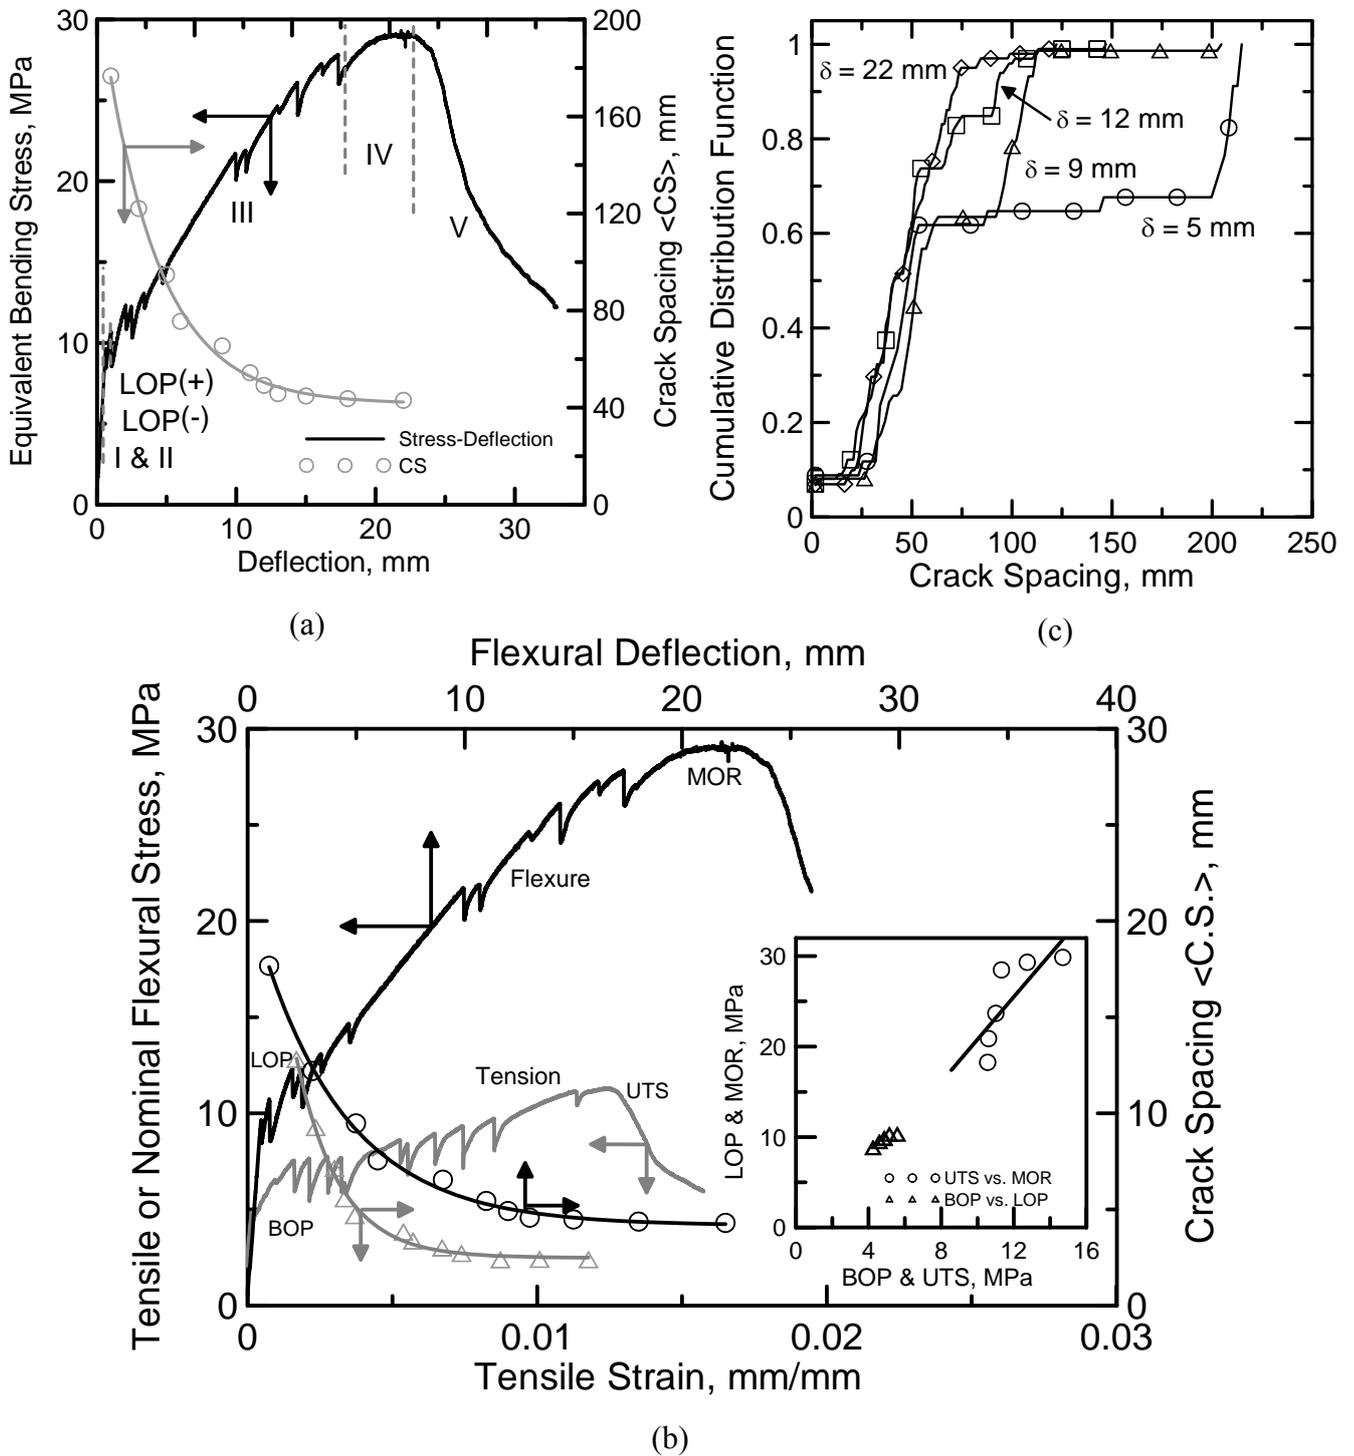
Figure 7. Bending response of the sisal fiber reinforced composite system: (a) Bending stress and crack spacing vs. displacement, (b) comparison of flexural vs. tensile response, and (c) cumulative distribution function for crack spacing.

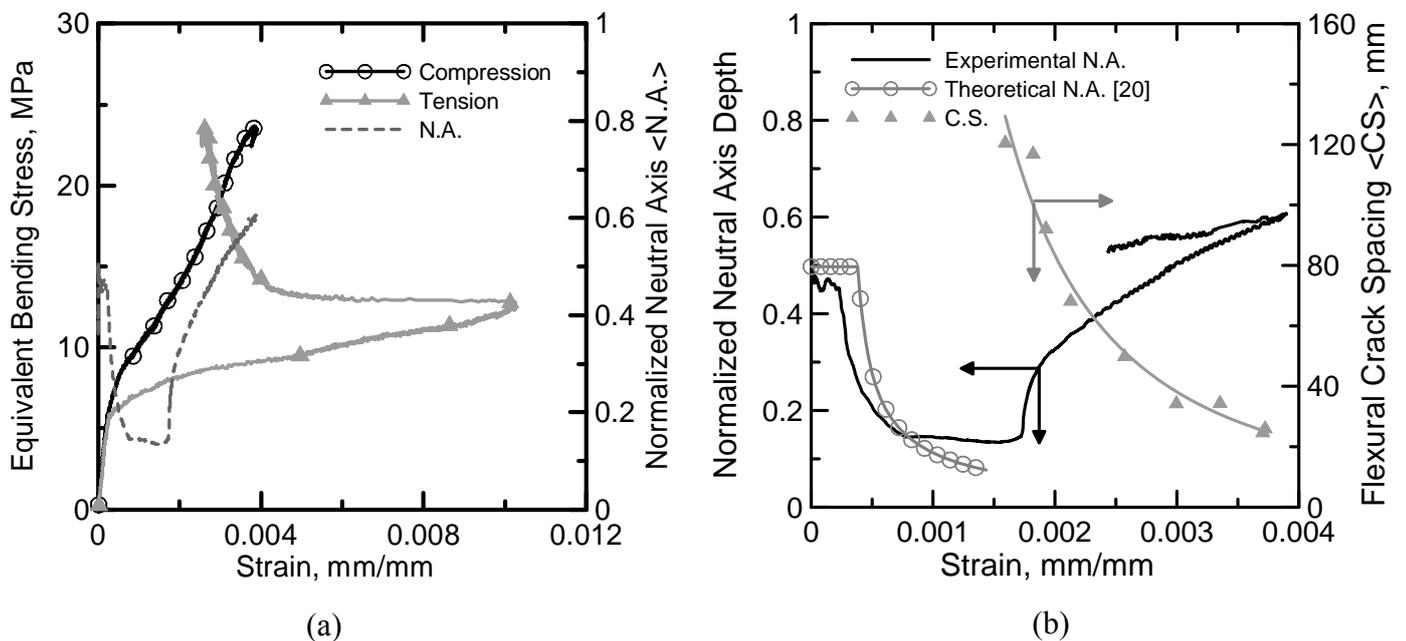
Figure 8. Neutral axis computation: (a) compression and tension strains under four bending loading and (b) crack spacing versus neutral axis.

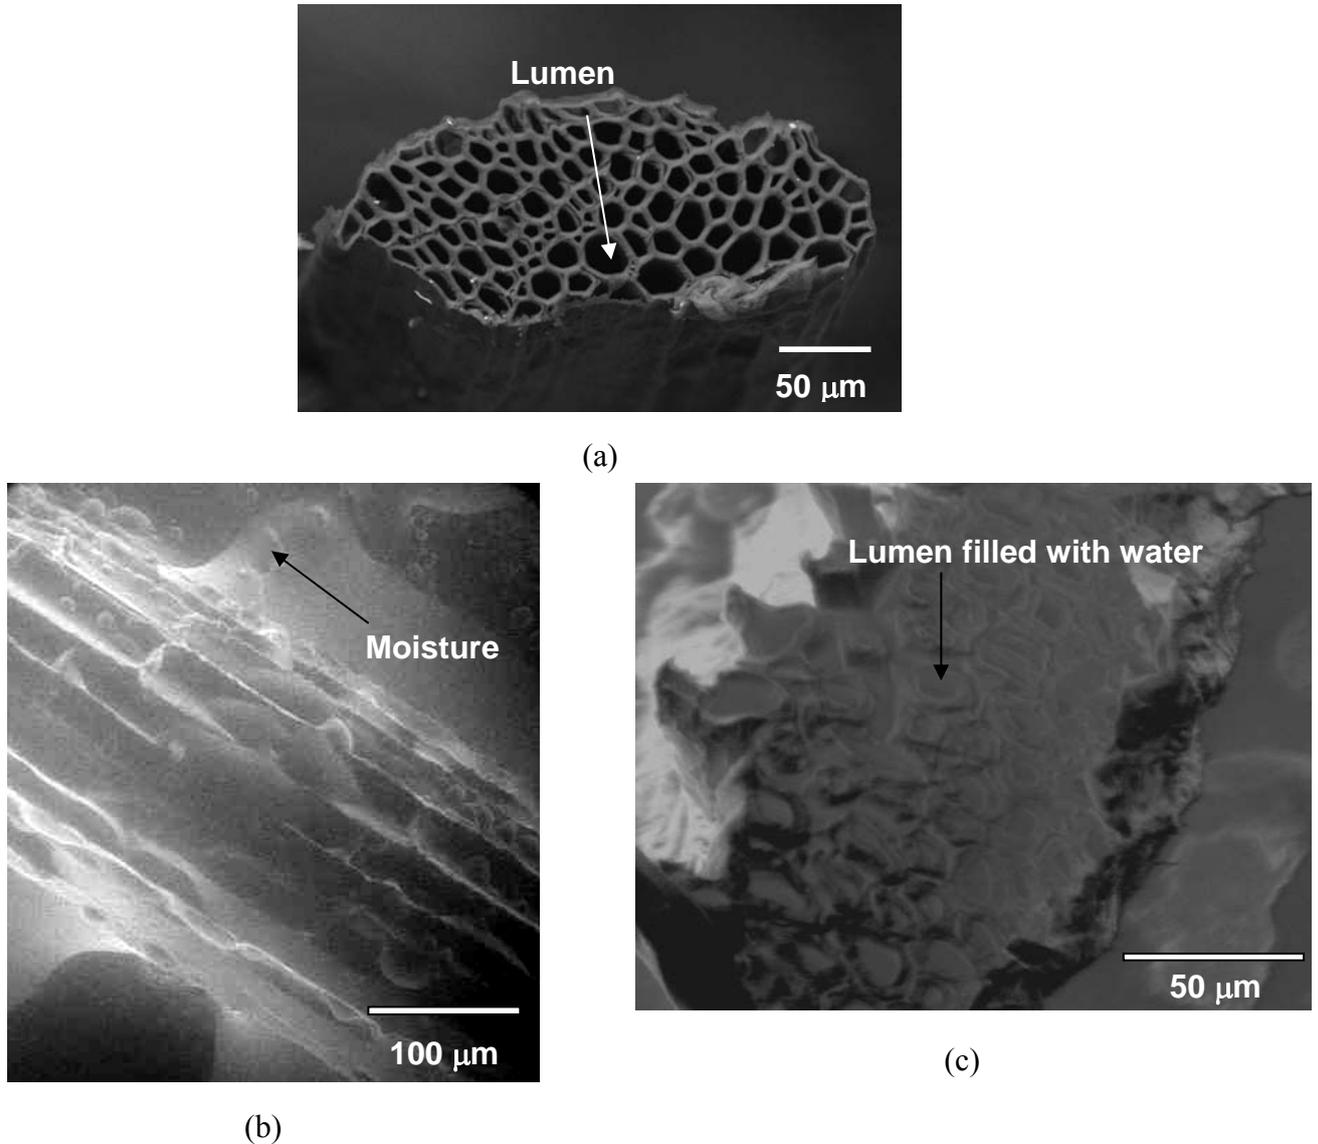
Figure 1. SEM images of the sisal fiber: a) cross section view using low vacuum chamber (Jeol SEM), b) lateral view at 100 % RH and c) cross section view at 100% RH (using ESEM).

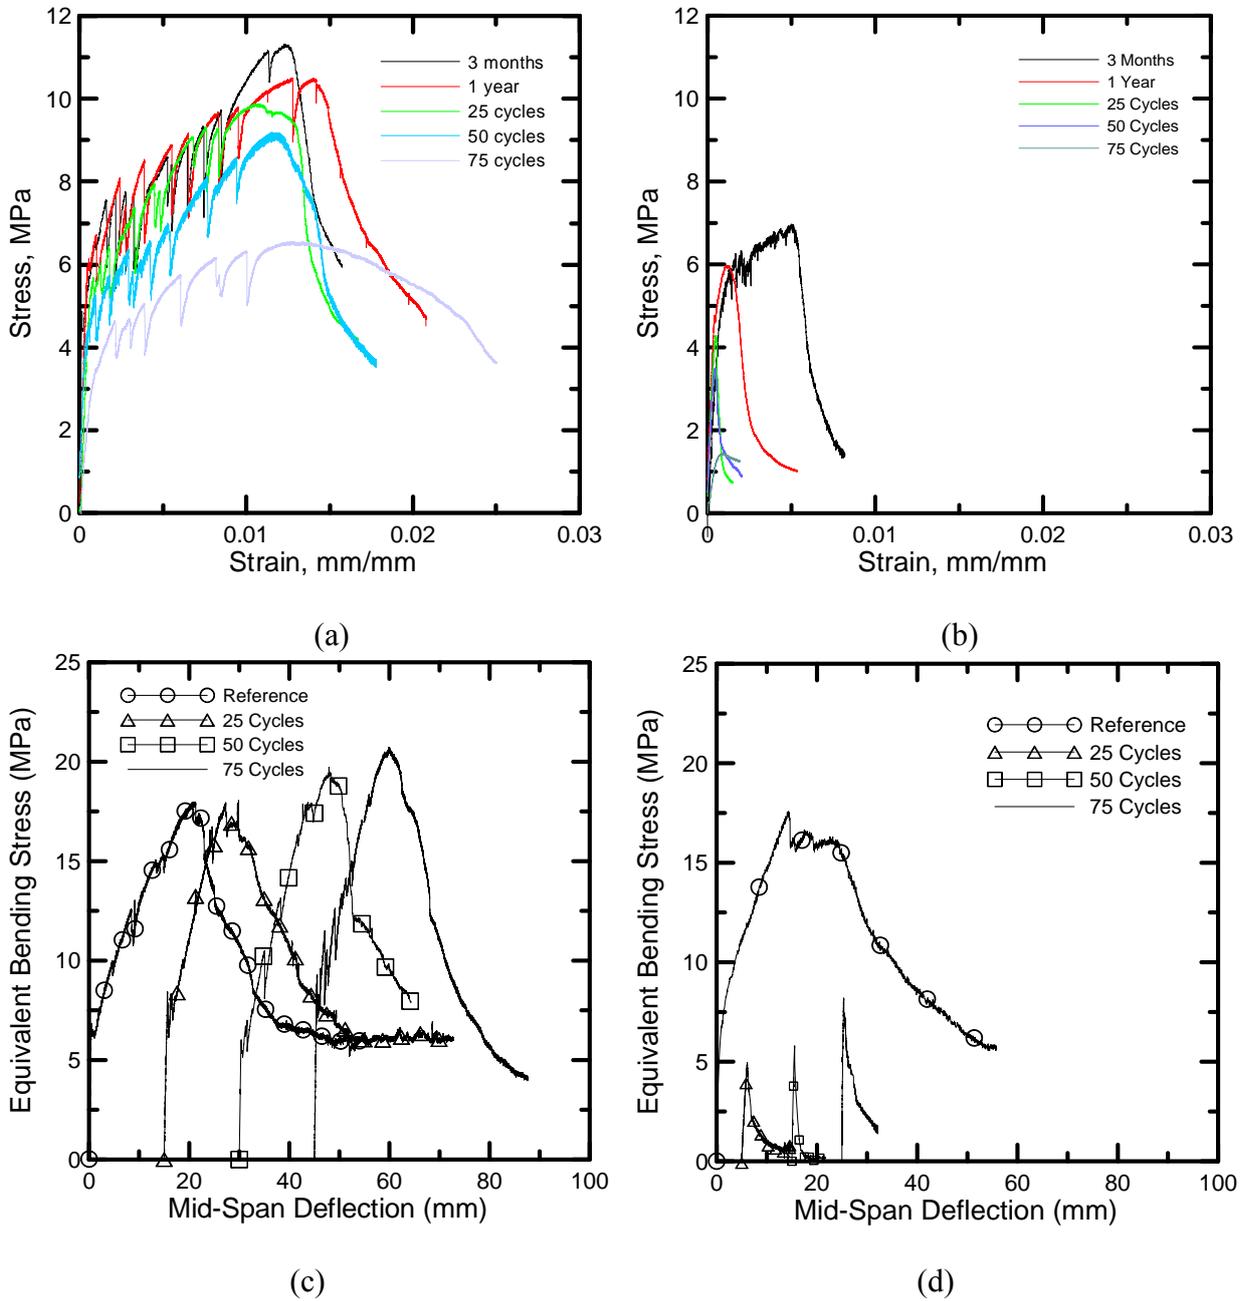
Figure 2. Effect of aging on mechanical response of sisal fiber reinforced cement composite. Tensile response: a) low content of CH matrix, b) Portland cement matrix and bending response: c) low content of CH matrix, d) Portland cement matrix.

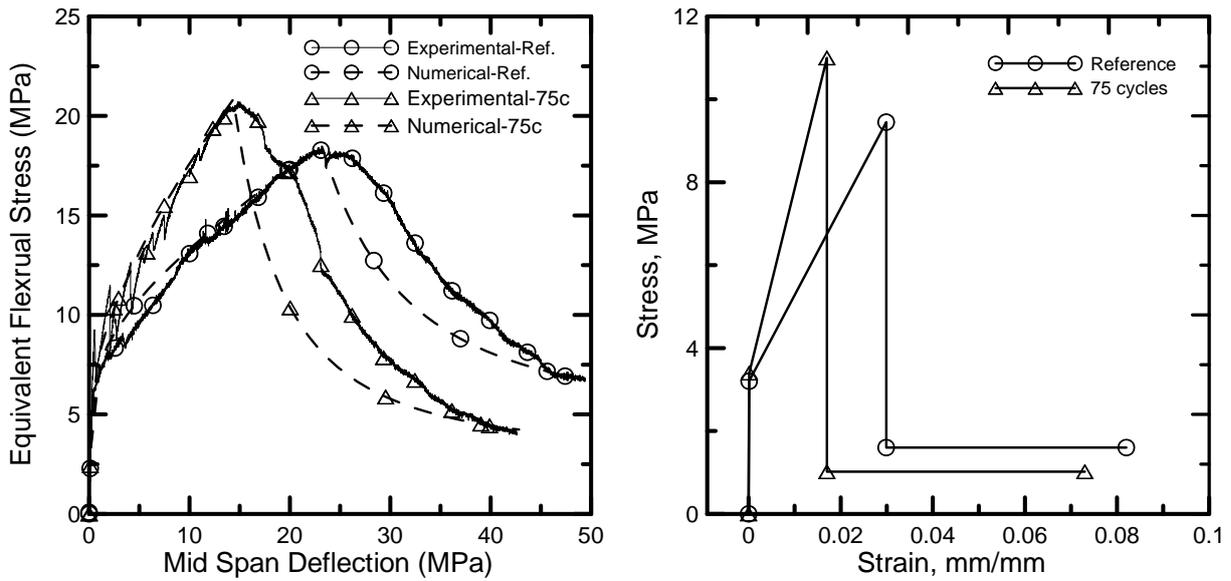
Figure 4. Inverse analysis from bending response.

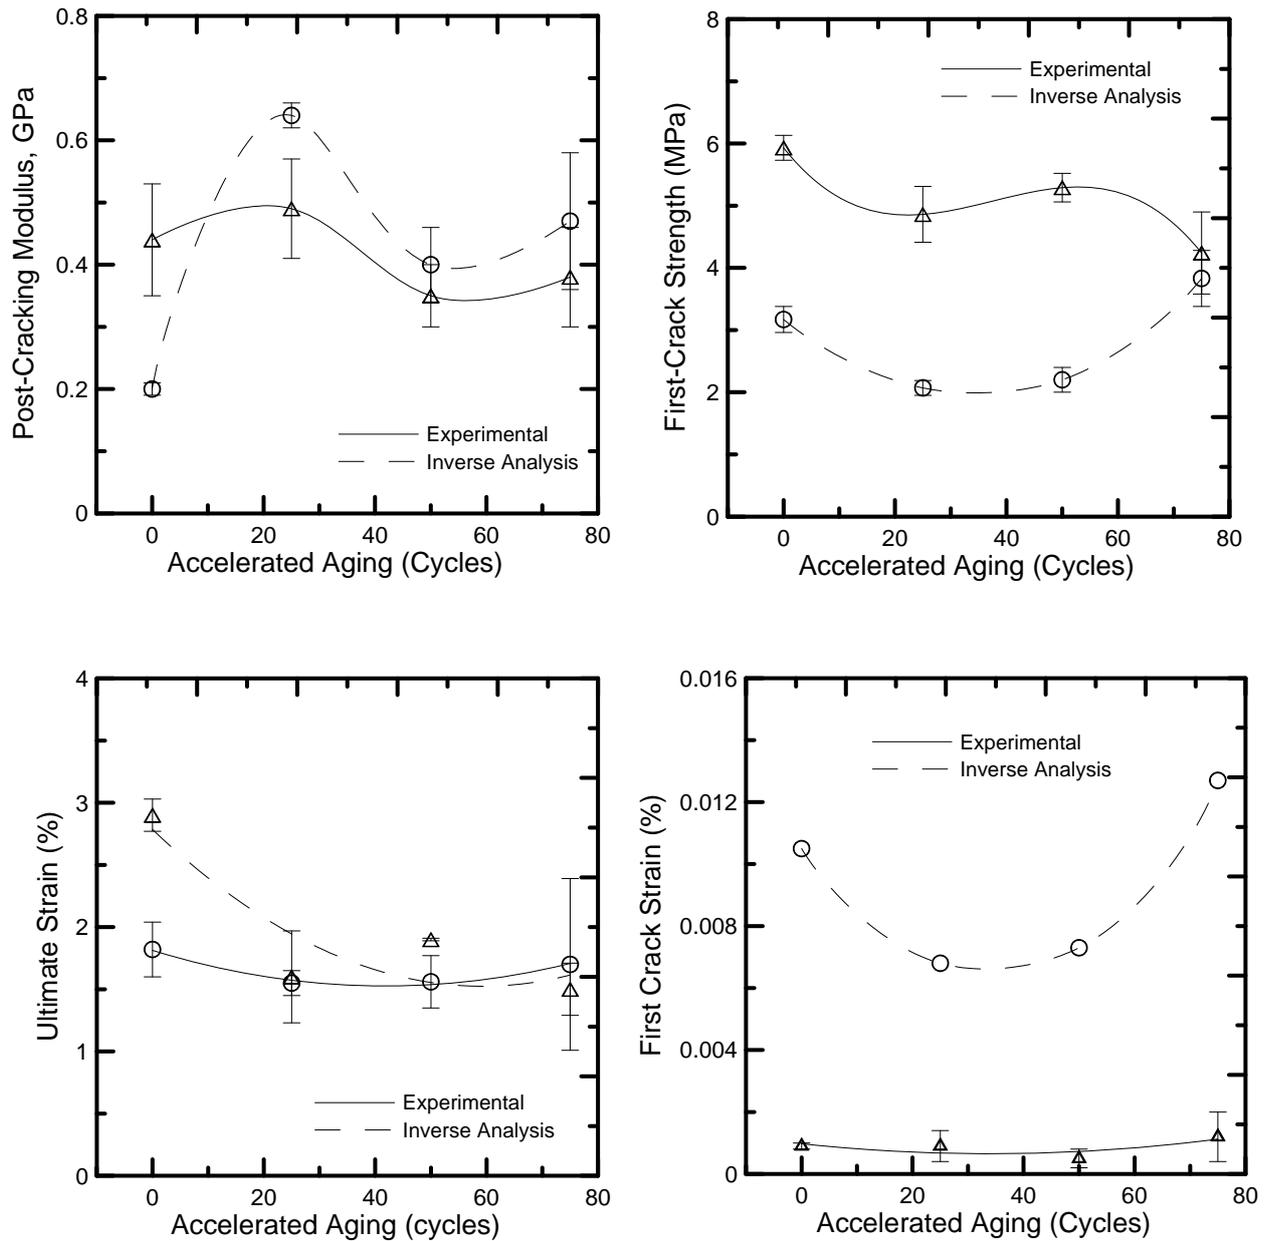
Figure 5. Effect of aging on time dependent parameters for the low CH content composite.

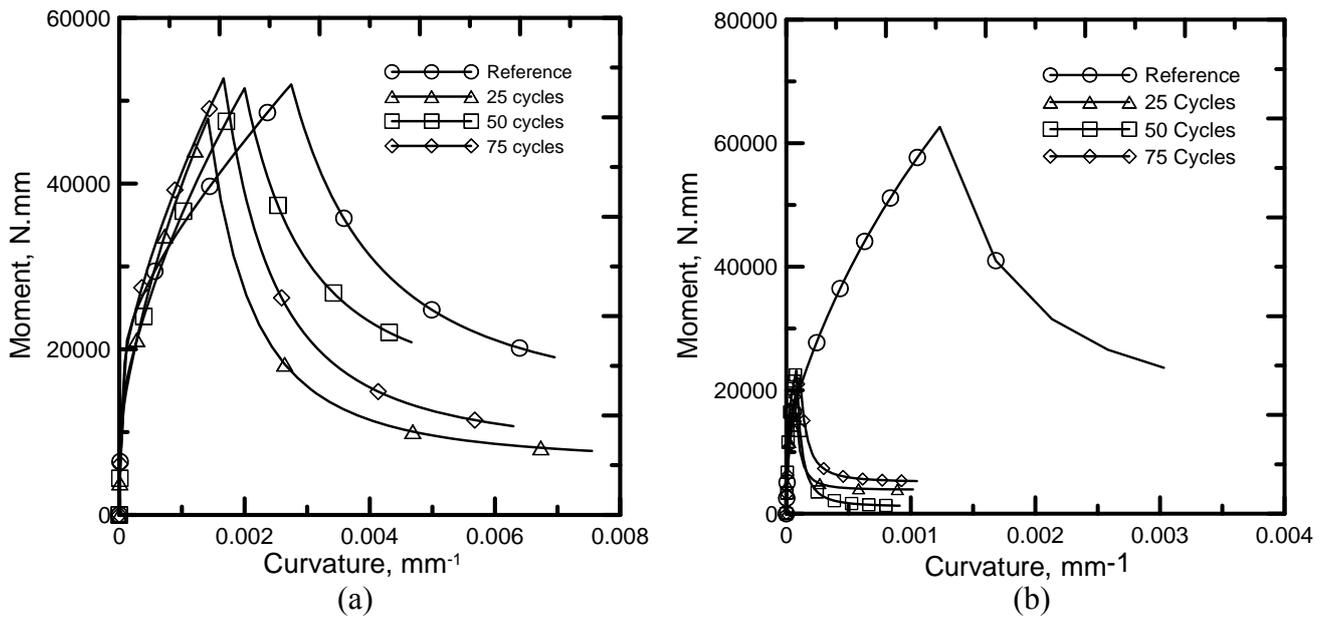
Figure 6. Moment curvature: a) CH free composites and b) PC composites.

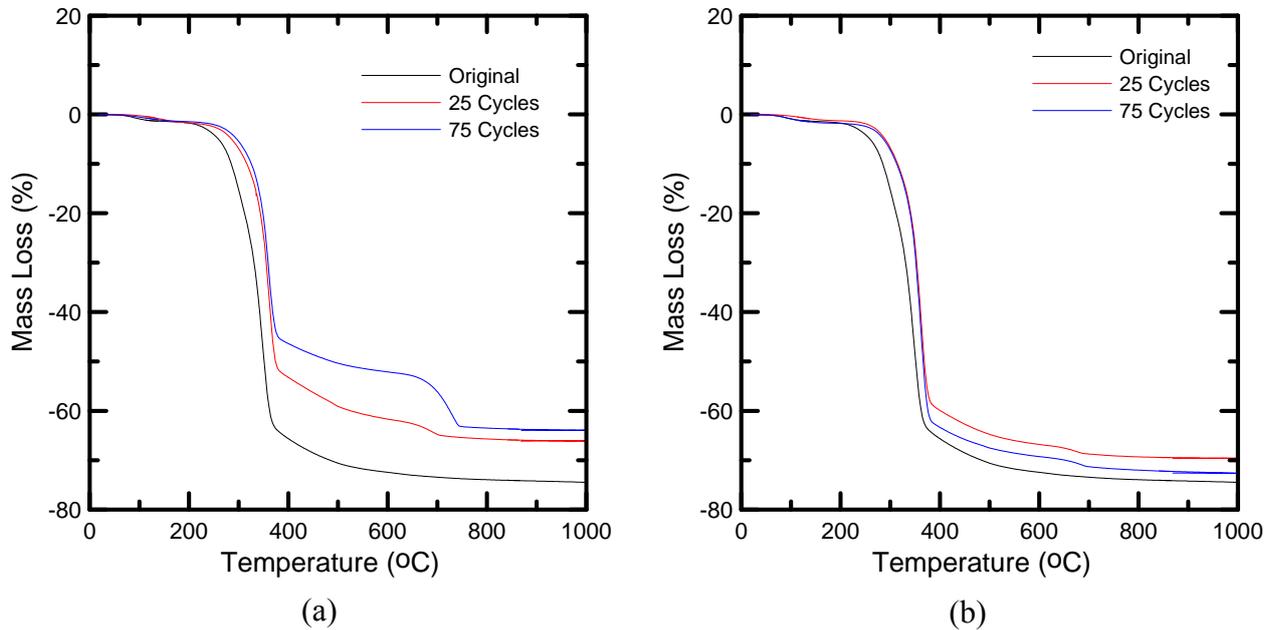
Figure 7. Effect of aging on the chemical properties of sisal fibers. (a) Fibers extracted from PC aged composites and (b) fibers extracted from CH free composites.

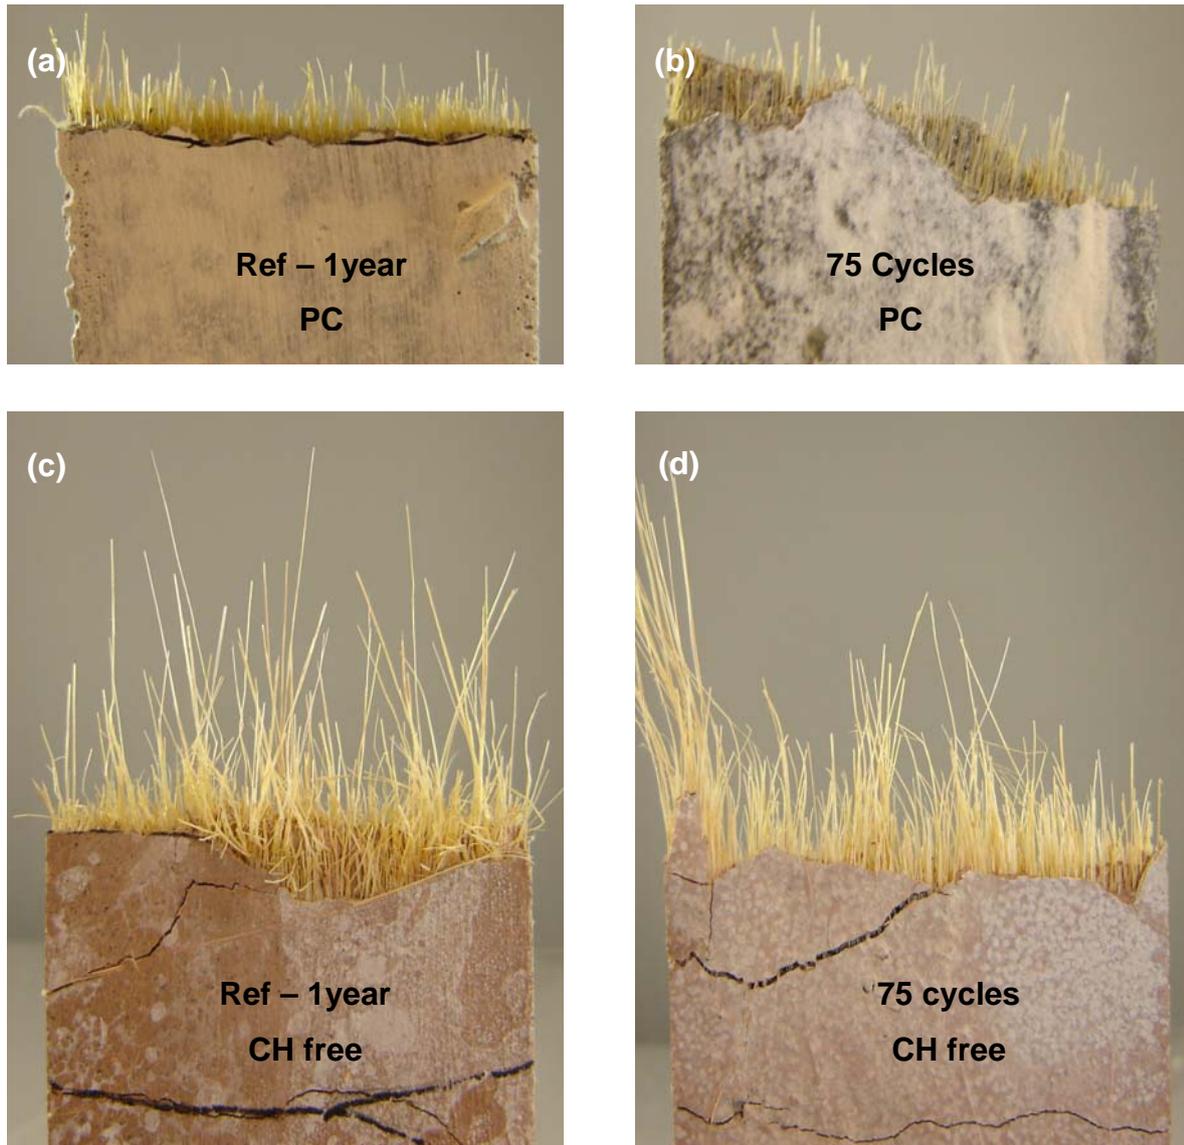
Figure 8. Pull-out length of the fibers in non aged PC specimens (a,b) PC composites and (c,d) CH free composites.

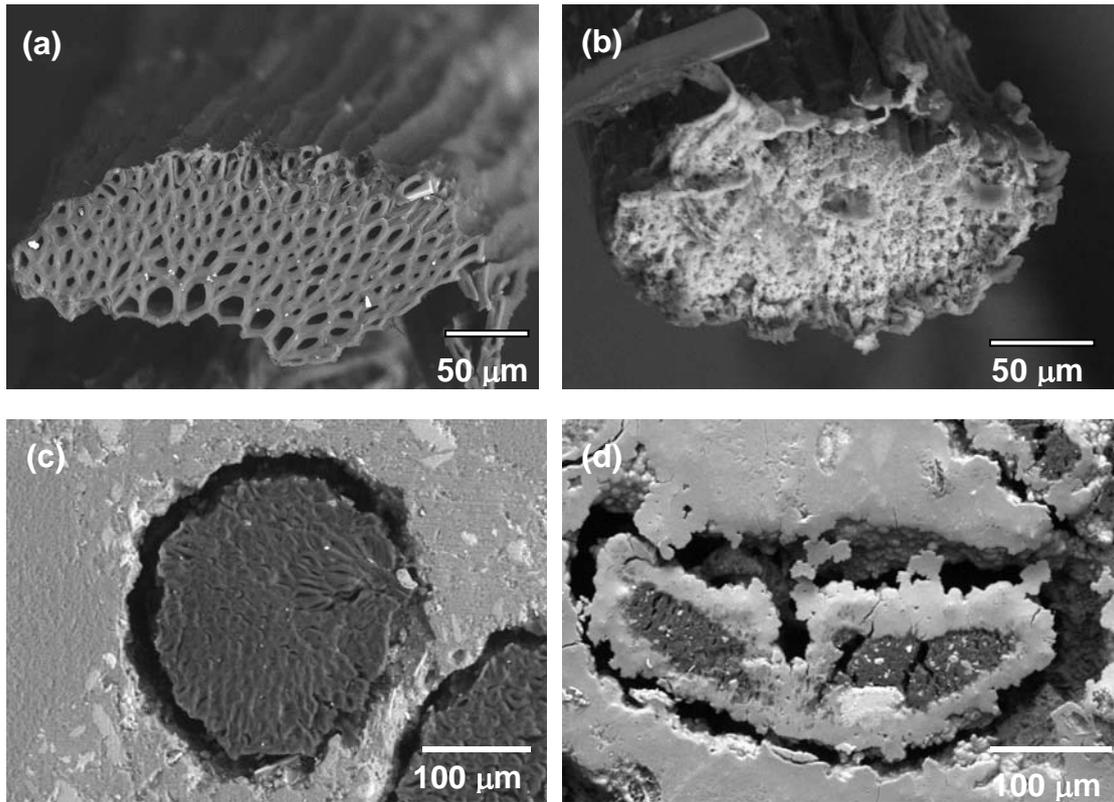
Figure 9. Effect of accelerated aging on sisal fibers: a) non-aged fiber, b) fiber extracted from a PC composite subjected to 25 cycles, c) fiber inside a CH free composite subjected to 75 cycles and d) fiber inside a PC composite subjected to 75 cycles.

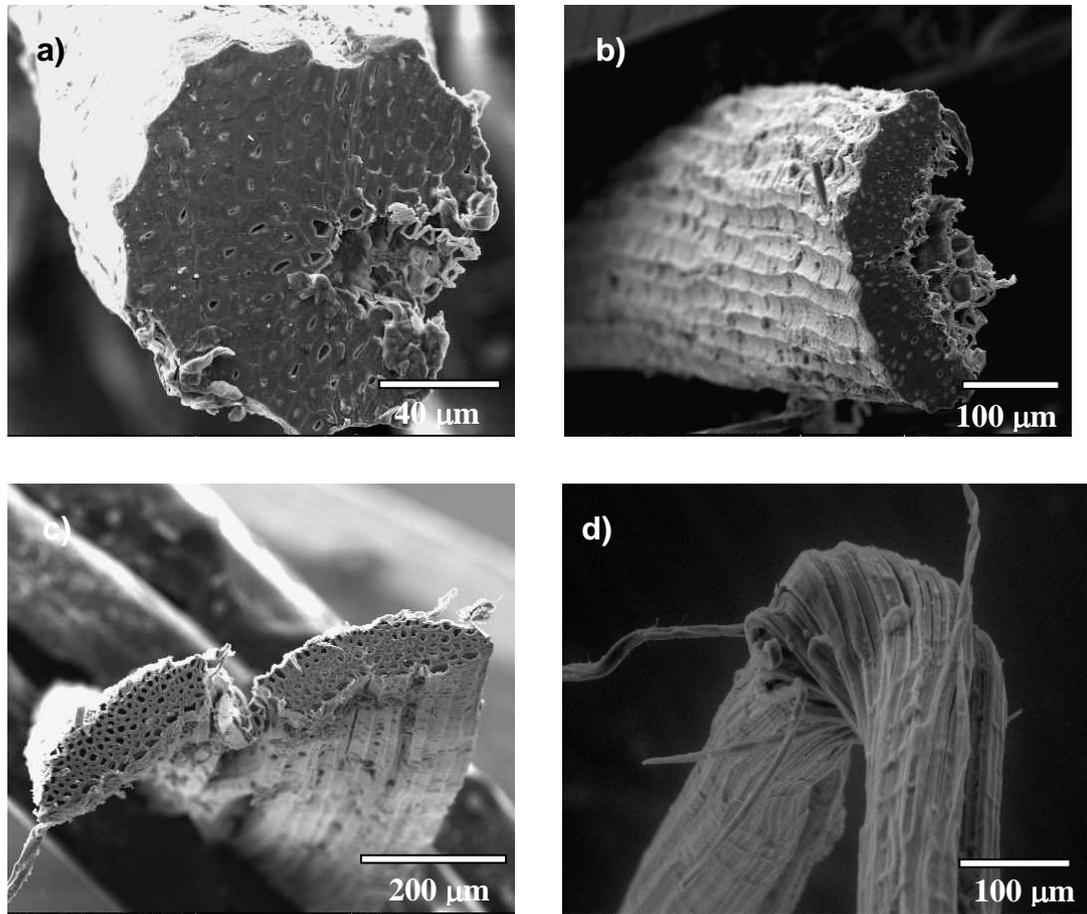
Figure 1. Different morphologies of the sisal fiber: a) horse-shoe shape, b) arch shape, and c) twisted arch shape. The different type of morphologies affects the fiber-matrix bond strength. The rough surface and flexibility of the fiber is observed in d.

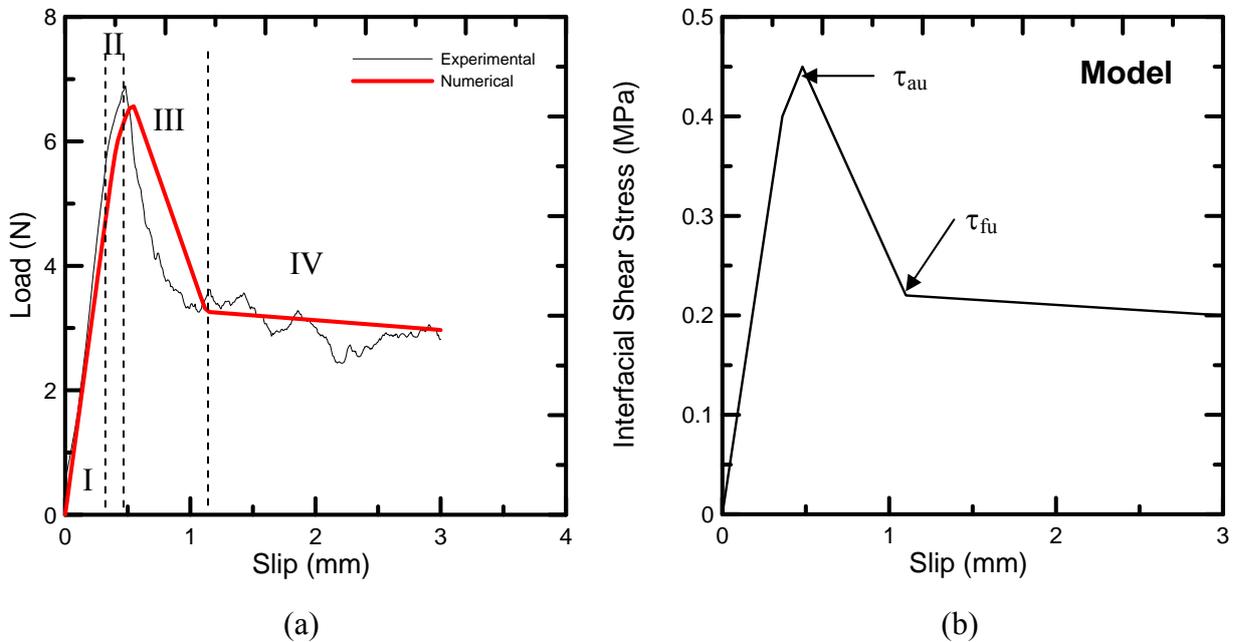
Figure 4. Fiber pull out test results of a sample tested a 3 days of curing with a embedded length of 20 mm. a) Comparison of the experimental and numerical result from the finite difference model and b) Interface constitutive relation obtained from the model.

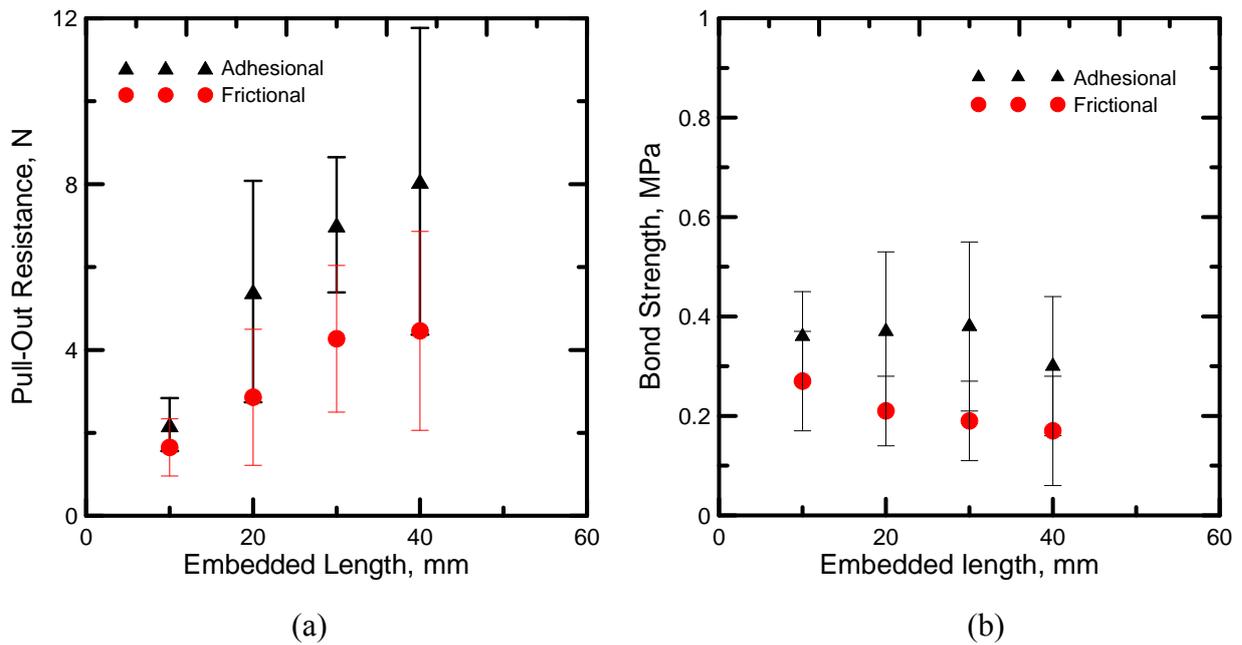
Figure 5. Influence of embedded length on the fiber-matrix interfacial bond strength: a) pull out resistance increase with increasing embedded length and b) bond strength does not improve when increasing embedded length.

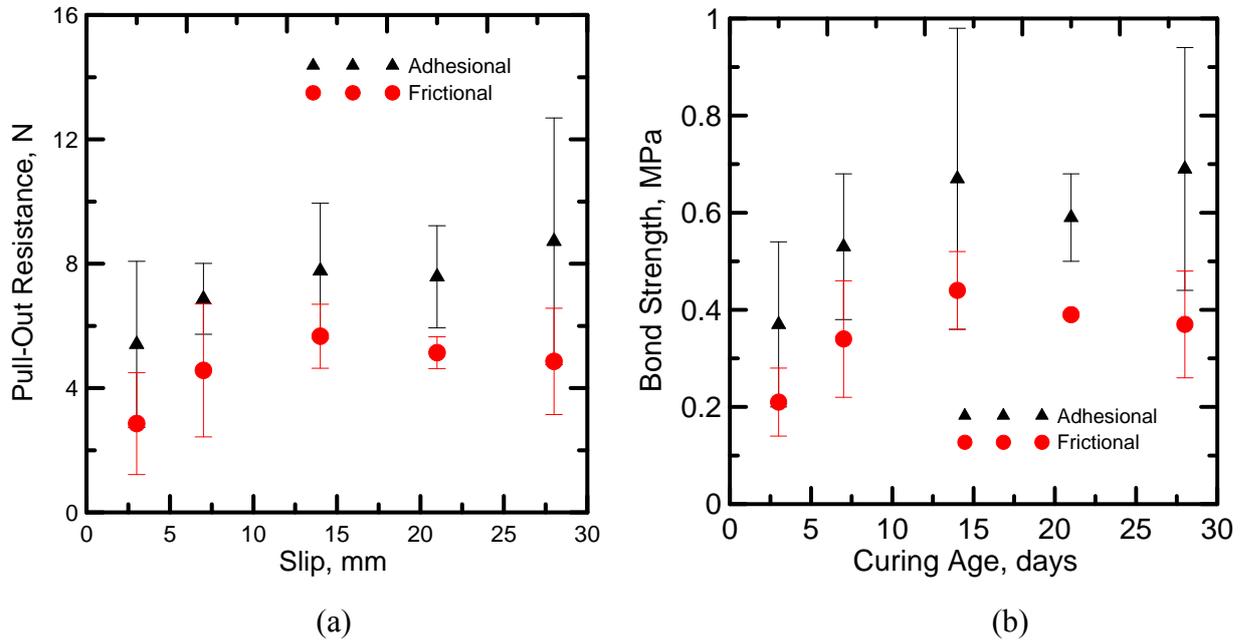
Figure 6. Influence of curing age on the fiber-matrix interfacial bond strength. After 14 days there is no further increase in a) pull out resistance and b) bond strength.
