**DURABILIDADE E PROPRIEDADES MECÂNICAS DE COMPÓSITOS
CIMENTÍCIOS REFORÇADOS POR FIBRAS DE SISAL**

Flávio de Andrade Silva

Tese de Doutorado apresentada ao Programa de Pós-graduação em Engenharia Civil, COPPE, da Universidade Federal do Rio de Janeiro, como parte dos requisitos necessários à obtenção do título de Doutor em Engenharia Civil.

Rio de Janeiro
Abril de 2009

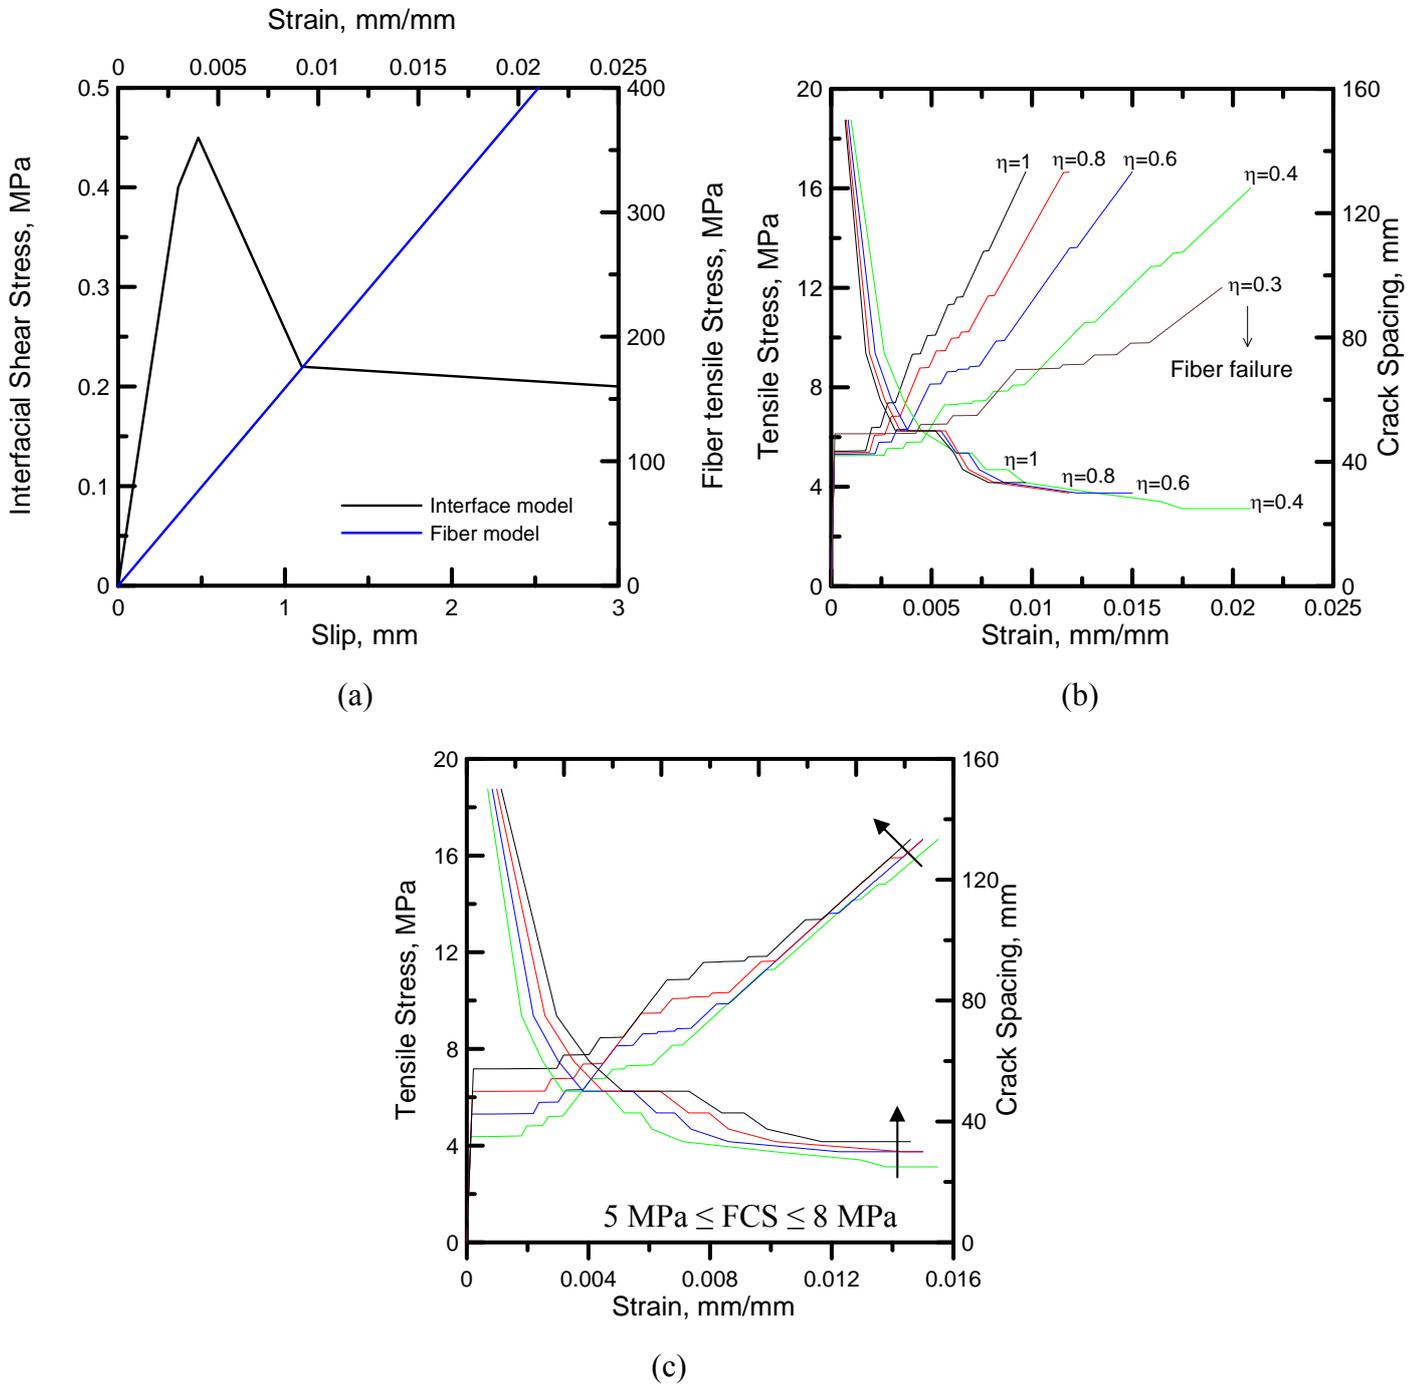
Figure 8. Prediction of tensile response and crack spacing: a) Interface and fiber model used in the finite difference simulation, b) effect of efficiency factor of fiber modulus and strength, and c) effect of matrix first crack strength.

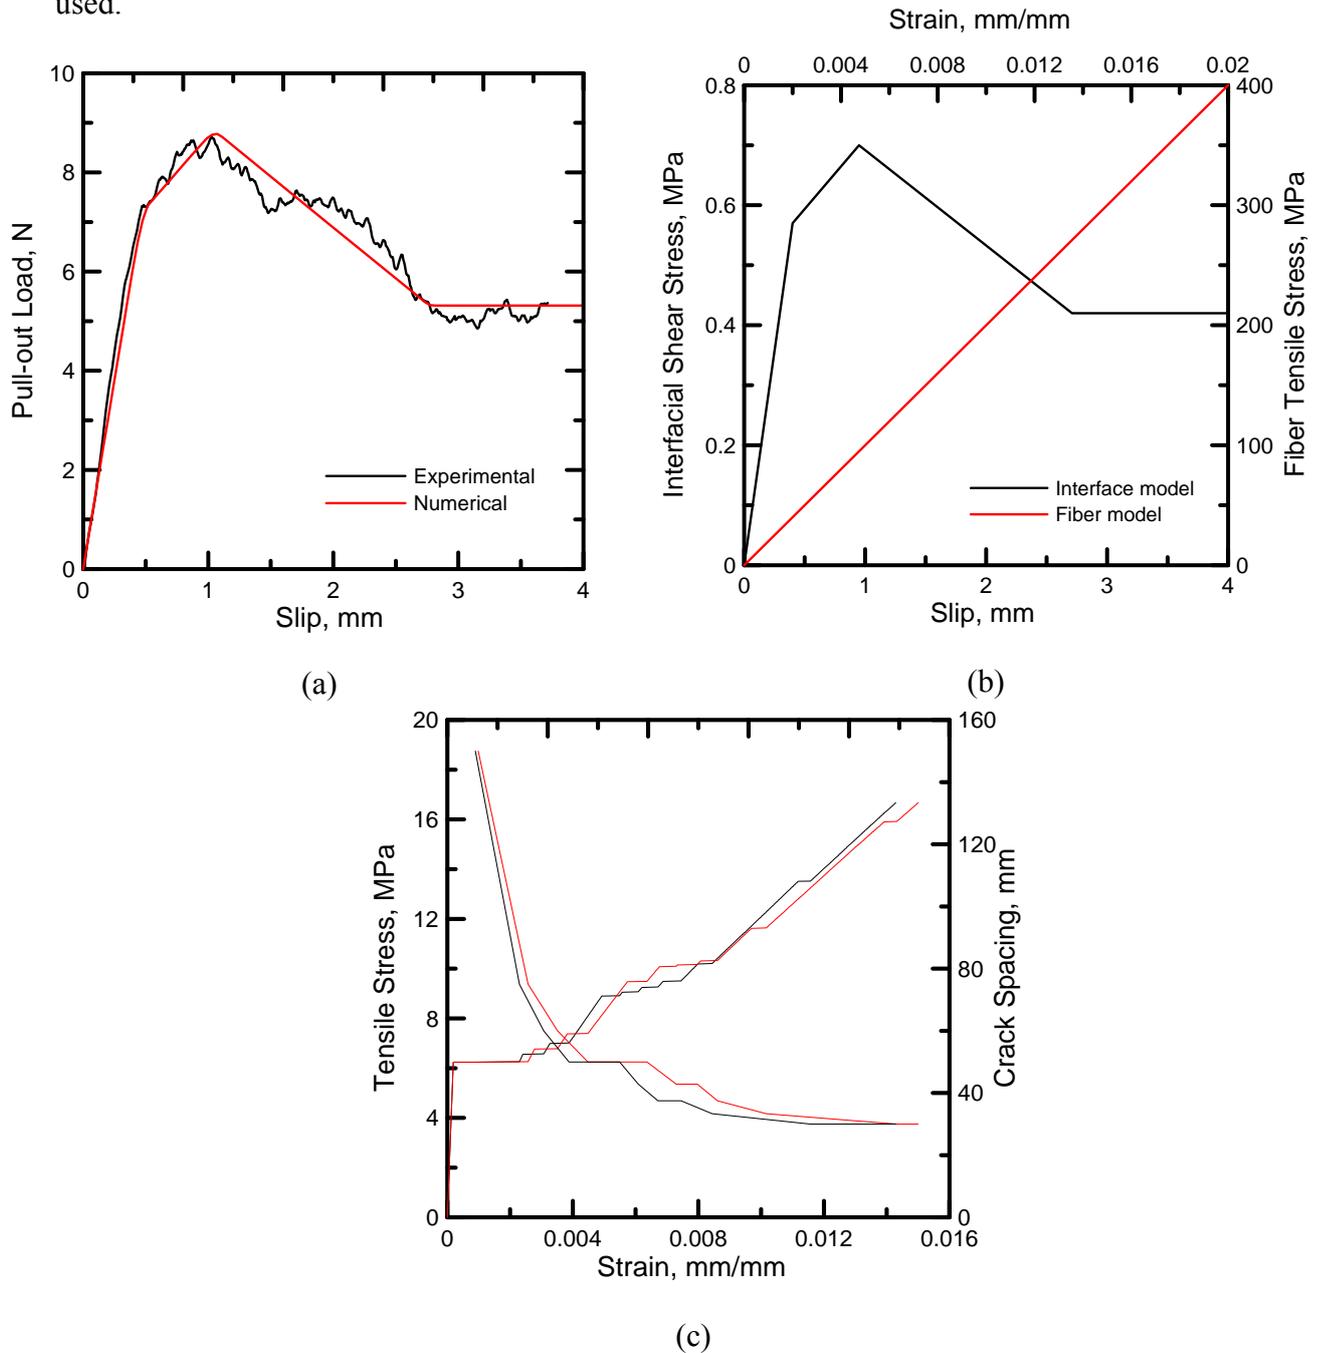
Figure 9. Study on the effect of the interface model on the tensile response and crack spacing: a) experimental and numerical pull-out response of a sample tested at 21 days

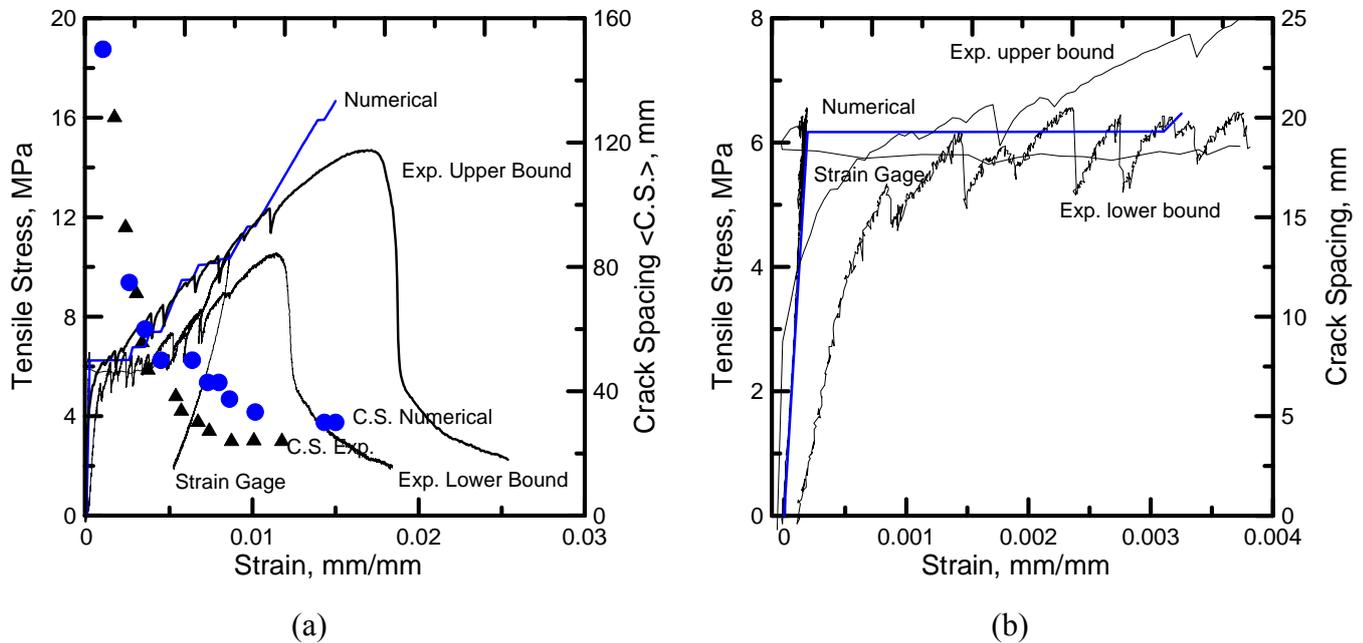
Figure 10. Comparison of experimental and numerical results of the composite tensile response and crack spacing. a) Two experimental tensile curves are shown: a lower and upper bound. b) Numerical simulation shows a perfect fit with the strain gage response in the linear elastic range up to the first crack formation.

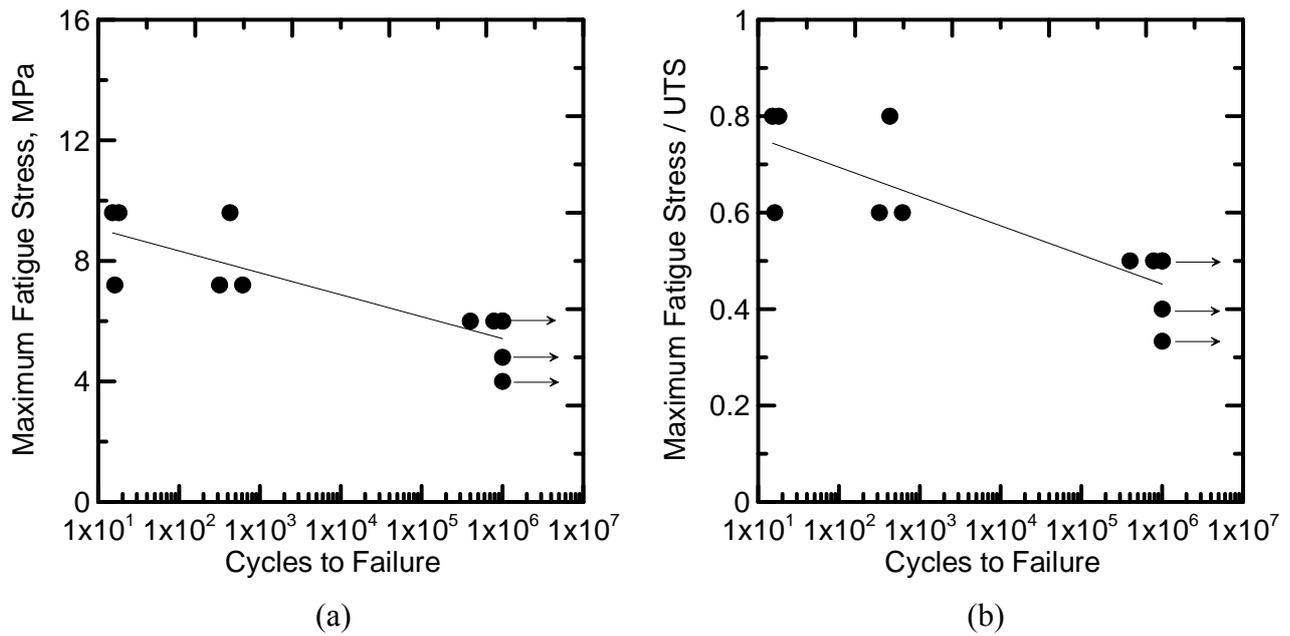
Figure 3. Stress versus cycles fatigue curve for composites subjected to maximum stress levels ranging from 4 to 9.8 MPa at constant R ratio of 0.2. Fatigue runout was taken at 10^6 cycles. The maximum stress was normalized by the ultimate tensile stress (UTS) of the composites in (b).

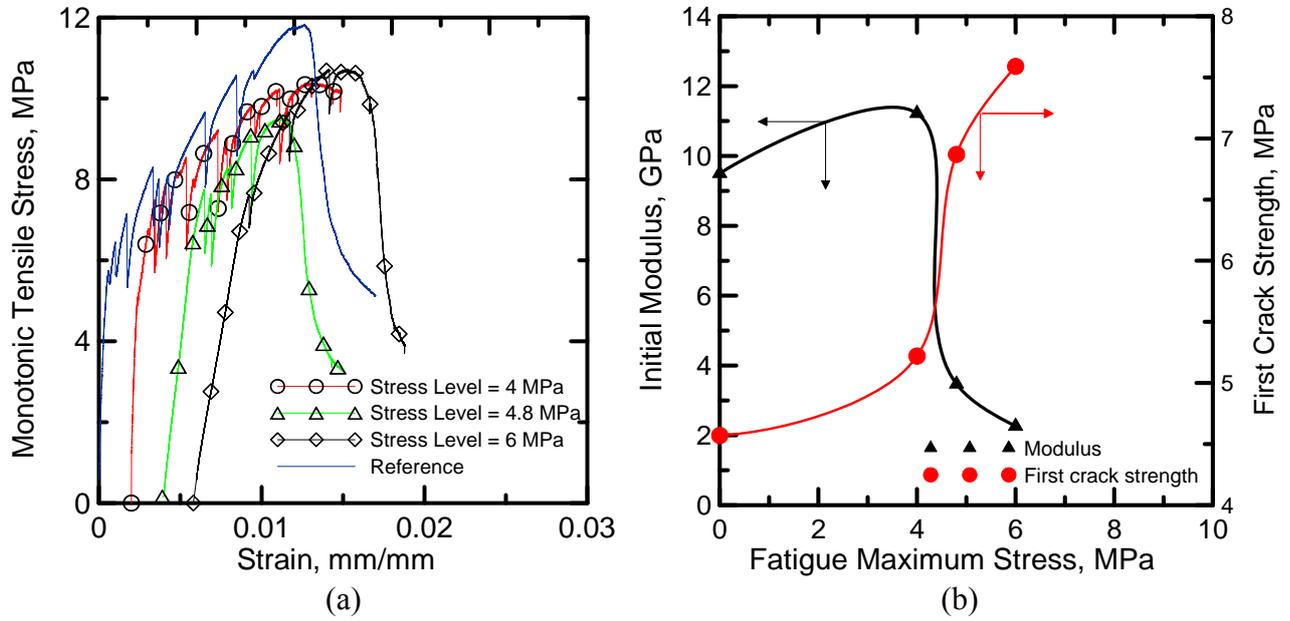
Figure 4. Monotonic tensile behavior of composites that have survived 10^6 cycles: (a) stress-strain curves of composites subjected to maximum fatigue stresses of 4, 4.8 and 6 MPa and (b) effect of the cycles on modulus of elasticity and first crack strength.

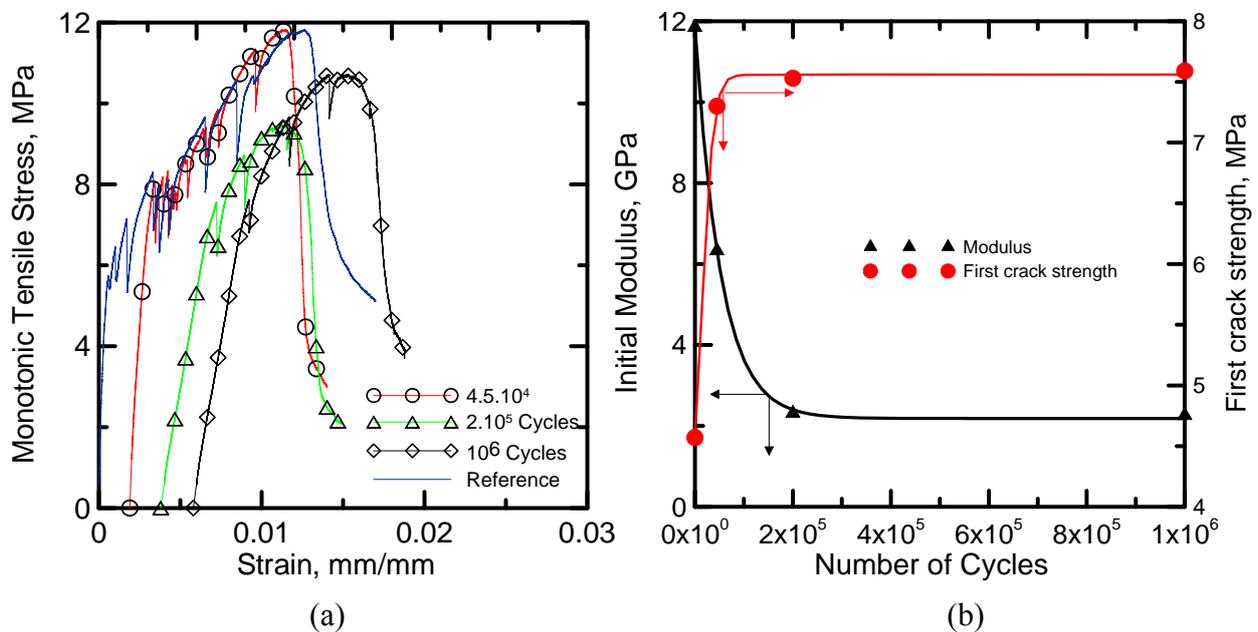
Figure 6. (a) Monotonic tensile behavior of composites cycled at maximum stress level of 6 MPa. The fatigue tests were stopped at 4.5×10^4 , 2.10^5 and 10^6 cycles. (b) Effect of the cycles on the modulus of elasticity and first crack strength.

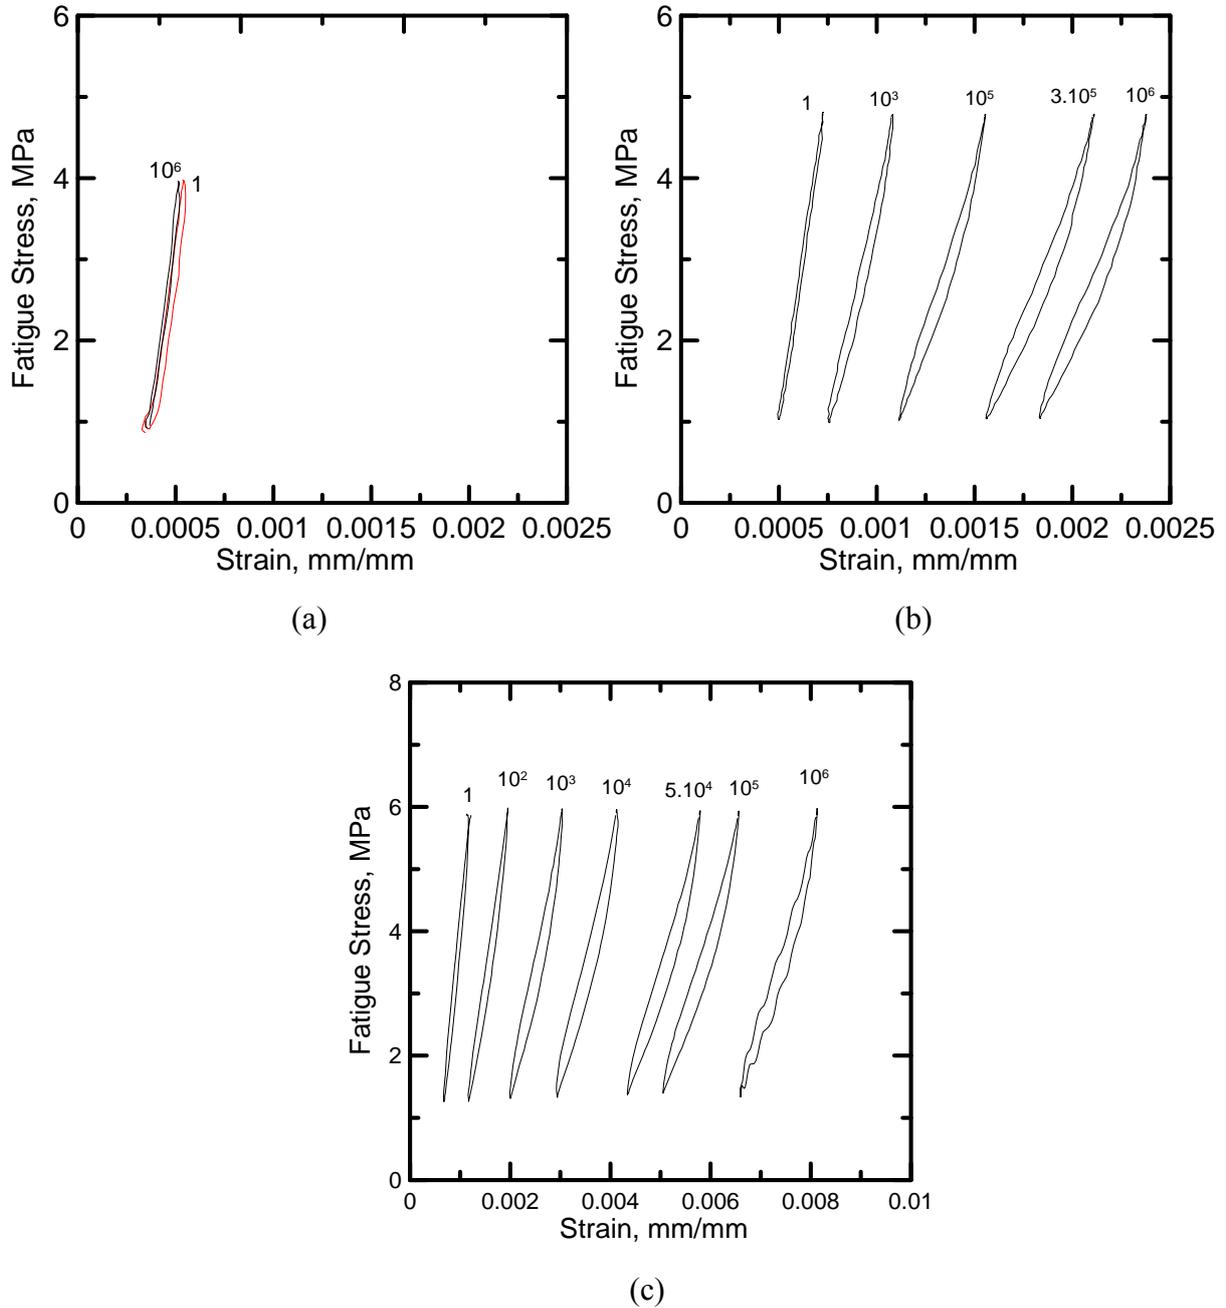
Figure 7. Hysteresis stress-strain behavior of composites subjected to 10^6 cycles. Maximum stress levels of (a) 4 MPa, (b) 4.8 MPa and (c) 6 MPa.

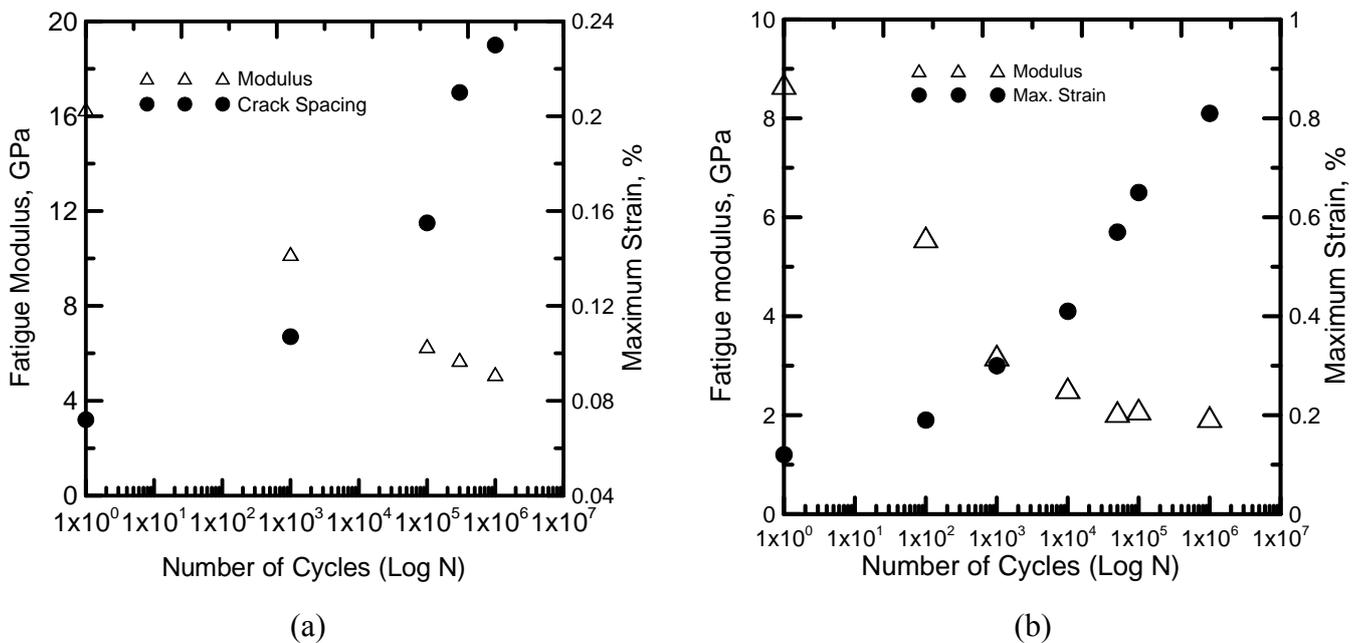
Figure 8. Effect of the cycles on the fatigue modulus and maximum strain of composites subjected to maximum stresses of (a) 4.8 MPa and (b) 6 MPa.

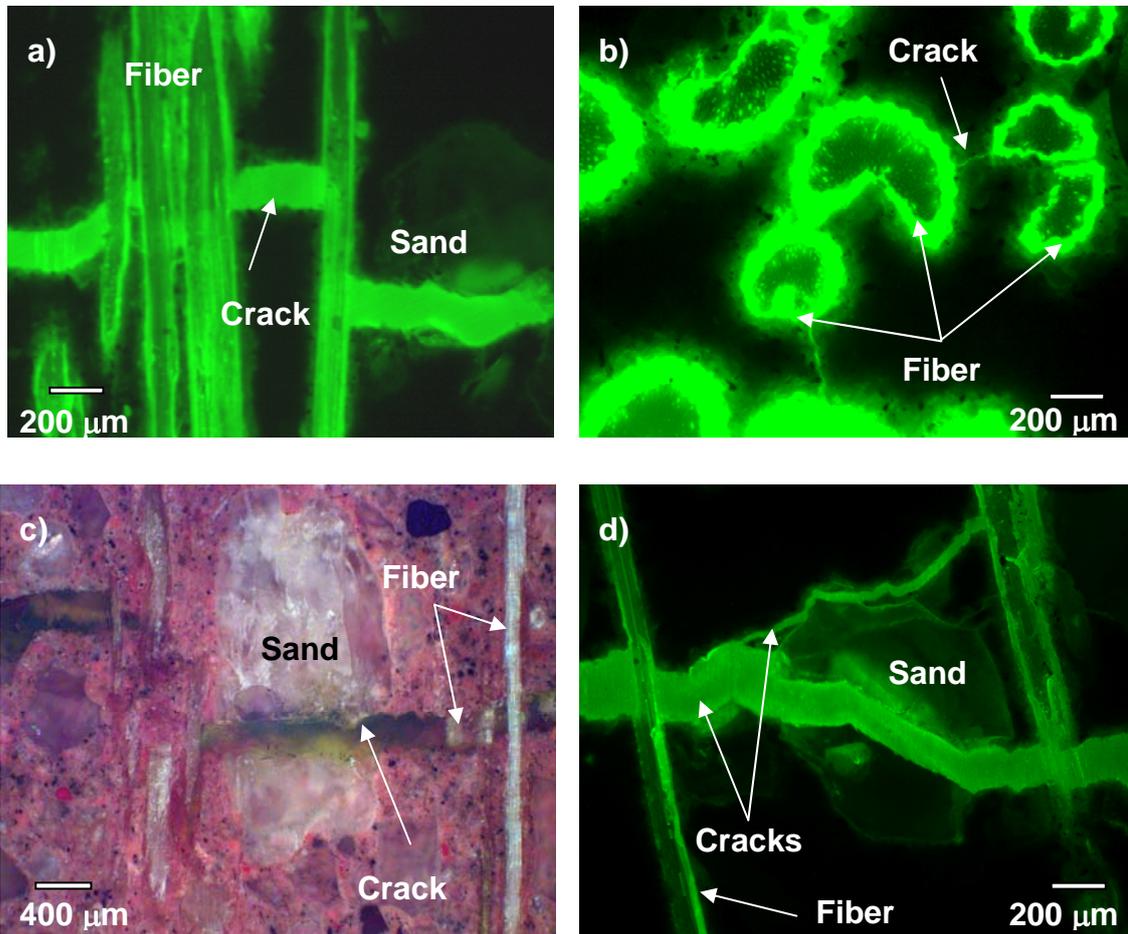
Figure 9. Cracks on composites subjected to 10^6 cycles at maximum fatigue level of 6 MPa. Fluorescent and conventional optical microscopy. Note the higher contrast in the fluorescent optical microscopy that allows the visualization of small cracks ($< 20\mu\text{m}$).

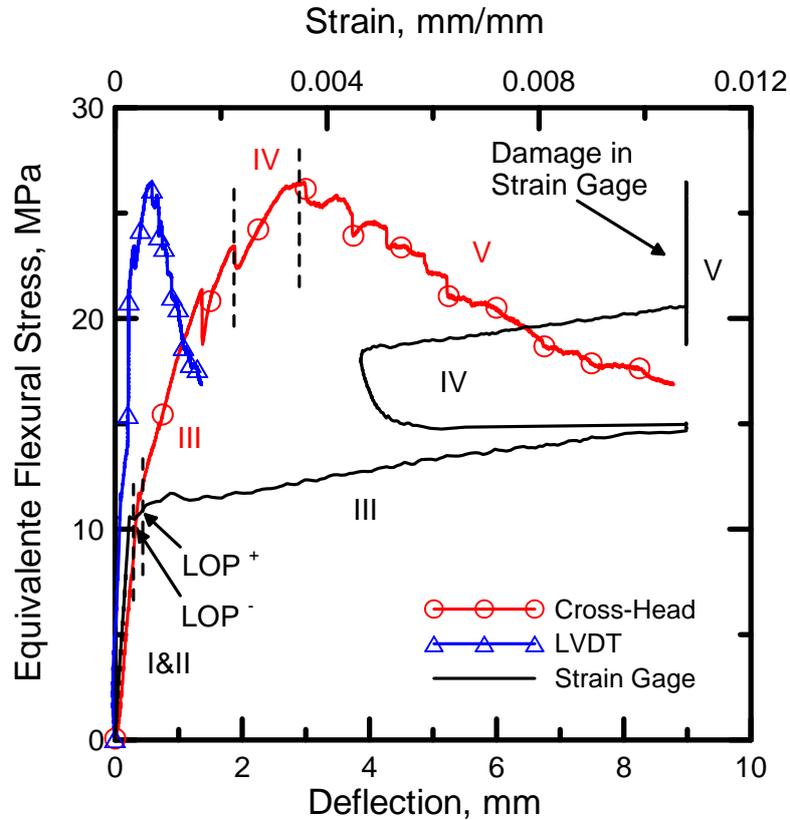
Figure 3. Response of sisal fiber reinforced composite under static three point bending. Mid-span deflection was measured by LVDT while bottom face strain was measured by strain gages.

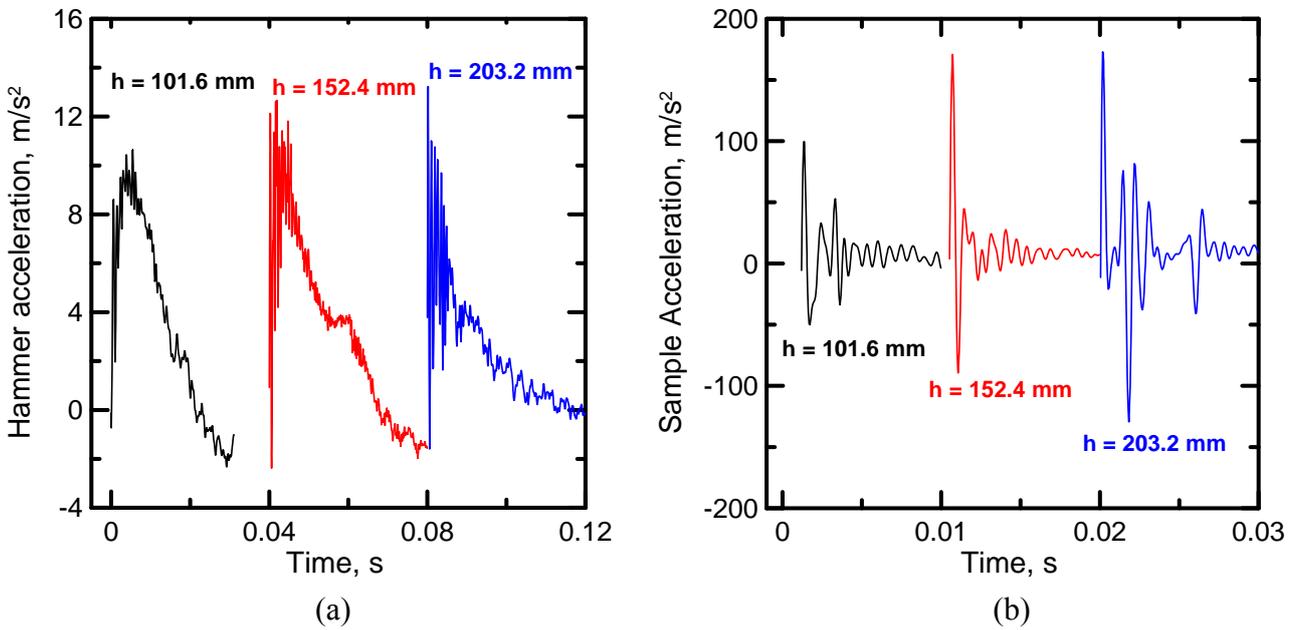
Figure 4. Effect of the drop height on the striker (a) and sample (b) acceleration.

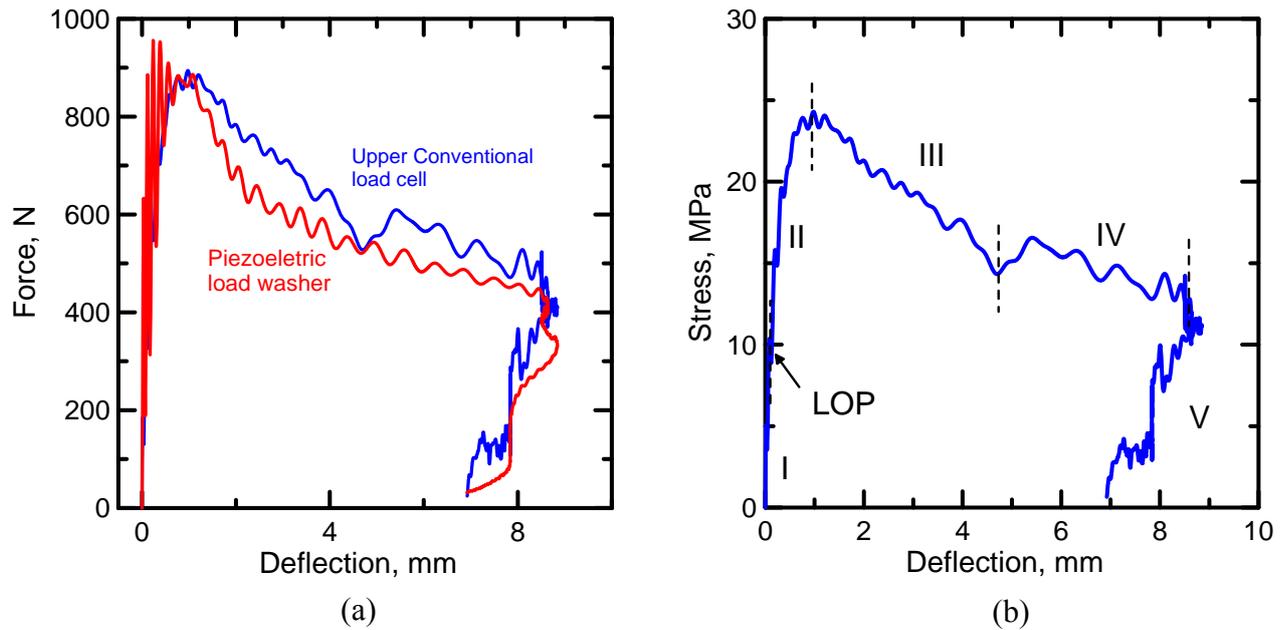
Figure 6. Comparison of piezoelectric load washer and upper conventional load cell responses (a) and different zones in a typical stress vs. deflection impact curve (b). Note the less oscillation measured from the conventional load cell.

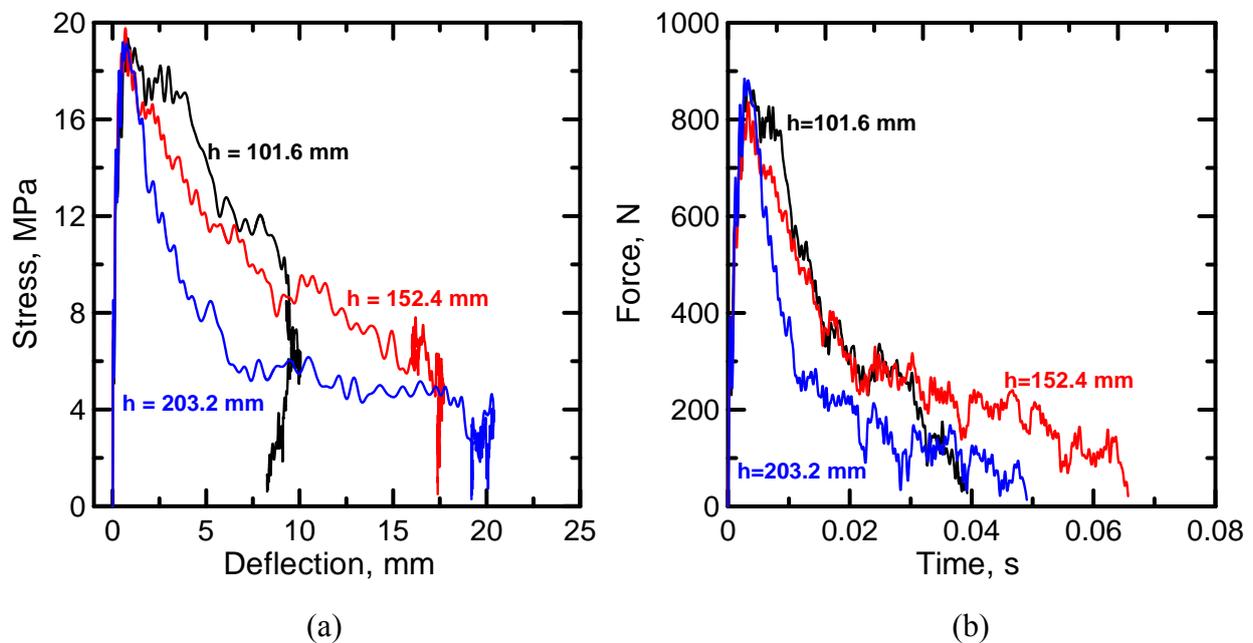
Figure 7. Effect of drop height on the stress vs. deflection (a) and stress vs. time (b) response of the sisal fiber reinforced composite.

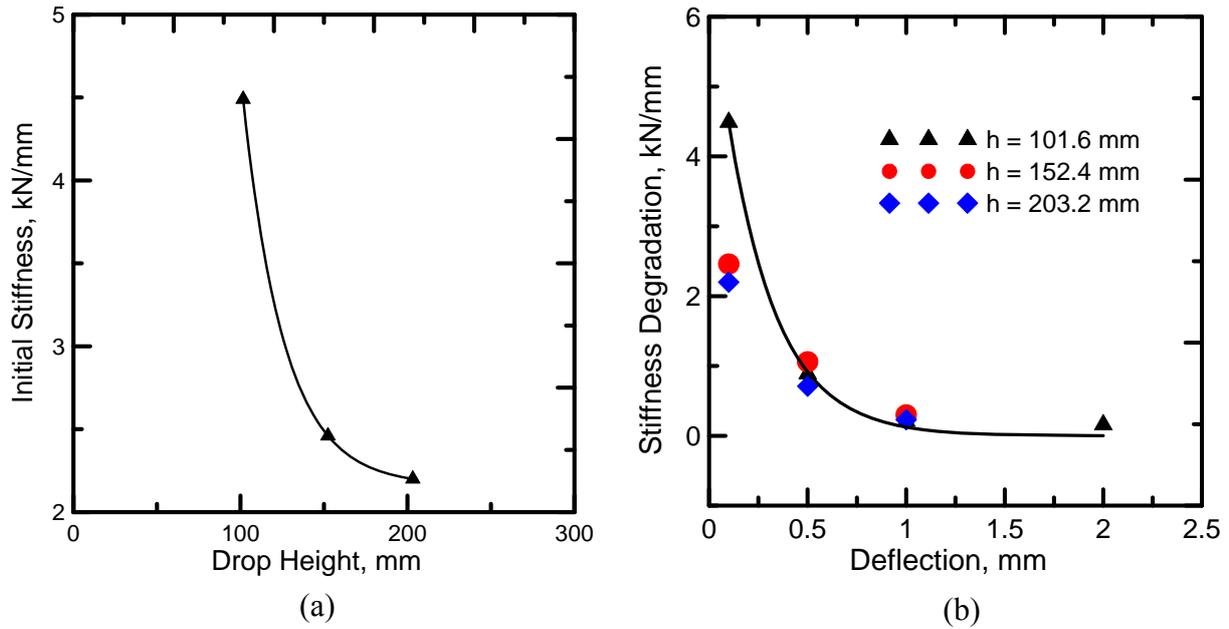
Figure 8. Effect of drop height on the initial stiffness (a) and degraded stiffness (b).

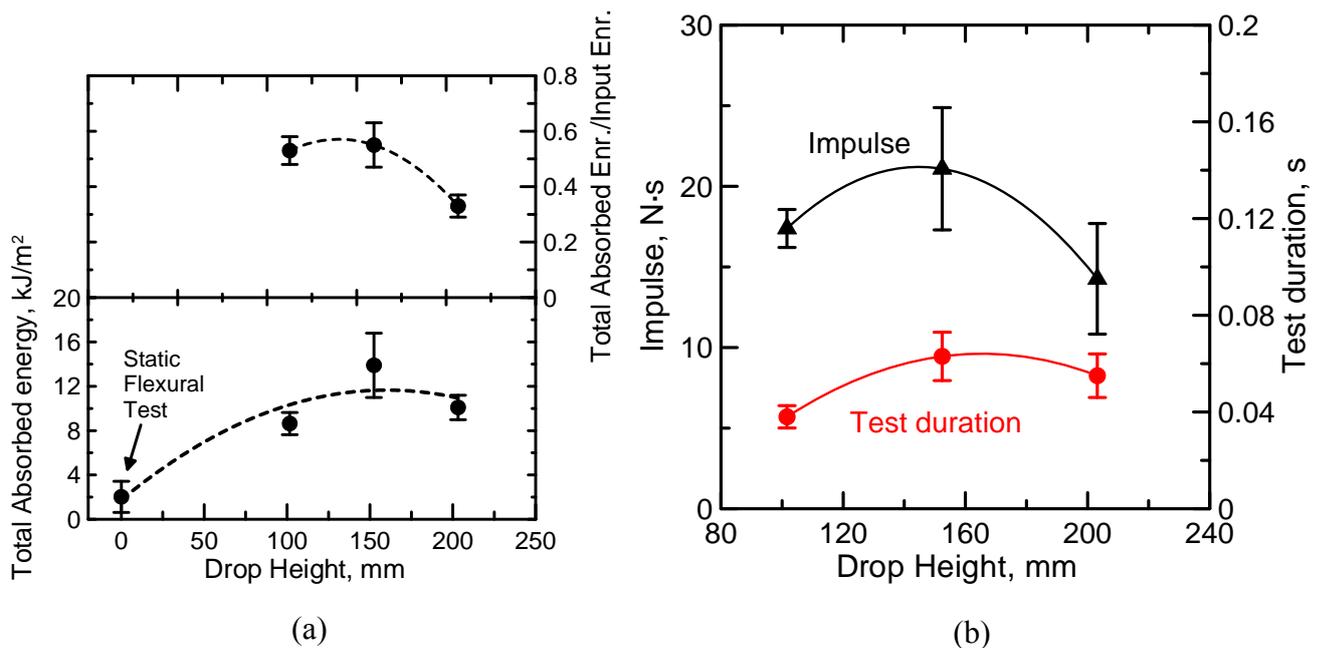
Figure 9. Effect of drop height on toughness (a) and impulse (b). Total absorbed energy was normalized in respect to the impact energy (input energy) in (a).

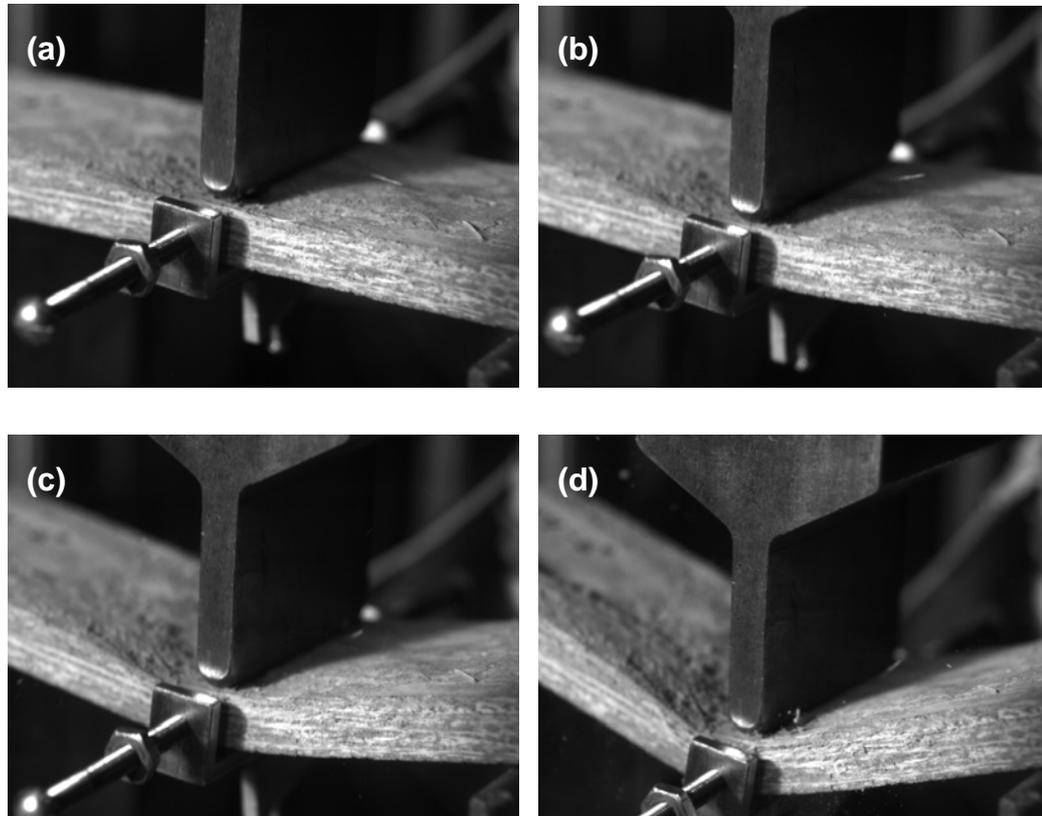
Figure 10. Effect of impact load on the deflection of sisal fiber composites subjected to impact at drop height of 152.4 mm. Note the high ductility of the material.

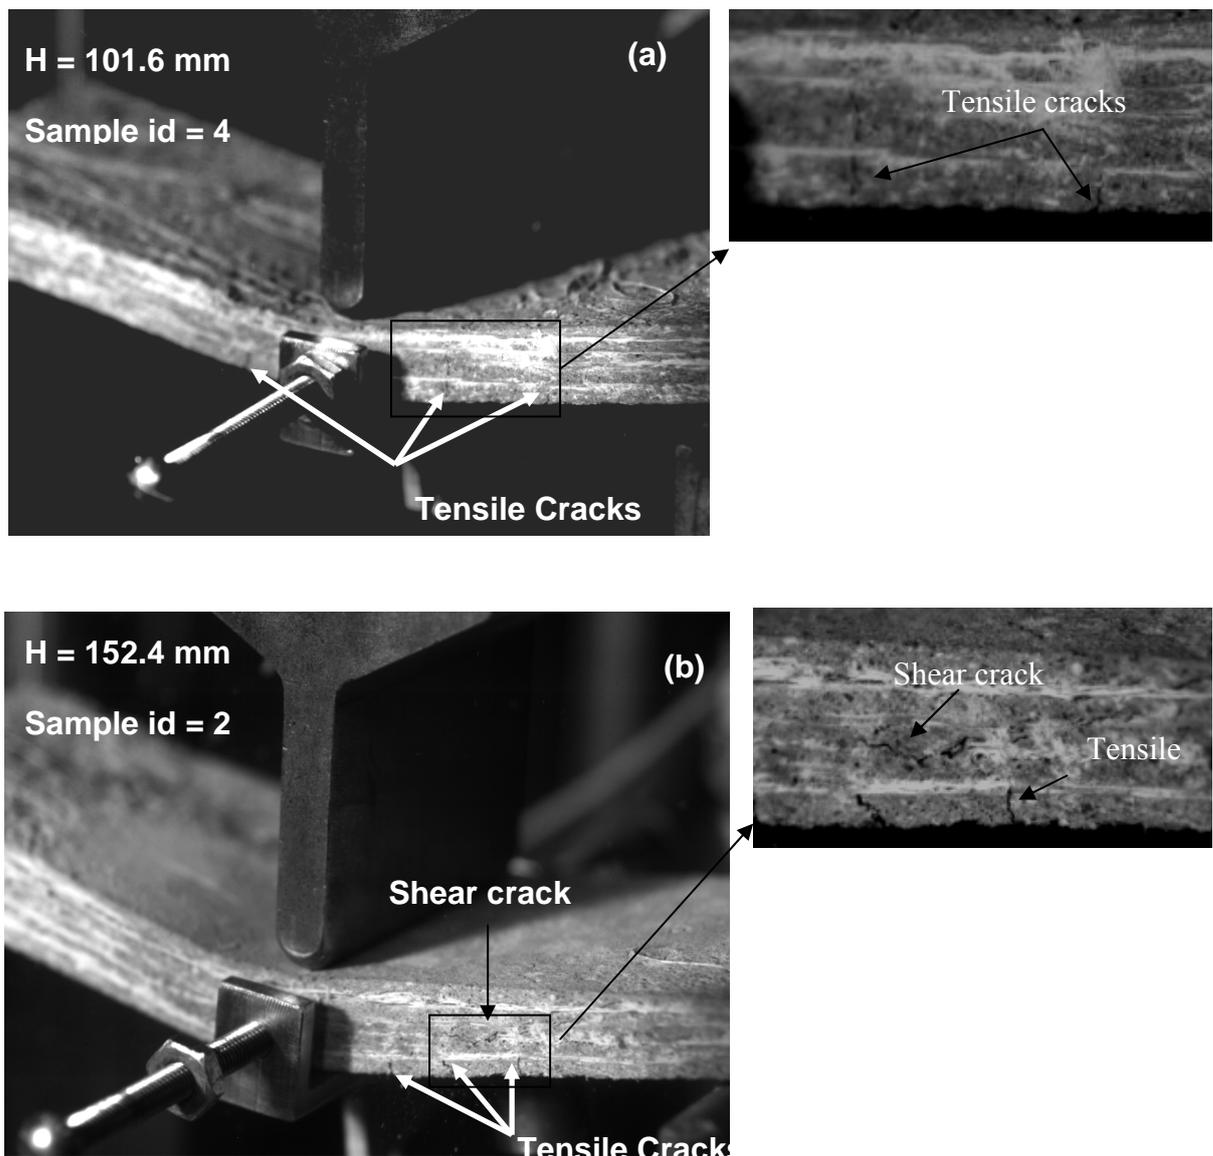
Figure 11. Damage mechanisms in composites subjected to impact: (a) drop height = 101.6 mm and (b) 152.4 mm. Tensile cracks were observed in the bottom face and shear cracks in the midplane.

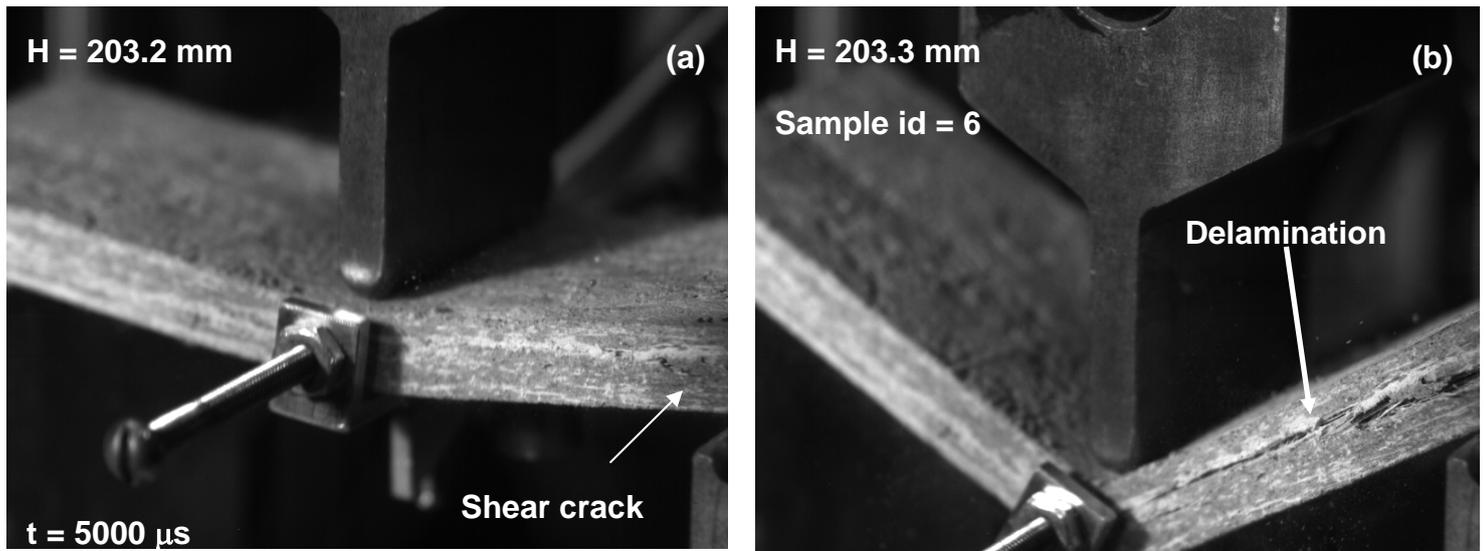
Figure 12. Damage mechanisms in sample subjected to impact height of 203.2 mm. Shear crack (a) initiated the delamination process in (b).

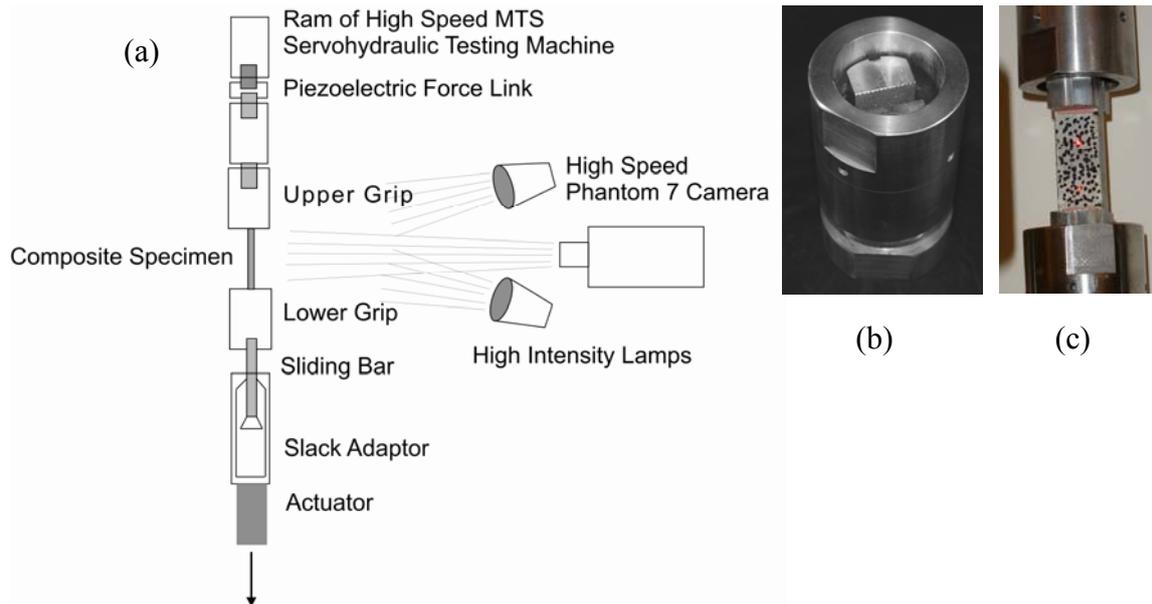
Figure 1. Schematic diagram of test set-up for high speed tensile testing (a). The grip can fit different specimen widths by changing the internal wedge grips (b) and the sample in place before the dynamic test (c).

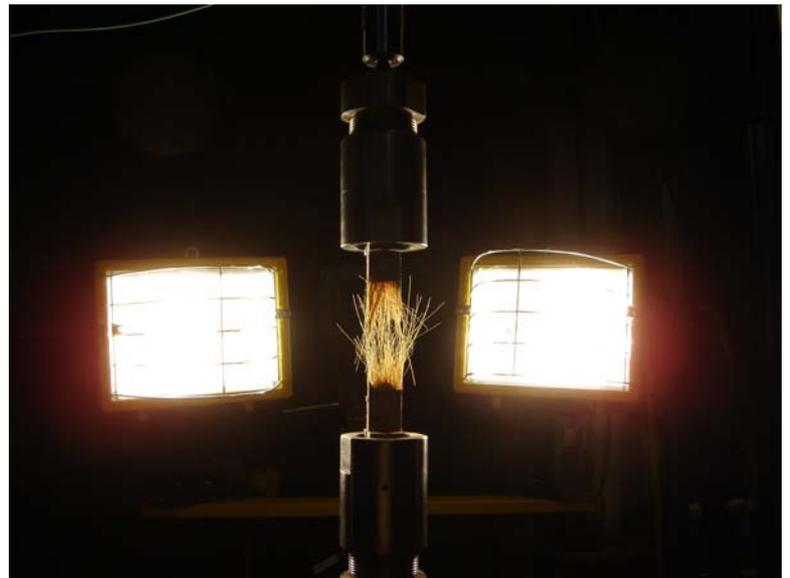
Figure 2. Dynamic test set-up before (a) and after (b) the test.

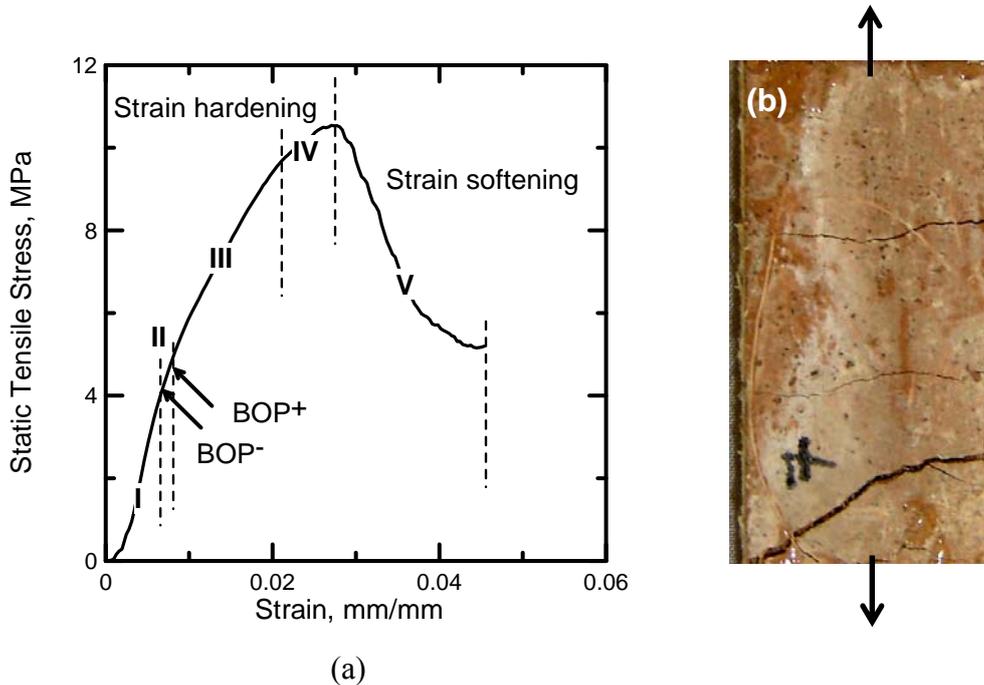
Figure 4. Static stress-strain behavior of the sisal fiber cement composite (50.8 mm span) (a) and a tested sample showing only 3 cracks (b). Both tensile and shear cracks can be observed.

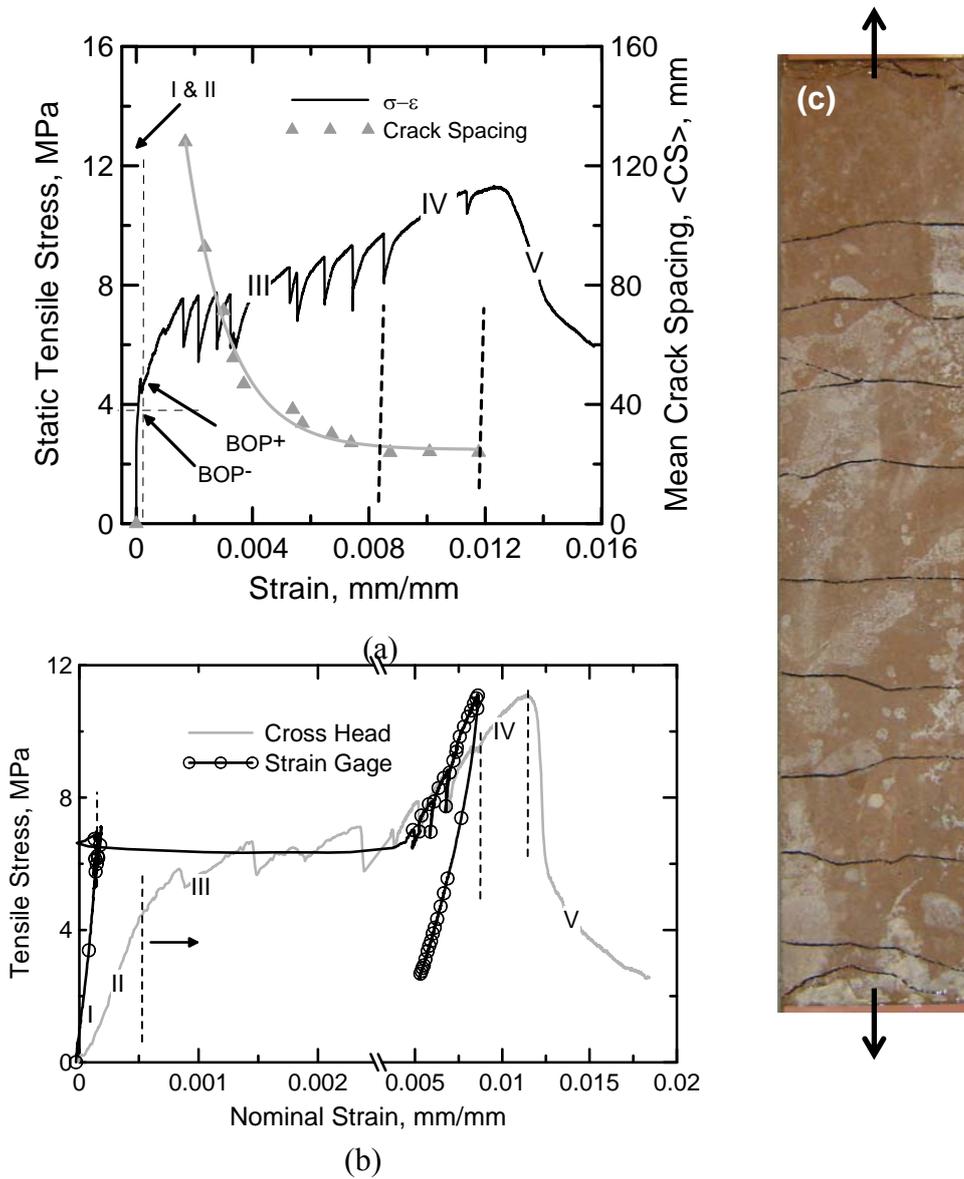
Figure 5. Static stress-strain response of the sisal fiber cement composite for a span of 300 mm [1]. Note in (a) the drops in the curve that correspond to the crack formation and in (b) the difference in the stiffness in the linear elastic zone obtained from strain gage and cross head measurements. Parallel tensile cracks in a total of 12 were observed (c).
