**DURABILIDADE E PROPRIEDADES MECÂNICAS DE COMPÓSITOS
CIMENTÍCIOS REFORÇADOS POR FIBRAS DE SISAL**

Flávio de Andrade Silva

Tese de Doutorado apresentada ao Programa de Pós-graduação em Engenharia Civil, COPPE, da Universidade Federal do Rio de Janeiro, como parte dos requisitos necessários à obtenção do título de Doutor em Engenharia Civil.

Rio de Janeiro
Abril de 2009

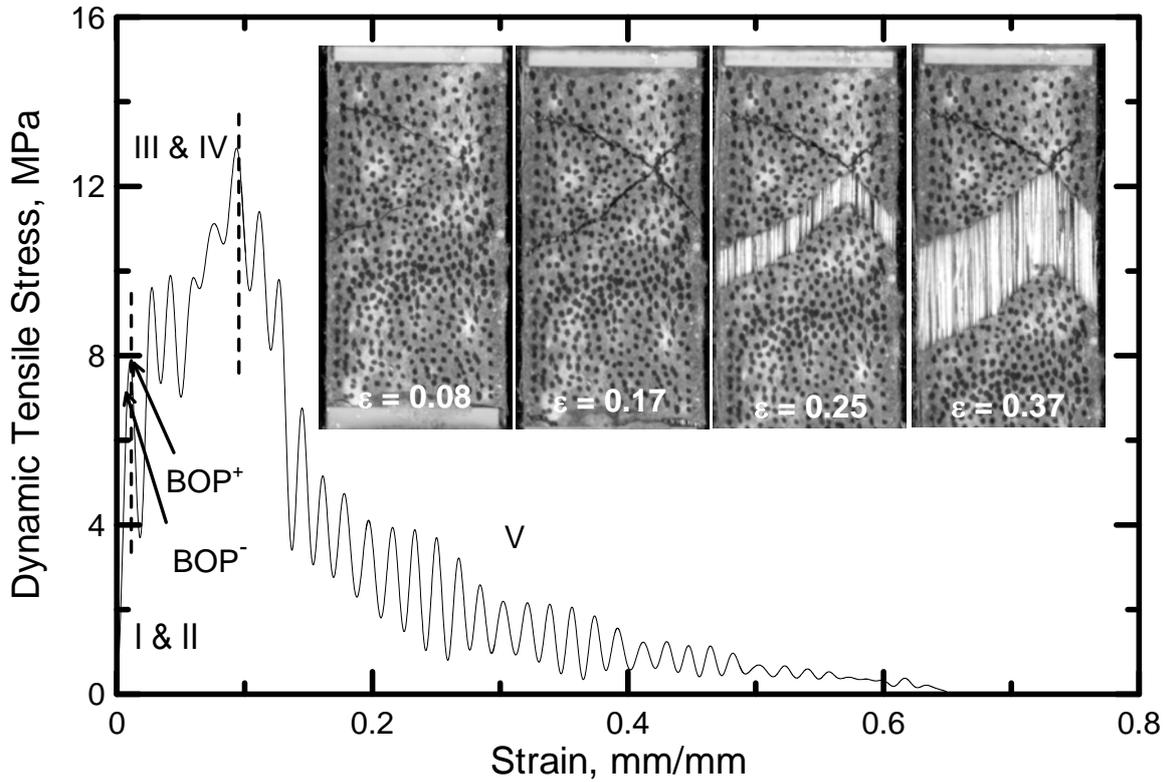
Figure 6. Dynamic stress-strain behavior of the sisal fiber cement composite. Images obtained from high speed Phantom camera shows the formation of shear cracks and the pull-out failure; therefore, resulting in high energy absorption.
