SMELT SPOUT CORROSION IN A RECOVERY BOILER

Dissertação apresentada à Universidade Federal de Viçosa, como parte das exigências do Programa de Pós-Graduação do Mestrado Profissional em Tecnologia de Celulose e Papel, para obtenção do título de *Magister Scientiae*.

**VIÇOSA
MINAS GERAIS - BRASIL
2010**

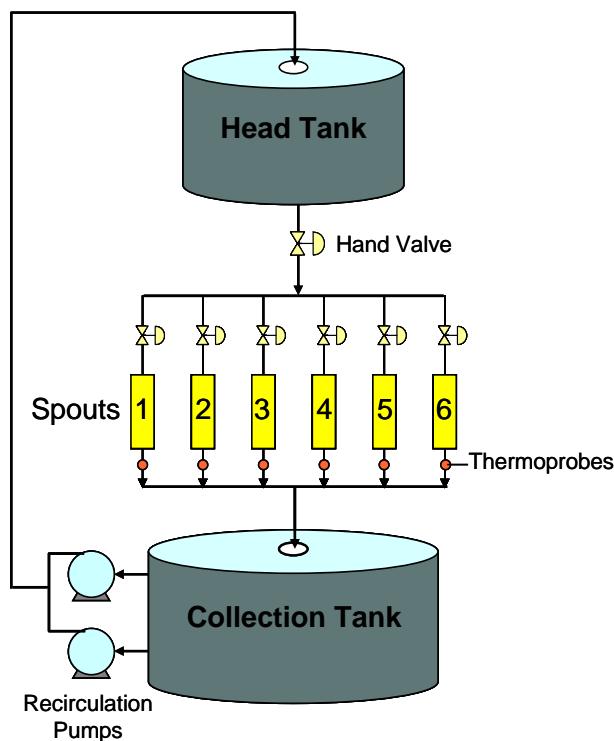
Figure 3. #2 RB smelt spout cooling water system

A thorough inspection was conducted on the spout cooling system, particularly the water lines shown in Figure 3. It was discovered during the inspection that the individual valve identifications were reversed between spouts #3 and #5, although the identification swap had probably been there since the boiler upgrade in 2004. This means that when the operator closed the water valve to spout #5 just before the ESP, he, in fact, shut off the cooling water to spout #3. This explains why water continued to enter the furnace through spout #5 even though the valve was closed. This also means that spout #3 passed through the ESP with no water cooling.

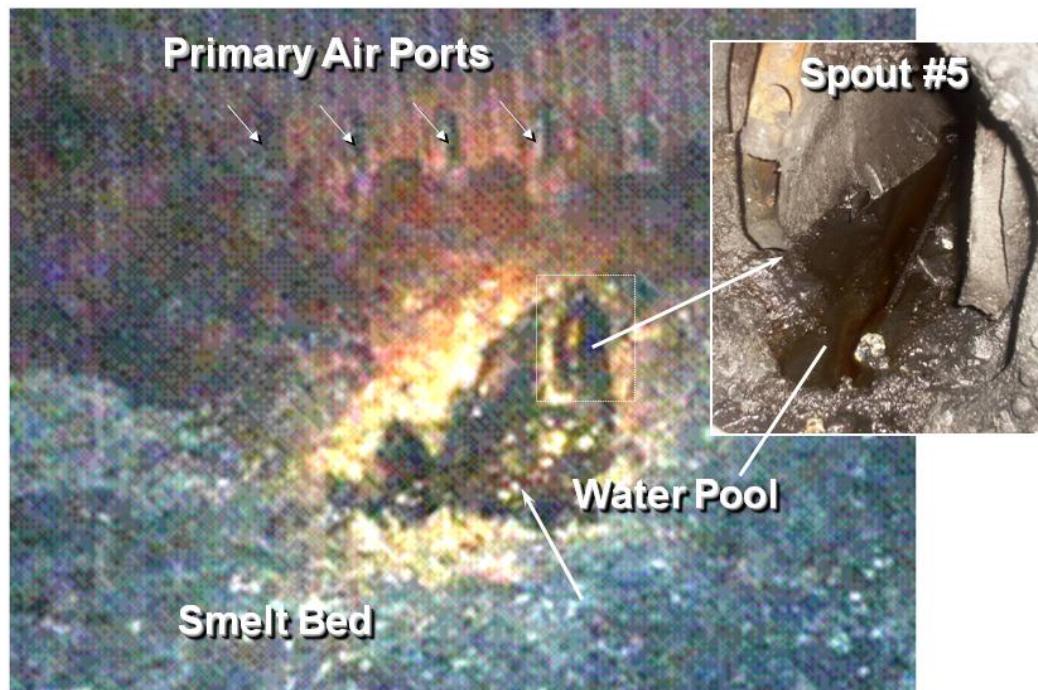
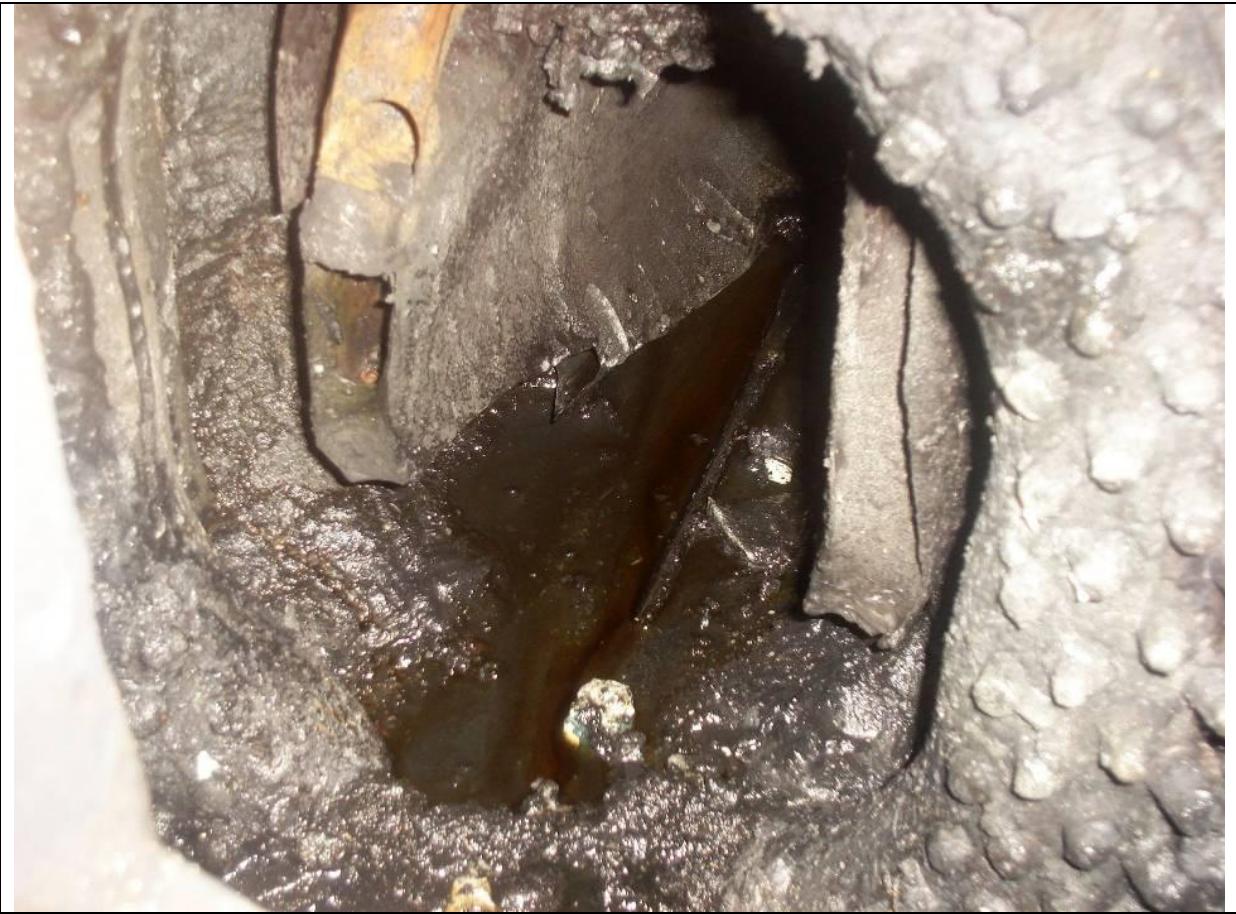
February 19, 2008 - Damage Inspection

- Spouts #1, 2, 3, 4 and 6 were in good shape
 - No sign of thinning or cracking
 - No internal deposits
- Only Spout #5 was severely damaged
 - A “defect” was found in the weld joint between the cooling water tube and the spout
- Metallurgical analysis of damaged area suggests overheating
- Some water passages were clogged with smelt

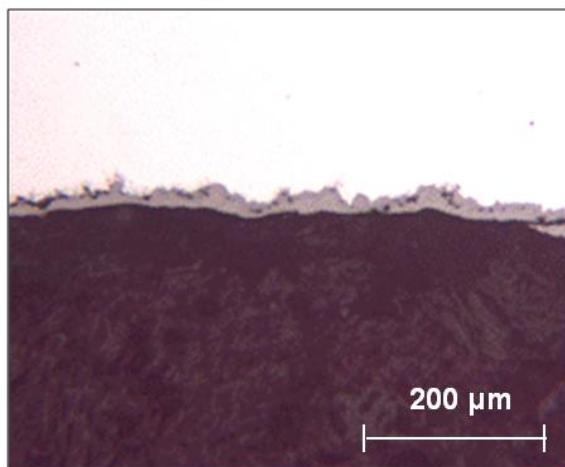
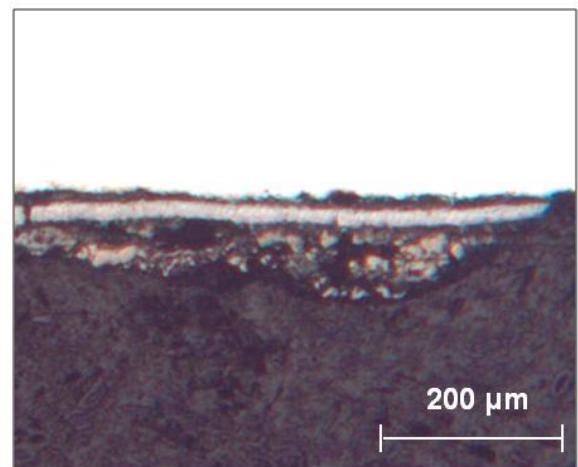
Spout #3

Spout #5

They have ran for the same time at the same condition.
